Tree Schedule for Survey of Plant Species of Conservation Importance

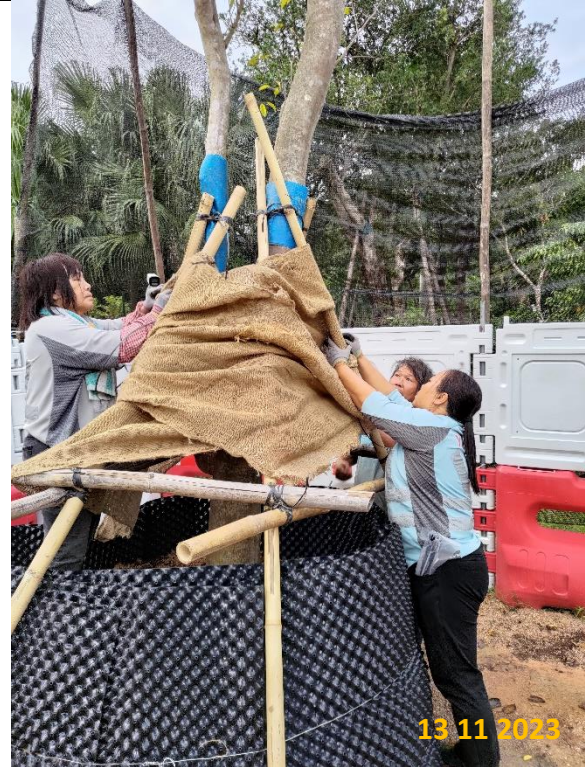
Trunk protection wrapping was adjusted away from the trunks on 13 Nov 2023. Slightly fertilizing was performed.

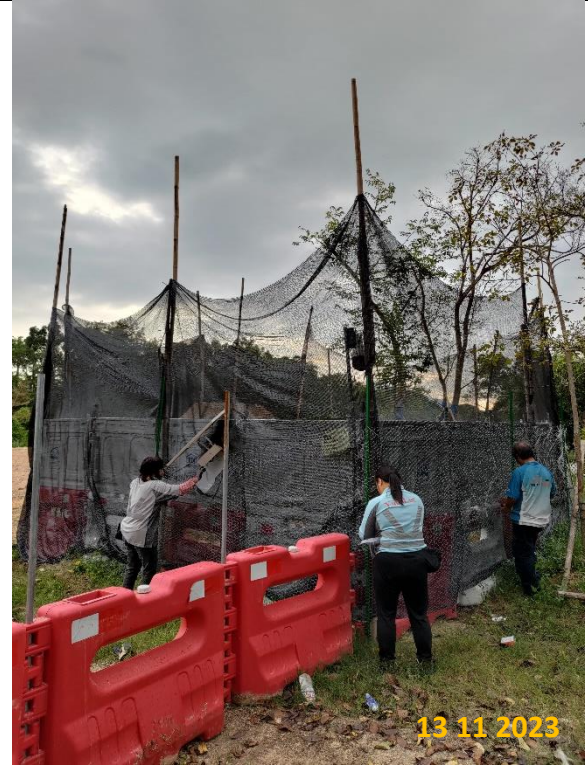
Additional shading net was installed

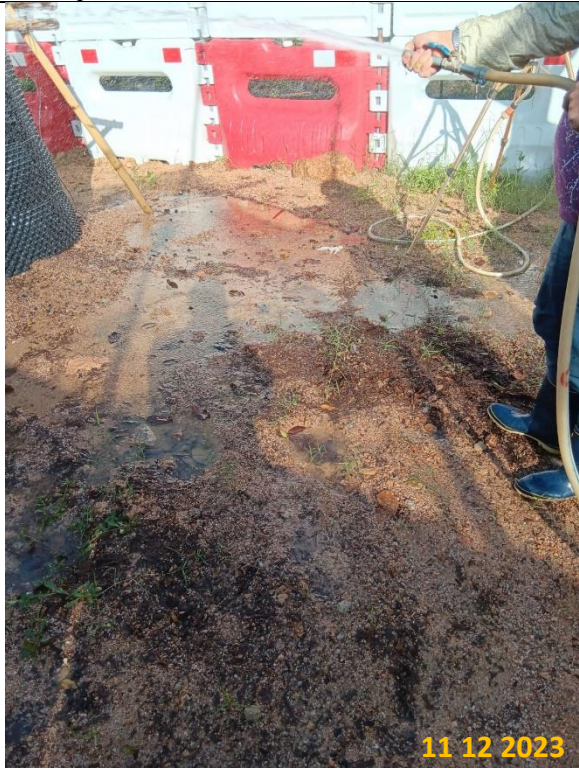
The semiautomatic irrigation was checked and is in order. Current watering frequency is three times per week

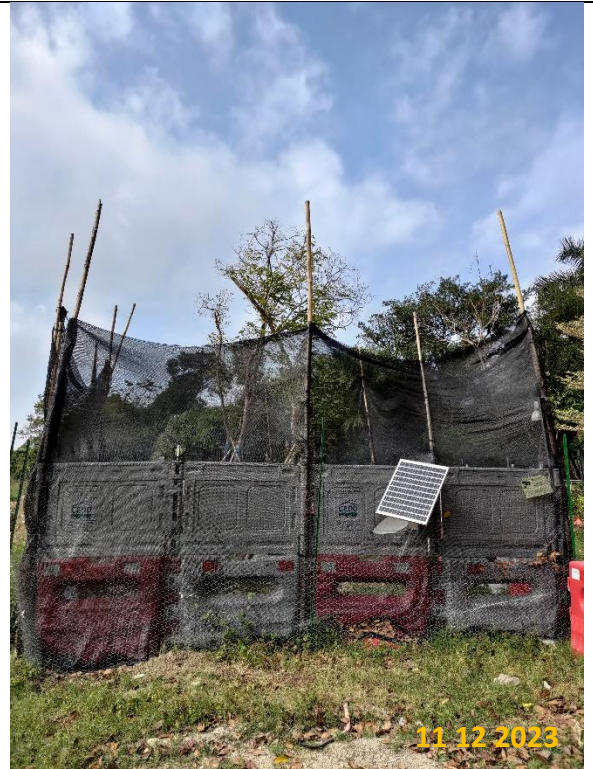
CCTV and fencing are in order
