Tung Chung New Town Extension – Site Formation and Infrastructure Works at Tung Chung Valley, Phase 1

Tree Schedule for Survey of Plant Species of Conservation Importance

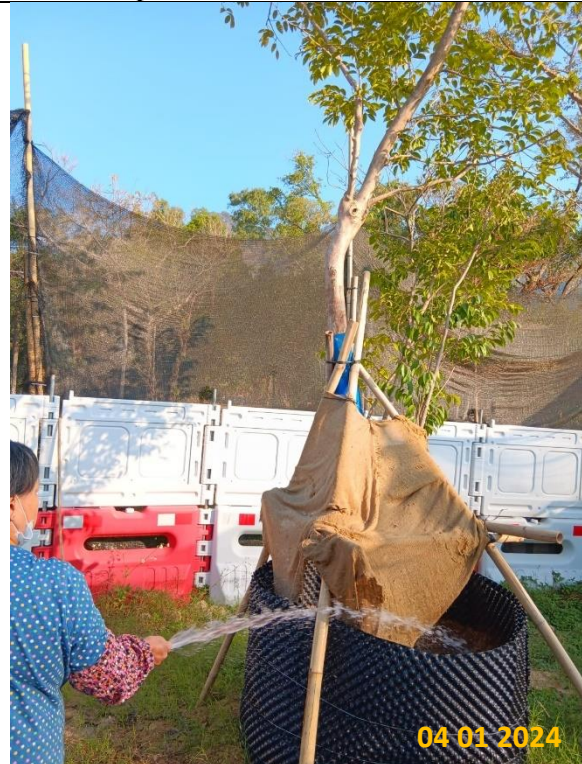
<p>A8 – Overall view</p>	<p>A8 – Foliage density was similar comparing to last inspection photos. While leaves were greener</p>
  <p>A photograph showing a young tree (A8) at a construction site. The tree is supported by a black mesh cage and wooden stakes. In the background, there are white and red safety barriers and other trees. The date '10 01 2024' is printed in yellow at the bottom right.</p>	  <p>A close-up photograph of the foliage of tree A8, showing green leaves against a clear blue sky. The date '10 01 2024' is printed in yellow at the bottom right.</p>
<p>A8 – Pruning wound previously damaged by typhoon KOINU (Oct 2023)</p>	<p>A8 – trunk condition.</p>
  <p>A close-up photograph of the trunk of tree A8, showing a pruning wound. The date '10 01 2024' is printed in yellow at the bottom right.</p>	  <p>A photograph showing the trunk of tree A8 supported by a black mesh cage and wooden stakes. The date '10 01 2024' is printed in yellow at the bottom right.</p>

Manual watering was carried out for A8 during the reporting period. The watering frequency is three time per week.

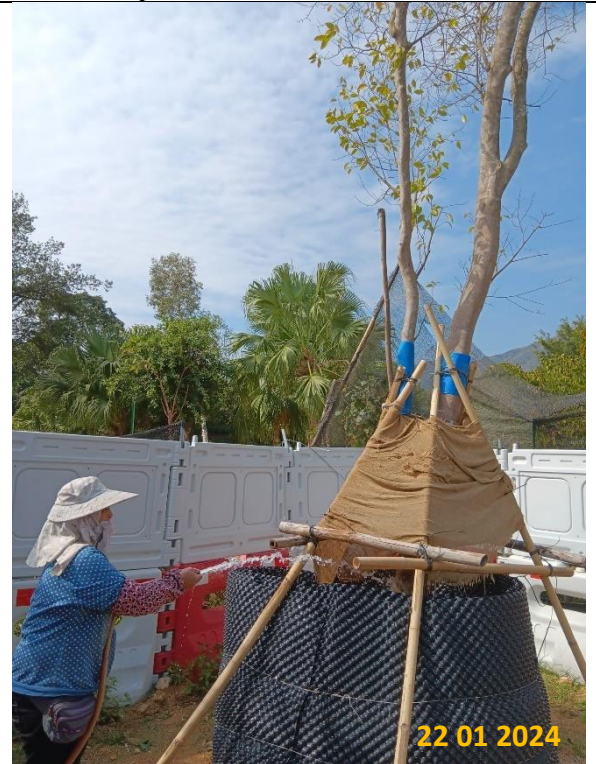
<p>A12 - Overall View</p>	<p>A12 – Foliage density is low since its collapse during Typhoon KOINU</p>
  <p>A photograph showing a young tree with a sparse canopy supported by a wooden tripod structure. The base of the tree is wrapped in black mesh. In the background, there are white and red plastic barriers and a clear blue sky. A yellow date stamp '10 01 2024' is visible in the bottom right corner.</p>	  <p>A close-up photograph of the tree's trunk and branches, highlighting the sparse, yellowish-green foliage. The trunk is light-colored and shows some texture. The background is a clear blue sky. A yellow date stamp '10 01 2024' is visible in the bottom right corner.</p>
<p>A12 – Codominant branch with included bark</p>	<p>A12 – trunk and root condition</p>
  <p>A close-up photograph of a codominant branch on the tree, showing a clear inclusion of bark between the branch and the main trunk. The branch is thin and has sparse foliage. The background is a clear blue sky. A yellow date stamp '10 01 2024' is visible in the bottom right corner.</p>	  <p>A close-up photograph of the tree's trunk and root area, showing the support structure and the black mesh wrapping. The trunk is light-colored and shows some texture. The background is a clear blue sky. A yellow date stamp '10 01 2024' is visible in the bottom right corner.</p>

Manual watering was carried out for A12 during the reporting period. The watering frequency is three time per week.

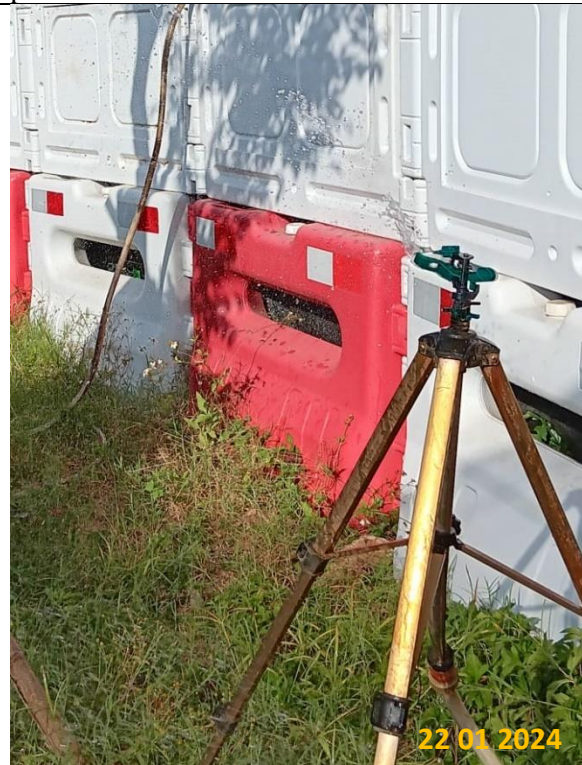
The semiautomatic irrigation was checked and is in order. The watering frequency is three times per week

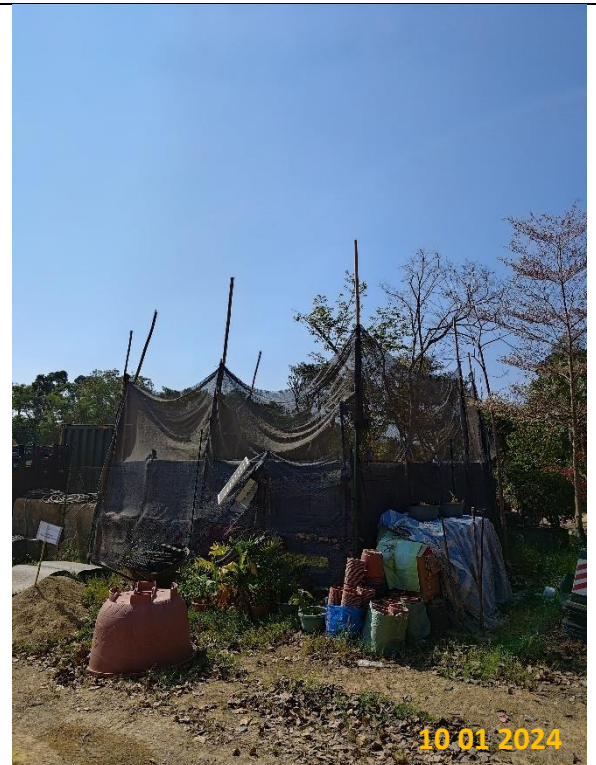
CCTV and fencing are in order
