Tung Chung New Town Extension – Site Formation and Infrastructure Works at Tung Chung Valley, Phase 1

**Tree Schedule for Survey of Plant Species of Conservation Importance**

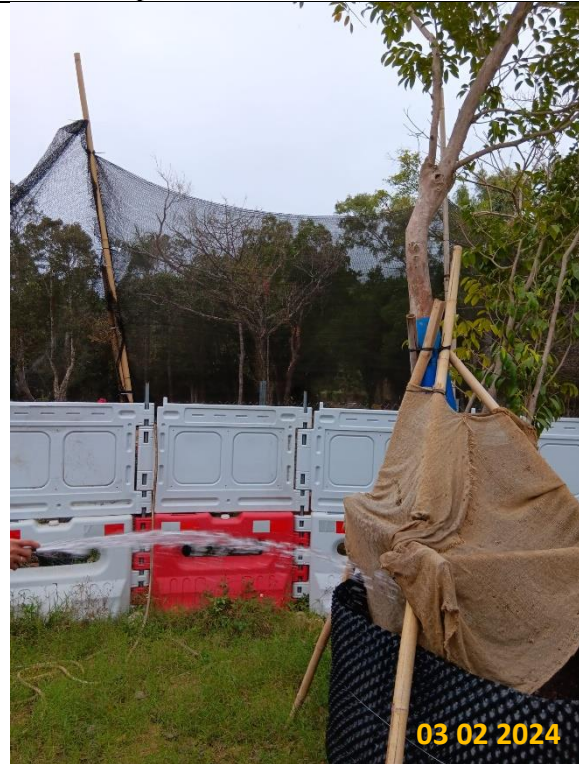
<p>A8 – Overall view</p>	<p>A8 – Foliage density was similar comparing to last inspection photos. While leaves were greener</p>
  <p>A photograph showing a young tree with green foliage. The tree is supported by a wooden tripod structure. The base of the tree is wrapped in a dark, patterned material. The tree is situated in a grassy area with a white and red plastic barrier in the background. A date stamp '08 02 2024' is visible in the bottom right corner.</p>	  <p>A close-up photograph of the tree's foliage, showing dense green leaves. The tree trunk is visible in the lower part of the frame. A date stamp '08 02 2024' is visible in the bottom right corner.</p>
<p>A8 – Pruning wound previously damaged by typhoon KOINU (Oct 2023)</p>	<p>A8 – trunk condition.</p>
  <p>A close-up photograph of the tree trunk, showing a large, irregular pruning wound. The wound is dark and appears to be a scar from a previous injury. The tree has green foliage. A date stamp '08 02 2024' is visible in the bottom right corner.</p>	  <p>A photograph showing the tree from a different angle, similar to the first overall view. The tree is supported by a wooden tripod structure. The base of the tree is wrapped in a dark, patterned material. The tree is situated in a grassy area with a white and red plastic barrier in the background. A date stamp '08 02 2024' is visible in the bottom right corner.</p>

Manual watering was carried out for A8 during the reporting period. The watering frequency is three time per week.

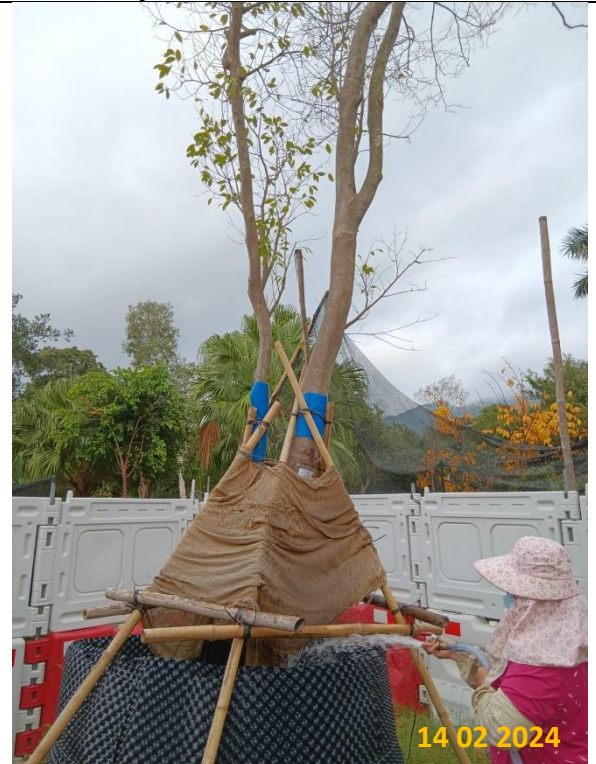
<p>A12 - Overall View</p>	<p>A12 – Foliage density is low since its collapse during Typhoon KOINU</p>
  <p>08 02 2024</p>	  <p>08 02 2024</p>
<p>A12 – Codominant branch with included bark</p>	<p>A12 – trunk and root condition</p>
  <p>08 02 2024</p>	  <p>08 02 2024</p>

Manual watering was carried out for A12 during the reporting period. The watering frequency is three time per week.

No.	Species		Conservation Status	Measurements			Tree Condition (Good(G) / Average(A) / Poor(P))			Recommendation (Retain / Transplant / Remove)	Findings	Remark
	Scientific Name	Chinese name		DBH (mm)	Height (m)	Crown (m)	Form	Health	Structure			
A8 (T8996)	<i>Aquilaria sinensis</i>	土沉香	RPPHK; Cap.586; IUCN:VU	110	5	4	P	A	P	Transplant	Foliage density is not yet improved in current inspection. The leaves are now greener.	Originally located at Site 1. Trunk wounds were observed before transplant operation. Shallow root. Sudden defoliation happened in May 2023 but recovered in Aug 2023. It was translocated to the temporary holding nursery on 29 Sep 2023. A branch (5cm) was broken and foliage density decreased due to typhoon in Oct 2023.
A12 (T3537)	<i>Aquilaria sinensis</i>	土沉香	RPPHK; Cap.586; IUCN:VU	185	8	3	A	P	A	Transplant	Foliage density is not yet improved in current inspection.	Originally located at Site 5. Trunk wounds were observed before transplant operation. Shallow root. Original root ball was full of stones which were removed partially during the translocation. It was translocated to the temporary holding nursery on 29 Sep 2023. It collapsed during typhoon dated Oct 2023 resulted in largely reduction in foliage density.

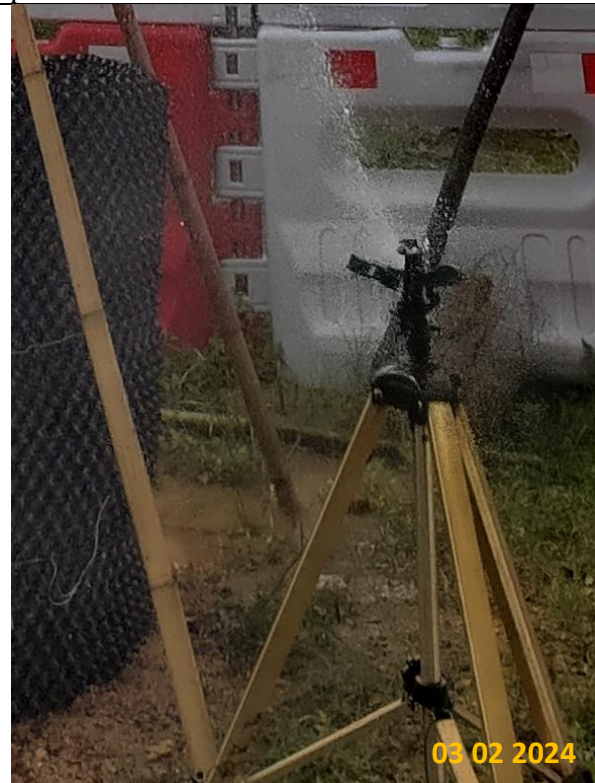
The semiautomatic irrigation was checked and is in order. The watering frequency is three times per week

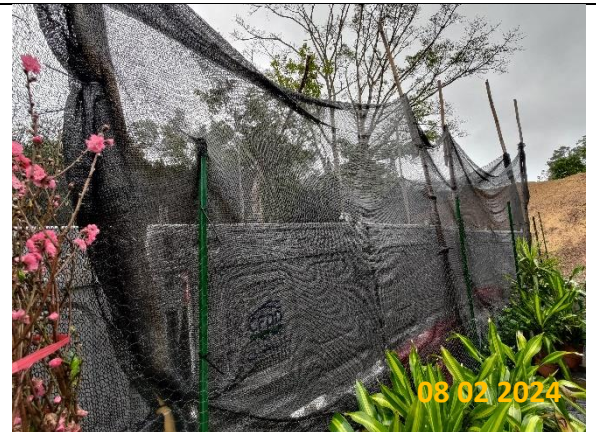
CCTV and fencing are in order
