Tree Schedule for Survey of Plant Species of Conservation Importance

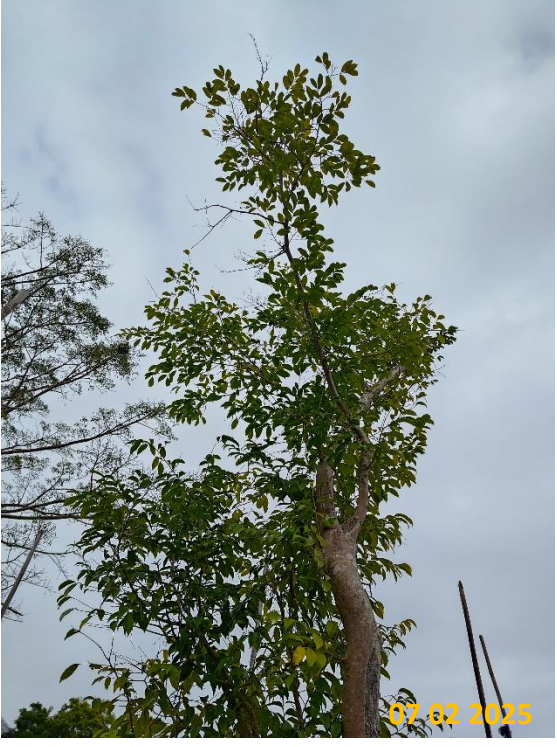
A close-up photograph of the crown of tree A8, showing its green foliage against a cloudy sky. A yellow date stamp "07 02 2025" is visible in the bottom right corner. <p>07 02 2025</p>
<p>A8 – Pruning wound previously damaged by typhoon KOINU (Oct 2023)</p>

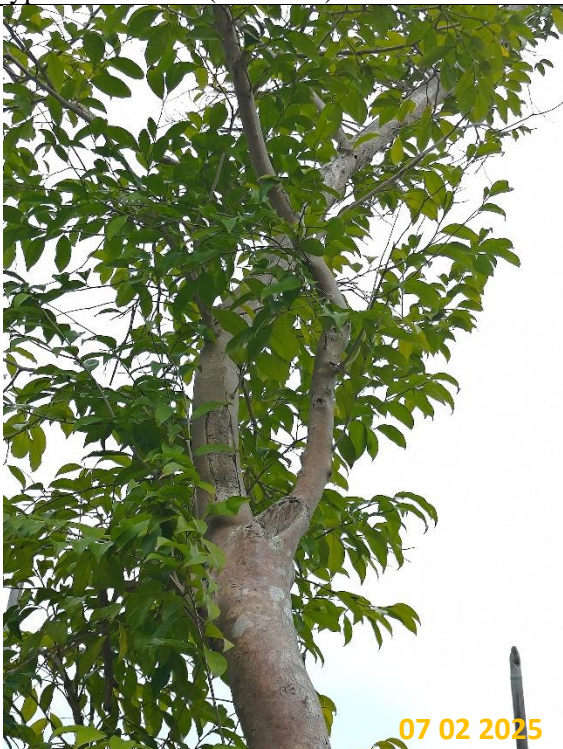
A close-up photograph of a pruning wound on the trunk of tree A8. The wound is a vertical cut in the bark, showing a lighter-colored interior. A yellow date stamp "07 02 2025" is visible in the bottom right corner. <p>07 02 2025</p>	<p>A8 – Trunk and root condition.</p>

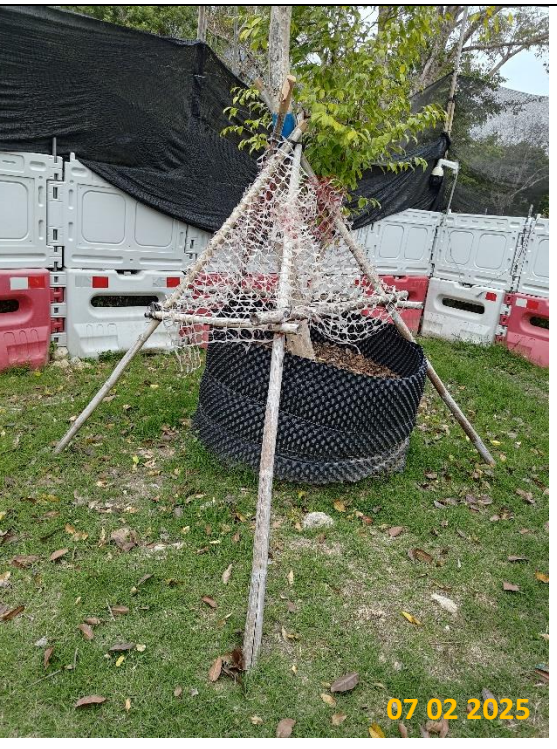
A photograph showing the trunk and root area of tree A8. The tree is supported by a wooden tripod frame, and a black mesh cage is around its base. The ground is grassy with some fallen leaves. A yellow date stamp "07 02 2025" is visible in the bottom right corner. <p>07 02 2025</p>

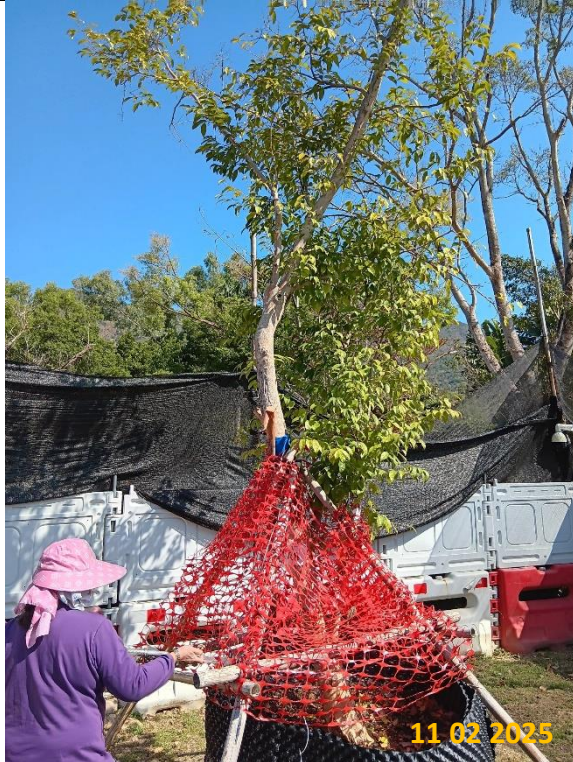
Manual watering was carried out for A8 during the reporting period. The watering frequency is one to two times per week.

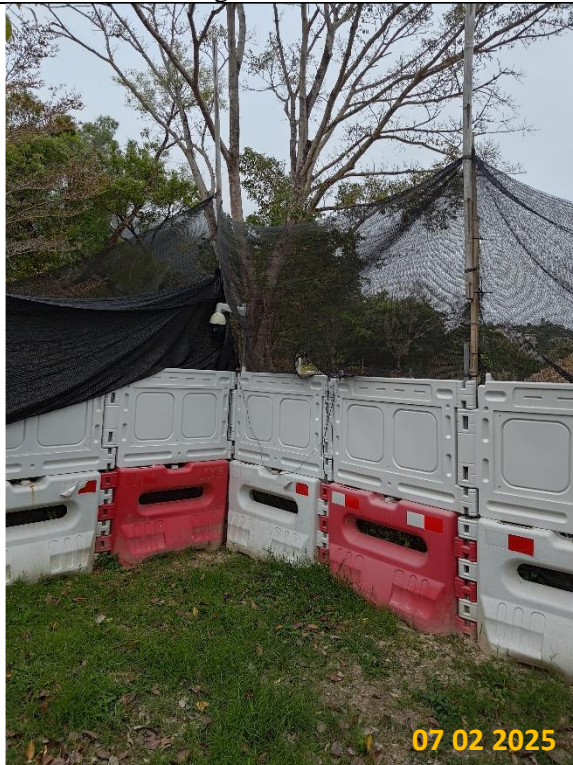
CCTV and fencing are in order.

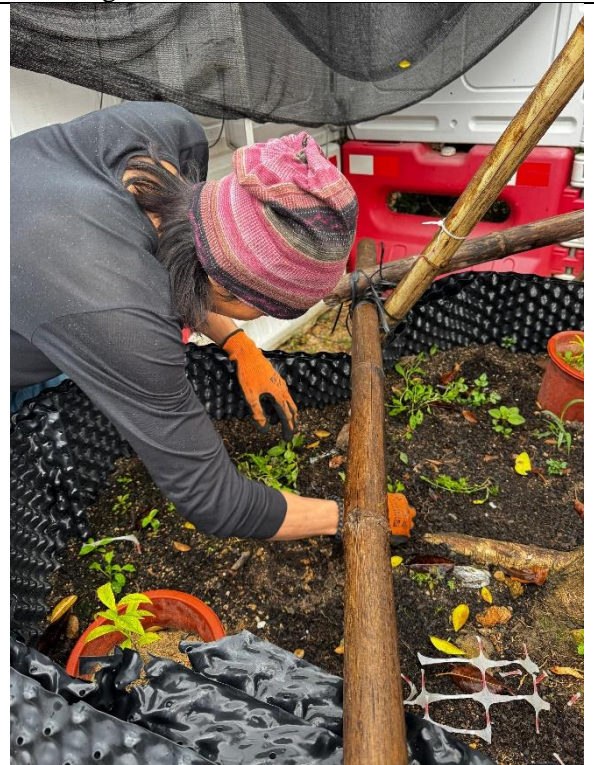
Weeding was done on 03/02/2025
