NL/2020/05 Photographic record (Monthly Monitoring Report for Preservation of Plant Species of Conservation Importance – October 2025)

CEDD Contract No. NL/2020/05 Tung Chung New Town Extension – Site Formation and Infrastructure Works at Ma Wan Chung

Tree Schedule for Survey of Plant Species of Conservation Importance

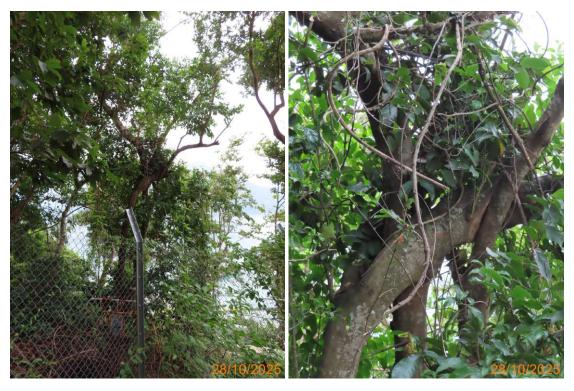
1: T8217

2: T8217_Cross branches

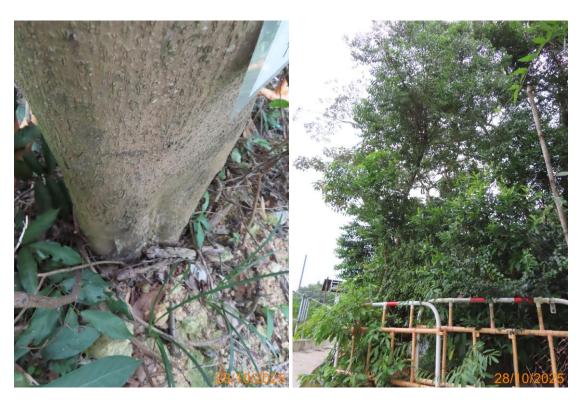
3: T8217_Trunk base

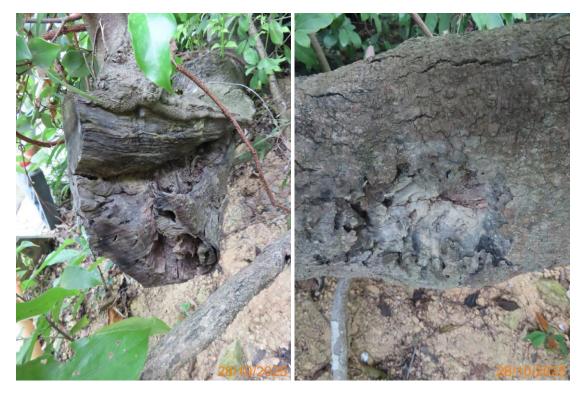
4: T8231

5: T8231_Borer hole#1

6: T8231_Borer hole#2

T8231	Canthium dicoccum	魚骨木	IUCN:VU	7	190	6	L	P	A	P	Retain	Second epicormic failure was found on 21 July 2025 due to Typhoon signal No. 10, Overall condition of tree and its remaining part is fair	There is no proper and safe assess towards T8231 & T8217, thus, plastics barriers were installed in lieu of 2m high barrier. Epiconmic branch failure was found on 03 May 2024. Staking to provide extra support and pruning of jagged wound to provide a clean cut was conducted on 16 May 2024. Application of insecticide and fungicide on wound was conducted on 31 October 2025, Adjustment of trunk protection pad was conducted on 31 October 2025 and 25 September 2025. The Staking was in normal condition during the time of inspection. No further significant defects were observed. Second epicormic failure was found on 21 July 2025, Overall condition of tree and its remaining part is fair. Pruning of jagged wound to provide a clean cut is recommended. Pruning works was completed on 21 July 2025.

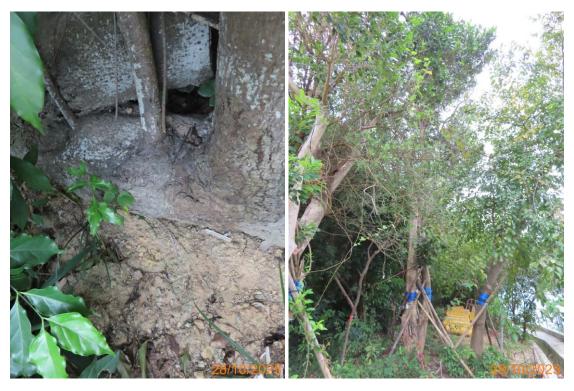
7: T8231_Trunk base

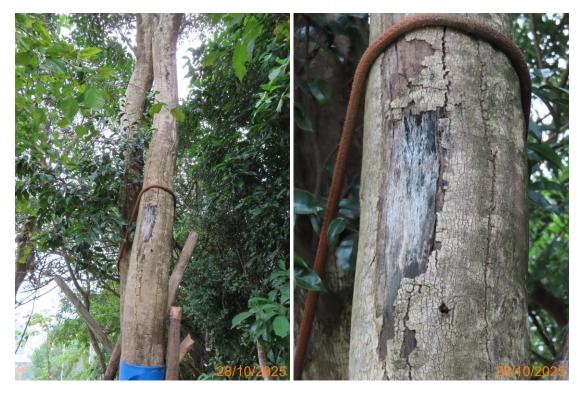
8: U041

9: U041_Abnormal bark crack on trunk

10: U041_Abnormal bark crack on trunk_Close up

U041	Aquilaria sinensis	土沉香	RPPHK; Cap.586; IUCN:VU	10	318	4	М	A	P	P	Retain	No obvious old termite track was found, damage of wood tissue was observed. Peeling off of bark and sign of split of internal wood tissue was observed. Trunk wound signficantly decayed. High trunk failure risk.	Located closed to cut slope. The crack on trunk was found slightly larger since late March 2024. Peeling off of bark and split of internal wood tissue was observed in July 2024. Abnormal bark crack was found in December 2024. Additional guying for tree no. U041 has been installed as an enhanced stabilization measure alongside the bamboo staking in May 2025. Adjustment of guying and application of insecticide and fungicide was conducted on 31 October 2025. Adjustment of trunk protection pad was conducted on 31 October 2025 and 25 September 2025.
U042	Gmelina chinensis	石梓	RPPHK	6	150	2	М	A	P	A	Retain	Large wound near trunk base with wound wood development. Trunk wound is decaying.	Located closed to cut slope. Application of insecticide and fungicide as preventive measure was conducted on 31 October 2025. Adjustment of trunk protection pad was conducted on 31 October 2025 and 25 September 2025.

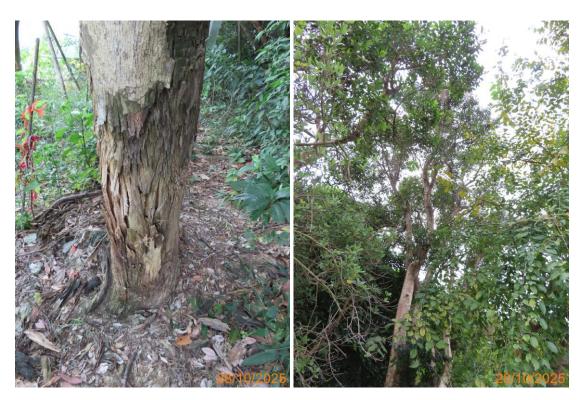
11: U041_Crack on trunk

12: U041_Crown

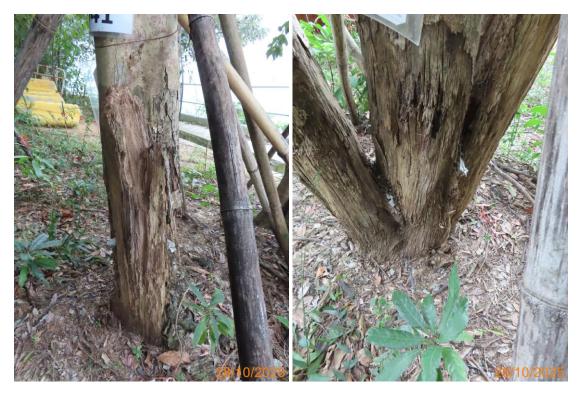
13: U041_Wood damage at trunk union#1

14: U041_Wood damage at trunk union#2

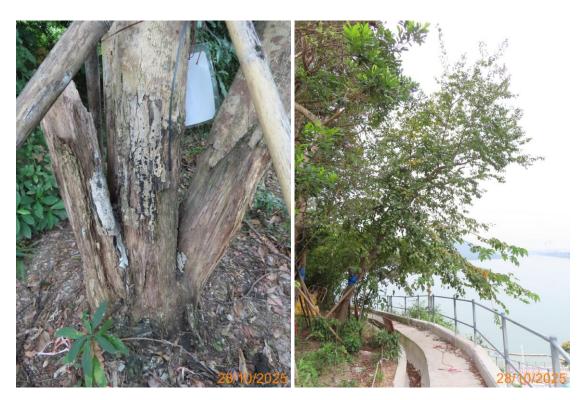
15: U041_Wood damage at trunk union#3

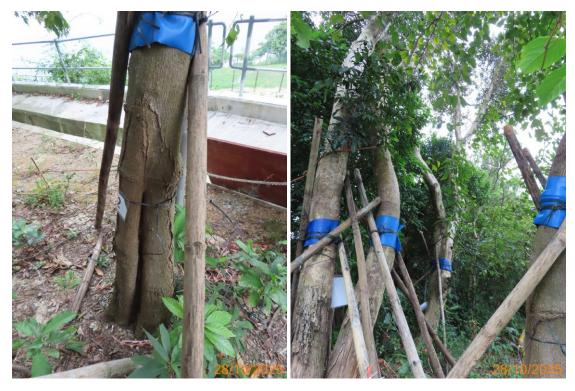
16: U042

17: U042_Wound on trunk base

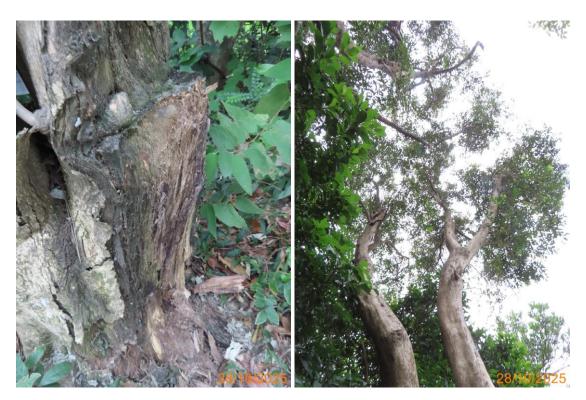
18: U043

19: U043_Crack on trunk

20: U043_Crown

U043	Aquilaria sinensis	土沉香	RPPHK; Cap.586; IUCN:VU	9	310	4	М	Α	Р	Р	Retain	Crack on trunk base. Trunk wound significantly decayed. High trunk failure risk.	Located closed to cut slope and fenced off by 2m high barrier. Application of insecticide and fungicide was conducted on 31 October 2025. Adjustment of trunk protection pad was conducted on 31 October 2025 and 25 September 2025.

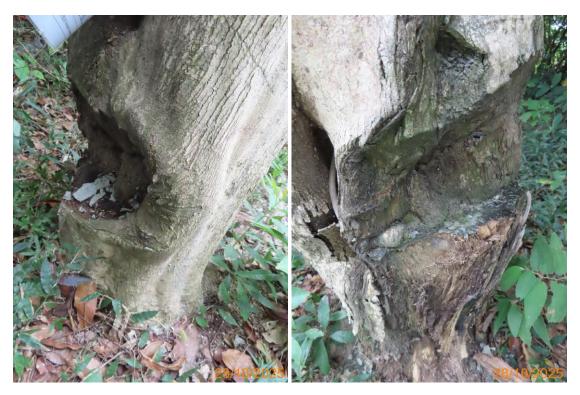
21: U043_Wound on trunk#1

22: U043_Wound on trunk#2

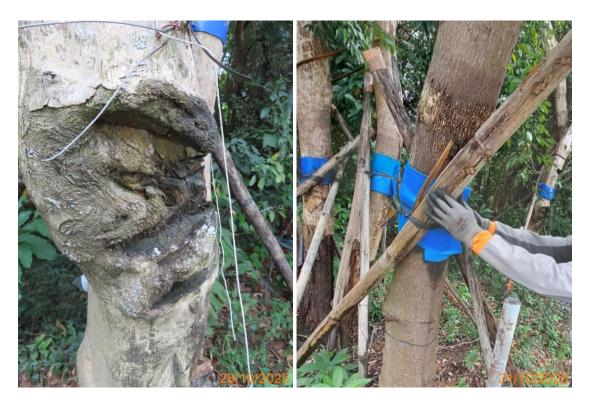
23: U043_Wound on trunk#3

24: Adjust protection pad for U042
