Tree Schedule for Survey of Plant Species of Conservation Importance

Tung Chung New Town Extension – Site Formation and Infrastructure Works at Tung Chung Valley, Phase 1

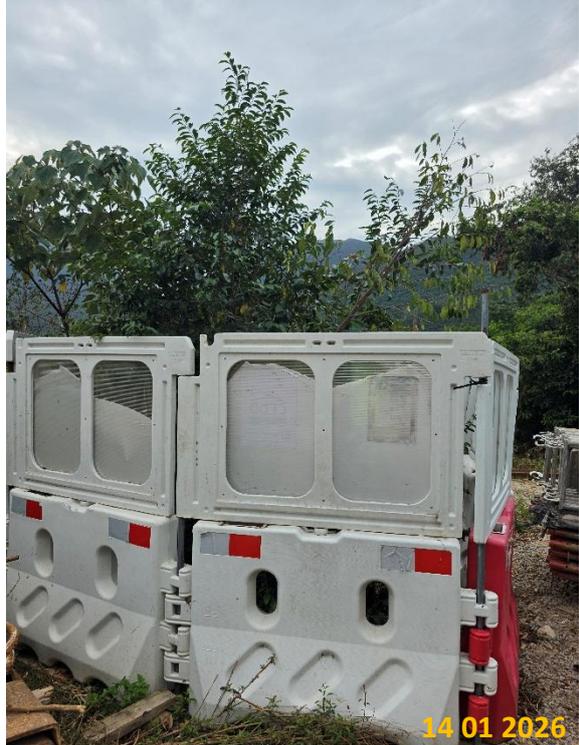
<p>A11 – Overall view</p>	<p>A11 – Crown condition.</p>

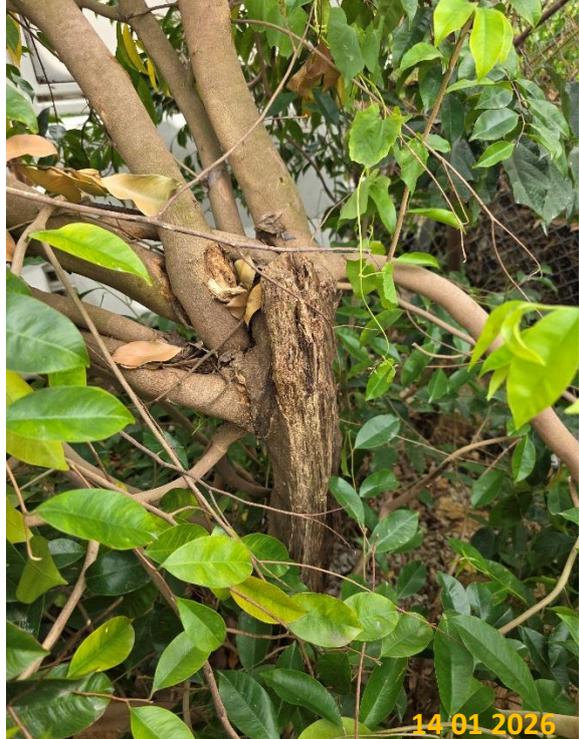
<p>14 01 2026</p>
<p>A11 – Shoots are epicormic generated from cut trunk which is decaying severely</p>	<p>A11 - Soil condition</p>

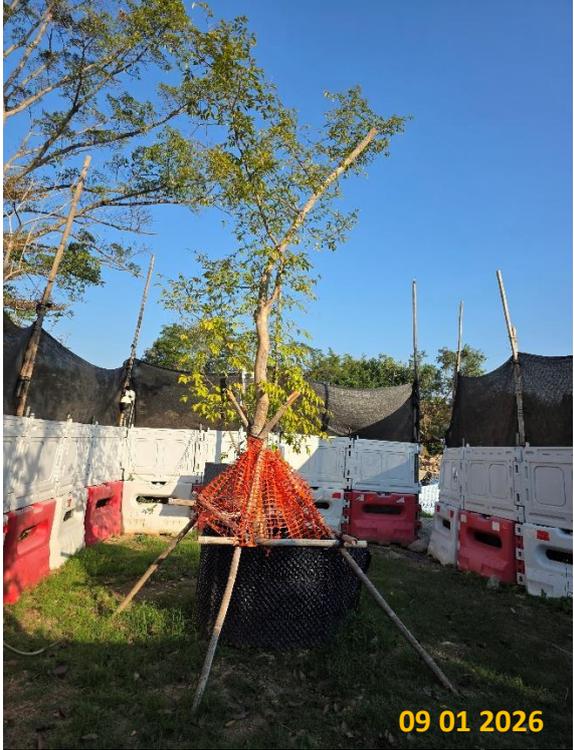
<p>A8 – Overall view</p>	<p>A8 – Crown condition. Foliage density is low since Super Typhoon dated Sep 2025.</p>

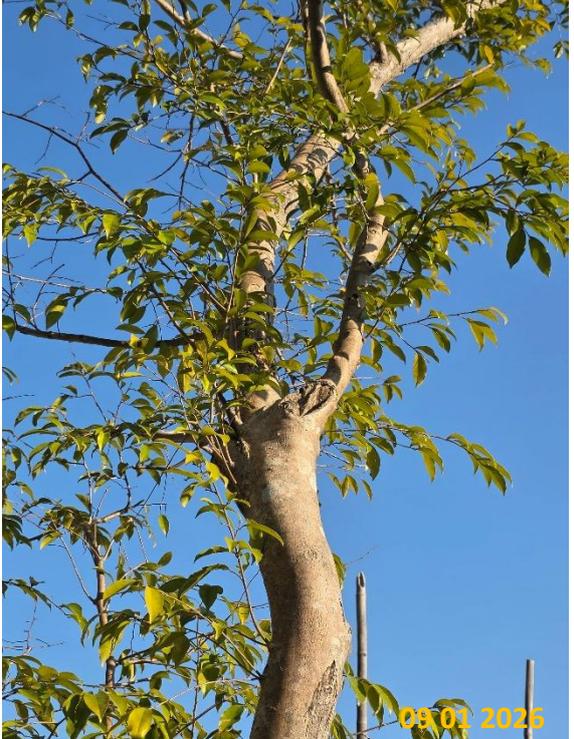
<p>A close-up photograph of the crown of tree A8, showing sparse foliage. The tree is supported by a wooden tripod structure. The date '09 01 2026' is visible in the bottom right corner.</p>
<p>A8 – Pruning wound previously damaged by typhoon KOINU (Oct 2023)</p>	<p>A8 – Trunk and root condition.</p>

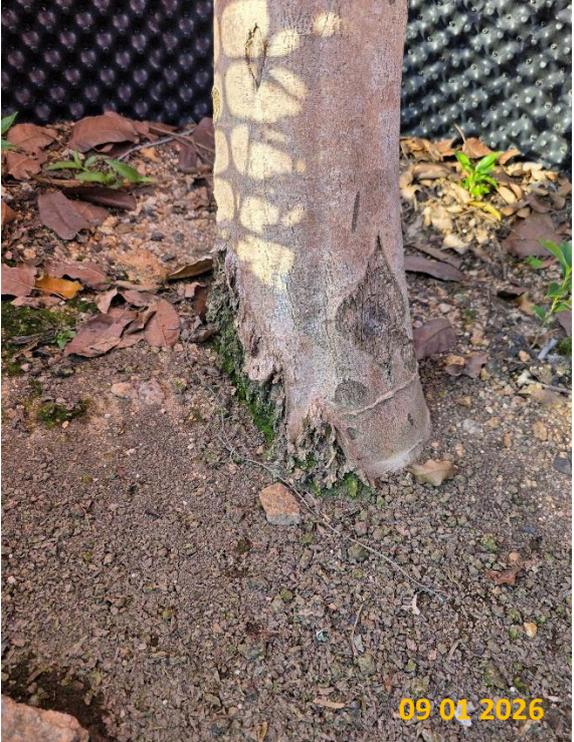
<p>A8 – Decaying wound at trunk base (size: ~180mm x170mm)</p>	<p>A8 – Decaying wound on trunk</p>

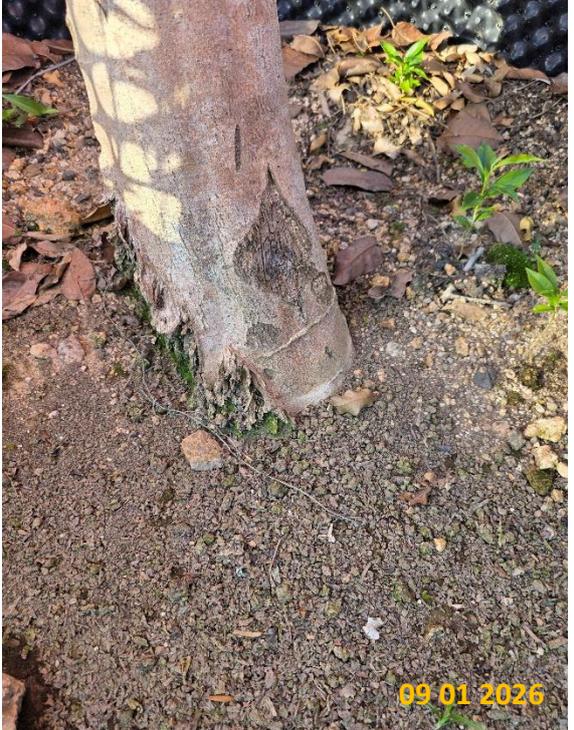
<p>A8 – Ant nest was not found</p>	<p>A8 – Leaves chlorosis and thin</p>

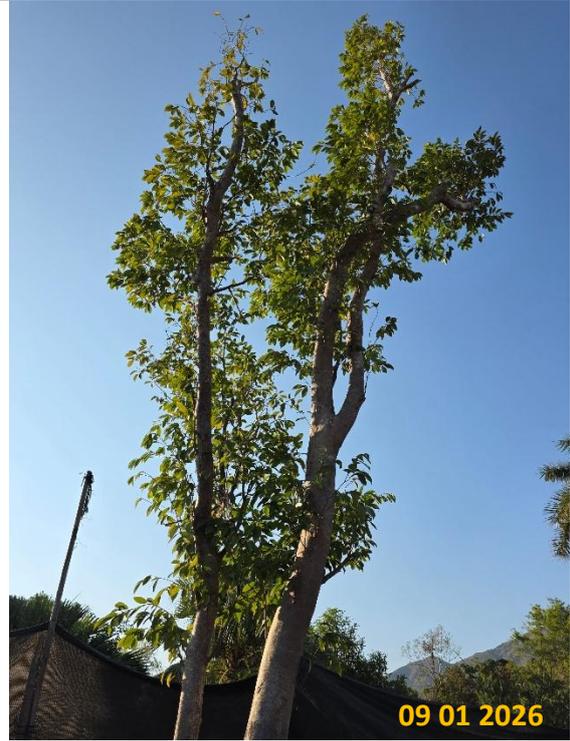
<p>09 01 2026</p> <p>This photograph shows a young tree with a thin trunk and sparse green foliage. The tree is situated in a construction area, with a black protective netting around its base and a barrier made of white and red plastic containers. The background shows a clear blue sky and some distant trees.</p>	<p>A12 - Dieback observed.</p>

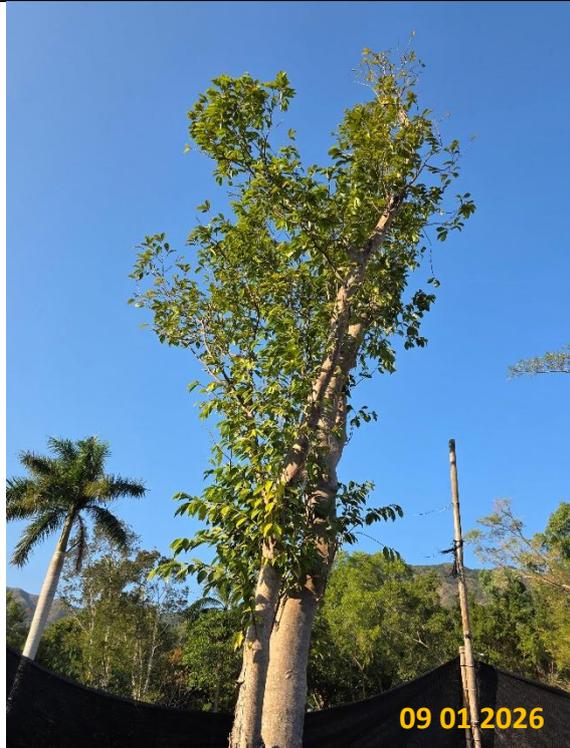
<p>09 01 2026</p> <p>This photograph is a closer view of the tree's canopy, highlighting areas where the leaves are sparse or missing, indicating dieback. The trunk is visible, and the background shows the same construction site environment.</p>
<p>A12 - Foliage density reduced significantly after previous inclement weather.</p>

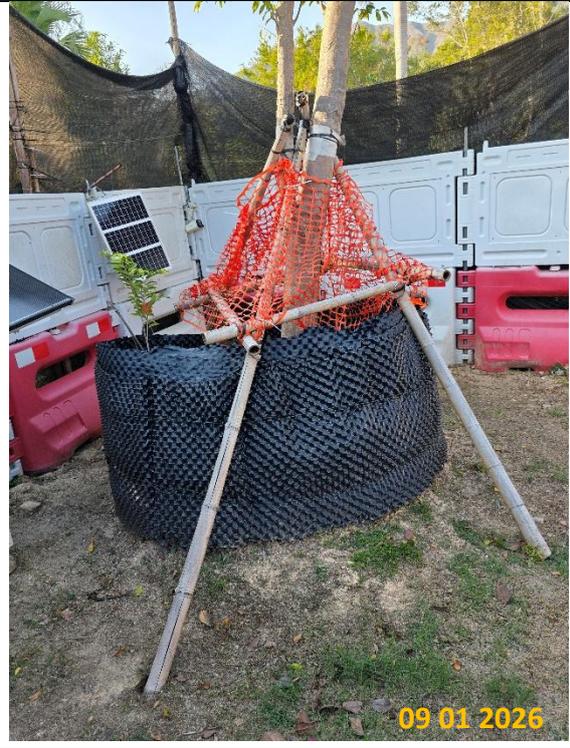
<p>09 01 2026</p> <p>This photograph shows the tree from a similar angle as the overall view, but the foliage appears noticeably thinner and less dense, consistent with the caption's description of a significant reduction after inclement weather.</p>	<p>A12 – Trunk and root condition</p>

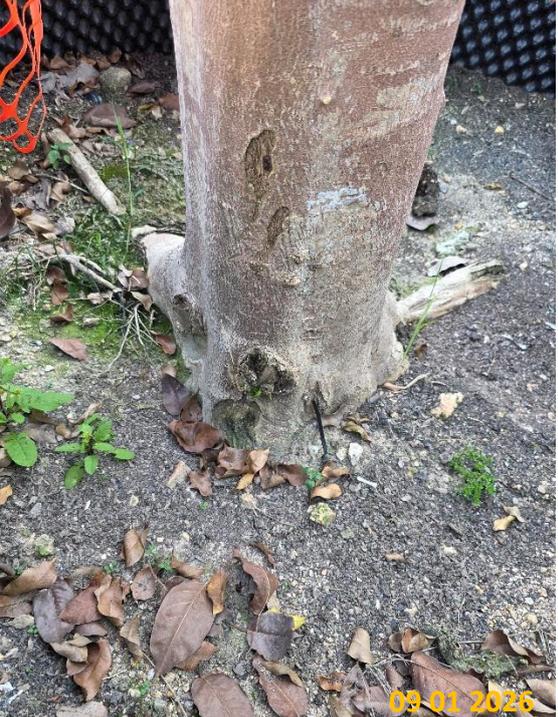
<p>A12 – Wound at trunk base</p>

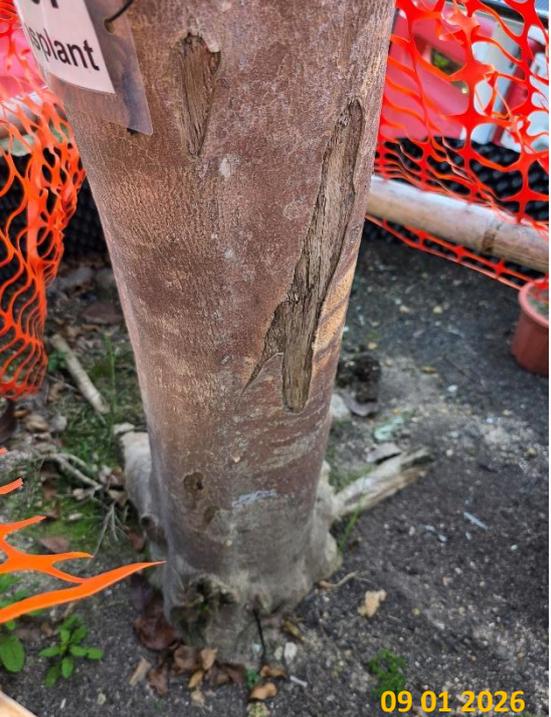
<p>09 01 2026</p>	<p>A12 – Decaying wound on trunk</p>

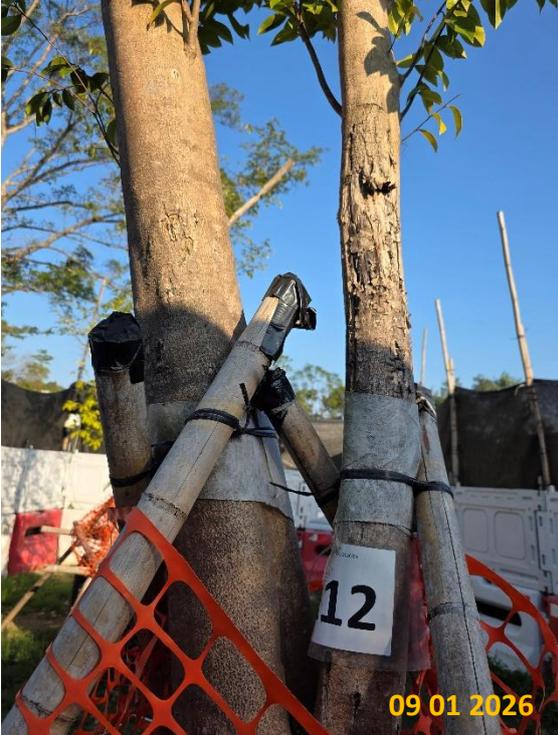
<p>09 01 2026</p>
<p>A12 – Epicormics on trunk. Decaying wound on Trnk.</p>

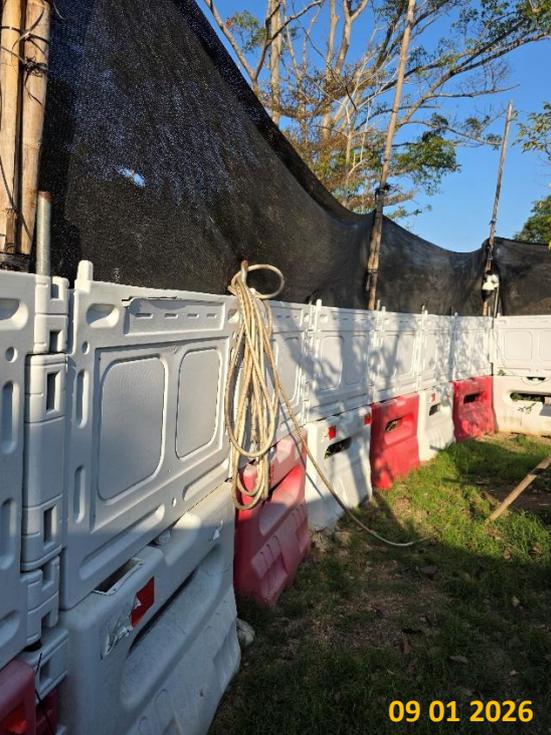
<p>09 01 2026</p>	<p>Fencing is in order during inspection</p>
