Tree Schedule for Survey of Plant Species of Conservation Importance

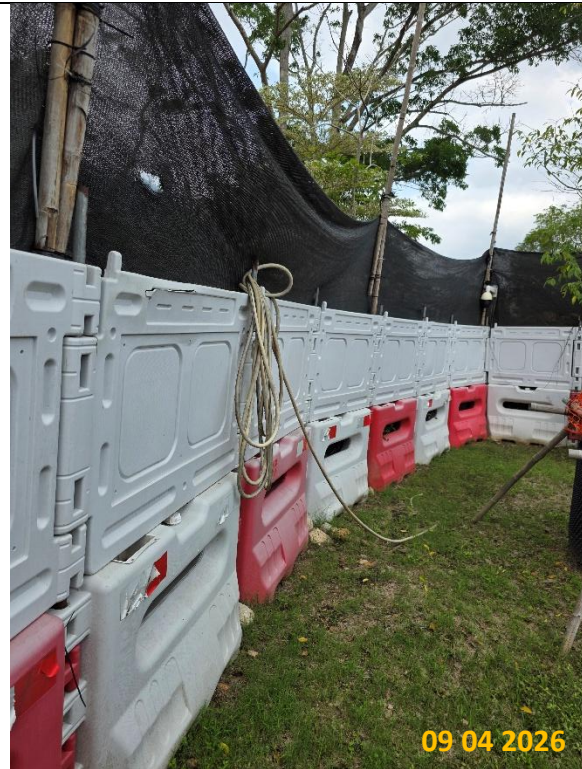
Fencing is in order during inspection

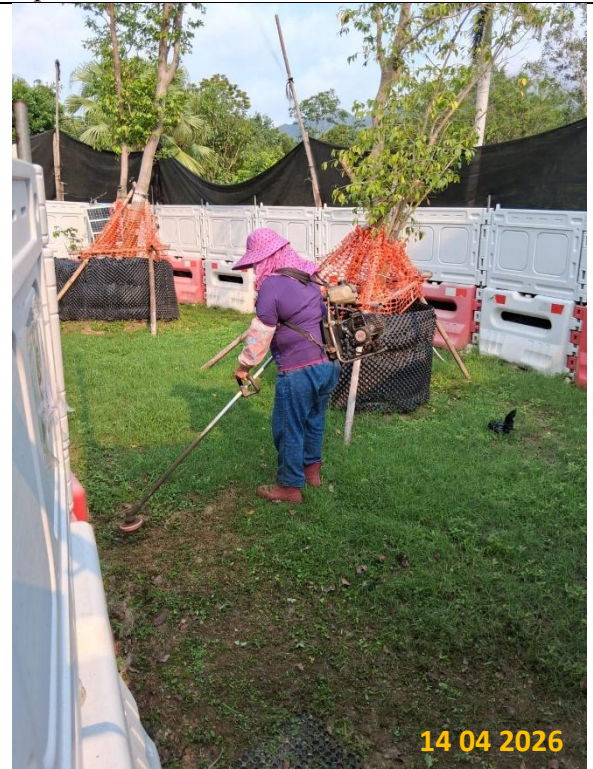
Grass cutting and weeding was conducted on 14 April 2026.

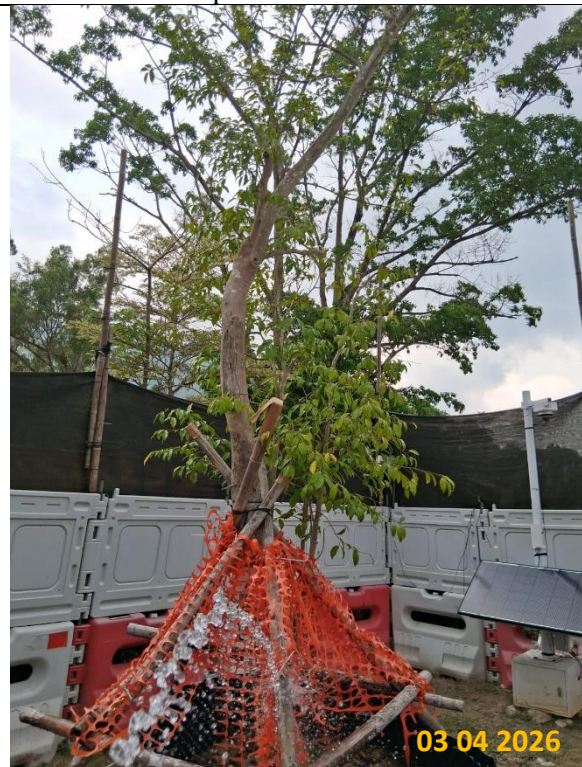
Manual watering was carried out for A8 during the reporting period. The watering frequency is one to two times per week.

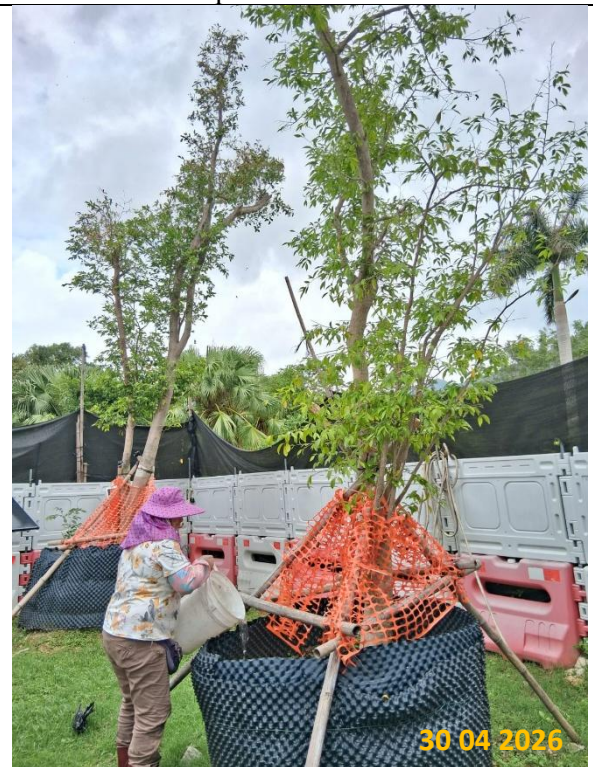
Manual watering was carried out for A12 during the reporting period. The watering frequency is one to two times per week.
