Tree Schedule for Survey of Plant Species of Conservation Importance

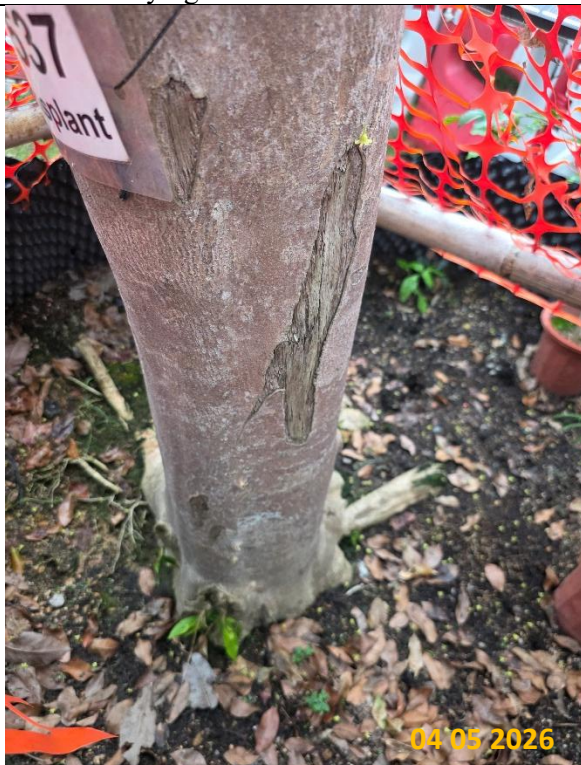
<p>A12 –Wound at trunk base</p>   <p>04 05 2026</p>	<p>A12 – Decaying wound on trunk</p>

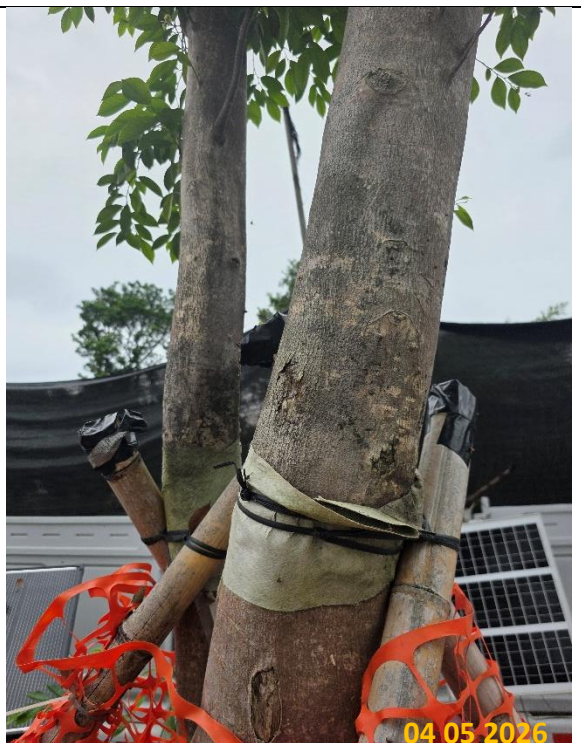
<p>04 05 2026</p>
<p>A12 – Epicormics on trunk. Decaying wound on Trnk.</p>

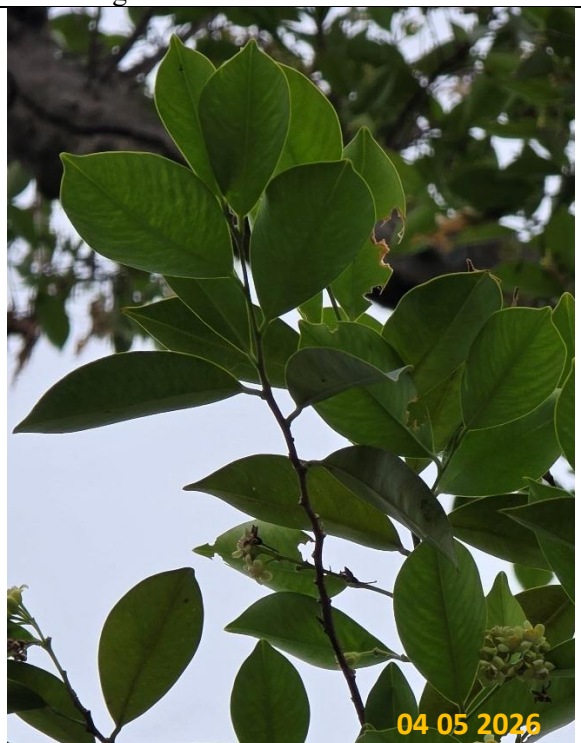
<p>04 05 2026</p>	<p>A12 – Unknown insect pest observed. Flowering was observed.</p>

A12 (T3537)	<i>Aquilaria sinensis</i>	土沉香	RPPHK; Cap.586; IUCN:VU	185	8	3	P	P	A	Transplant	No obvious wound wood production. Severity of the insect feeding was moderate. Pest control was done on 19 May 2026. Grass cutting and weeding was conducted on 2 May 2026. Adjustment of staking and protection pads were conducted on 19 May 2026. Cultivation and fertilizing were conducted on 8 May 2026. Application of compost mulch was carried out on 29 May 2026.	Trunk wounds were observed before transplant operation. Shallow root. Original root ball was full of stones which were removed partially during the translocation. It was translocated to the temporary holding nursery on 29 Sep 2023. It collapsed during typhoon dated Oct 2023 resulted in largely reduction in foliage density. It was slightly lean after a typhoon event dated 13-14 Nov 2024 and reinstated. Decaying wounds and exposed dead woods on trunk. The foliage density is low and further reduced after inclement weather events on Aug/Sep 2025.

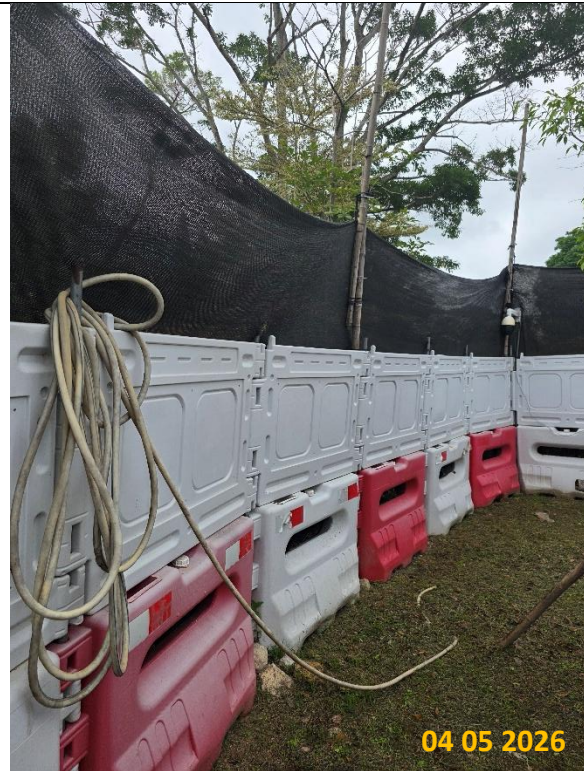
Fencing is in order during inspection
