Tree Schedule for Survey of Plant Species of Conservation Importance

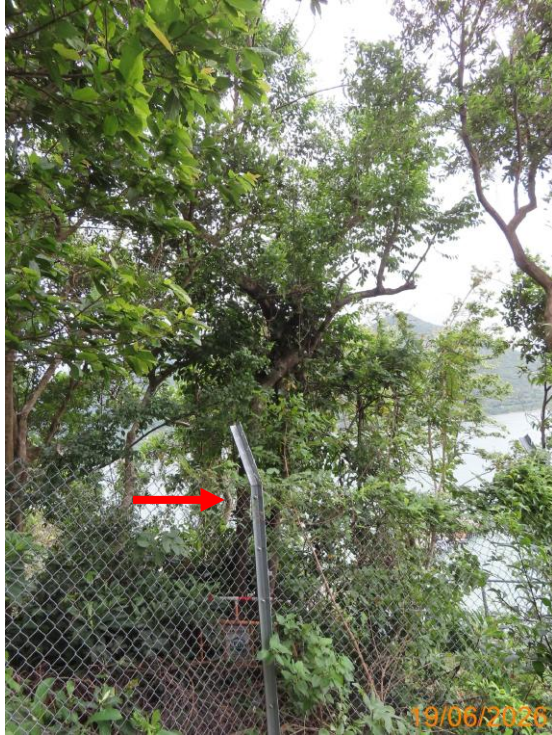
1: T8217

| Tree No. | Species | | | Measurements | | | Amenity Value<br>(High(H) / Medium (M) / Low(L) | Tree Condition (Good(G) / Average(A) / Poor(P)) | | | Recommendation<br>(Retain / Transplant / Remove) | Findings | Remark |
|---|---|---|---|---|---|---|---|---|---|---|---|---|---|
| T8217 | <i>Canthium dicoccum</i> | 魚骨木 | IUCN:VU | 9 | 220 | 6 | L | P | A | P | Retain | Branch failure of T8217 was found on 21 July 2025 due to Typhoon signal No. 10. Overall condition of tree and its remaining part is fair. | There is no proper and safe assess towards T8231 & T8217, thus, plastics barriers were installed in lieu of 2m high barrier. Branch failure of T8217 was found on 21 July 2025. It was identified that the fallen part was one of the branches on upper position of tree. No decay was observed on the tearing position. No other collapsed part was observed due to adverse weather during time of inspection. Overall condition of tree and its remaining part is fair. Pruning of jagged wound to provide a clean cut is recommended. The pruning work the completed on 21 July 2025. Application of insecticides and fungicides on wound was conducted to prevent infection of wound on 24 June 2026. |

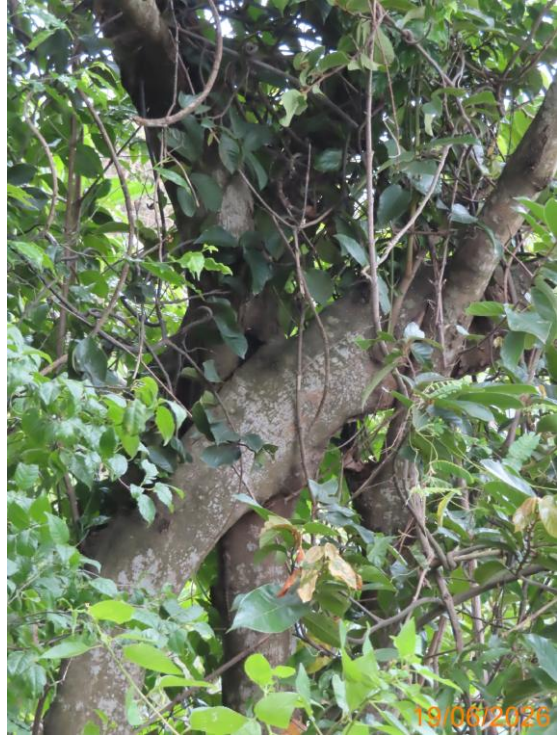
2: T8217\_Cross branches

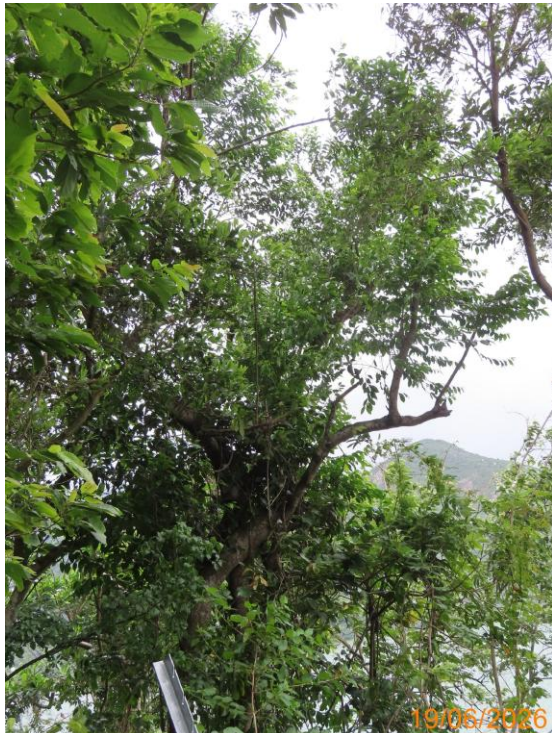
3: T8217\_Crown

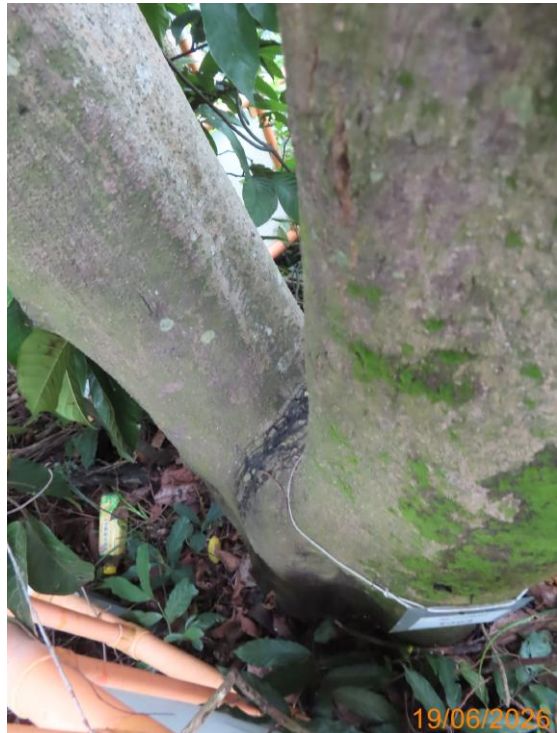
4: T8217\_Trunk base

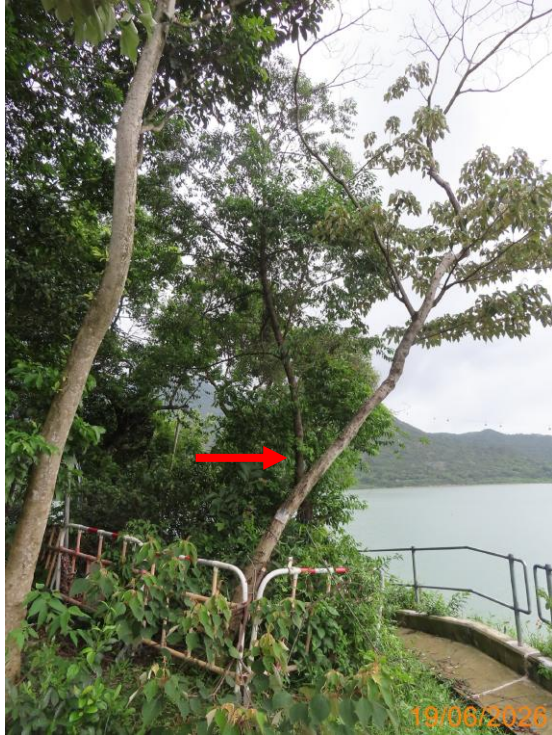
5: T8231

| Tree No. | Species | | | Measurements | | | Amenity Value<br>(High(H) / Medium (M) / Low(L) | Tree Condition (Good(G) / Average(A) / Poor(P)) | | | Recommendation<br>(Retain / Transplant / Remove) | Findings | Remark |
|---|---|---|---|---|---|---|---|---|---|---|---|---|---|
| T8231 | <i>Canthium dicoccum</i> | 魚骨木 | IUCN:VU | 7 | 190 | 6 | L | P | A | P | Retain | Second epicormic failure was found on 21 July 2025 due to Typhoon signal No. 10, third epicormics failure was found on 21 May 2026 due to Amber Rainstorm Warning signal, Overall condition of tree and its remaining part is fair | There is no proper and safe assess towards T8231 & T8217, thus, plastics barriers were installed in lieu of 2m high barrier. Epicormic branch failure was found on 03 May 2024. Staking to provide extra support and pruning of jagged wound to provide a clean cut was conducted on 16 May 2024. Application of insecticide and fungicide on wound was conducted on 24 June 2026, Adjustment of trunk protection pad was conducted on 24 June 2026. The Staking was in normal condition during the time of inspection. No further significant defects were observed. Second epicormic failure was found on 21 July 2025, Overall condition of tree and its remaining part is fair. Pruning of jagged wound to provide a clean cut is recommended. Pruning works was completed on 21 July 2025. Third epicormic failure was found on 21 May 2026. Pruning of jagged wound to provide a clean cut was conducted on 29 May 2026. |

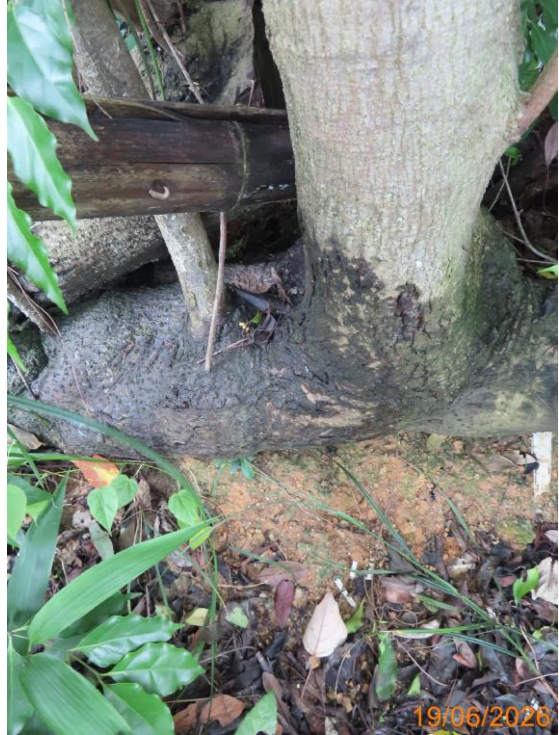
6: T8231\_Trunk base

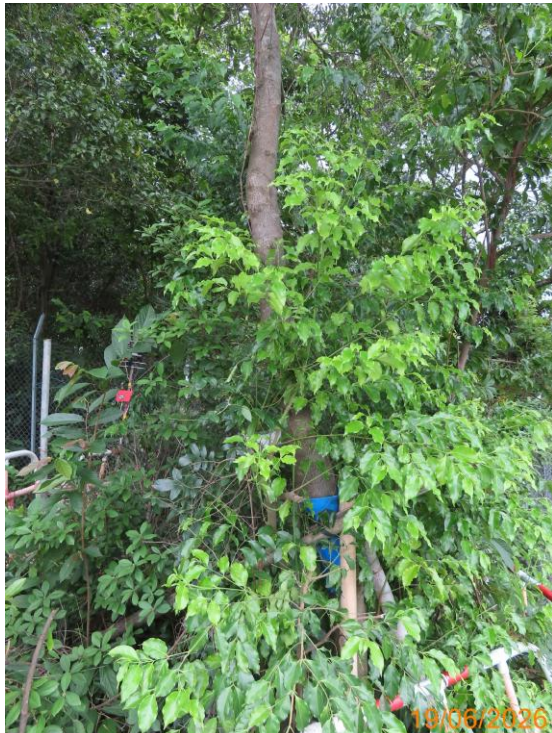
7: T8231\_Trunk

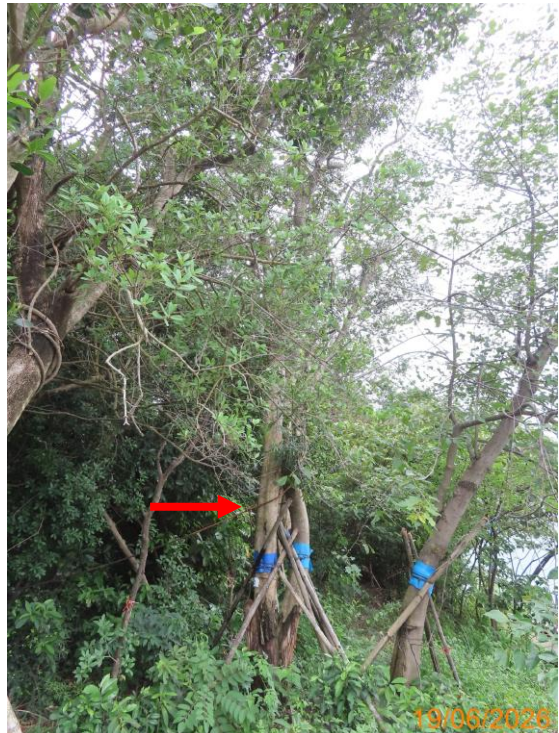
8: U041

| Tree No. | Species | | | Measurements | | | Amenity Value<br>(High(H) / Medium (M) / Low(L) | Tree Condition (Good(G) / Average(A) / Poor(P)) | | | Recommendation<br>(Retain / Transplant / Remove) | Findings | Remark |
|---|---|---|---|---|---|---|---|---|---|---|---|---|---|
| U041 | <i>Aquilaria sinensis</i> | 土沉香 | RPPHK;<br>Cap.586;<br>IUCN:VU | 10 | 318 | 4 | M | A | P | P | Retain | No obvious old termite track was found, damage of wood tissue was observed. Peeling off of bark and sign of split of internal wood tissue was observed. Trunk wound significantly decayed. High trunk failure risk. | Located closed to cut slope. The crack on trunk was found slightly larger since late March 2024. Peeling off of bark and split of internal wood tissue was observed in July 2024. Abnormal bark crack was found in December 2024. Additional guying for tree no. U041 has been installed as an enhanced stabilization measure alongside the bamboo staking in May 2025. Adjustment of guying and application of insecticide and fungicide was conducted on 24 June 2026. Adjustment of trunk protection pad was conducted on 24 June 2026. |

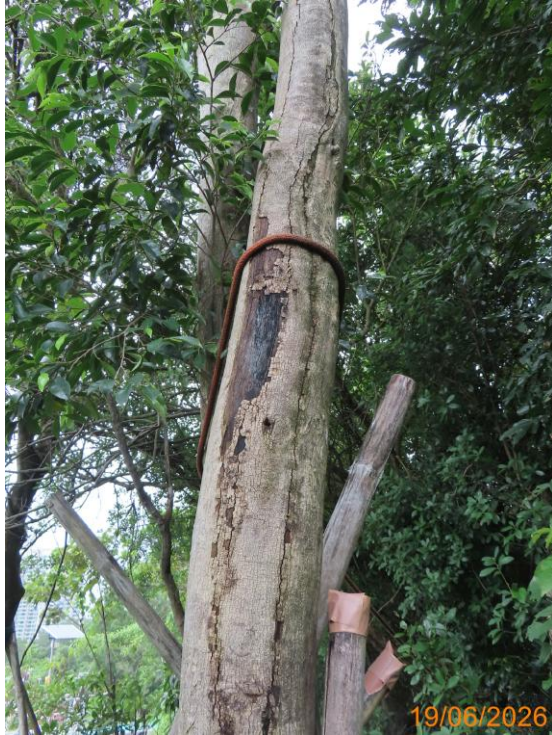
9: U041\_Abnormal bark crack on trunk

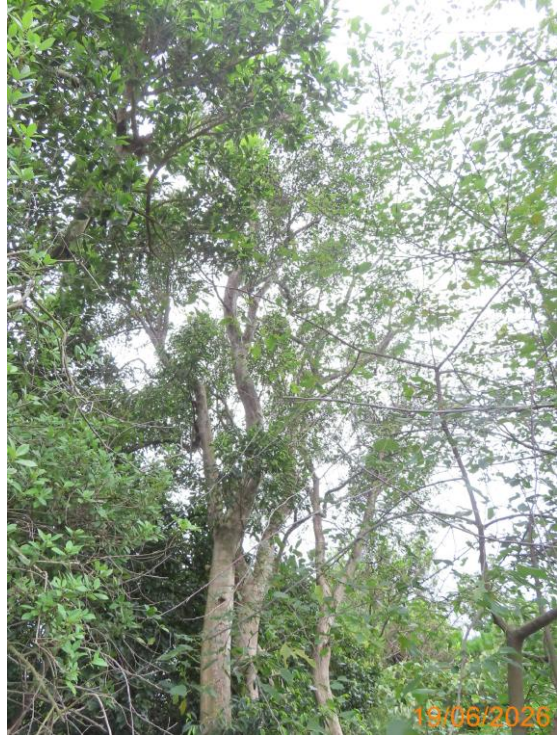
10: U041\_Crown

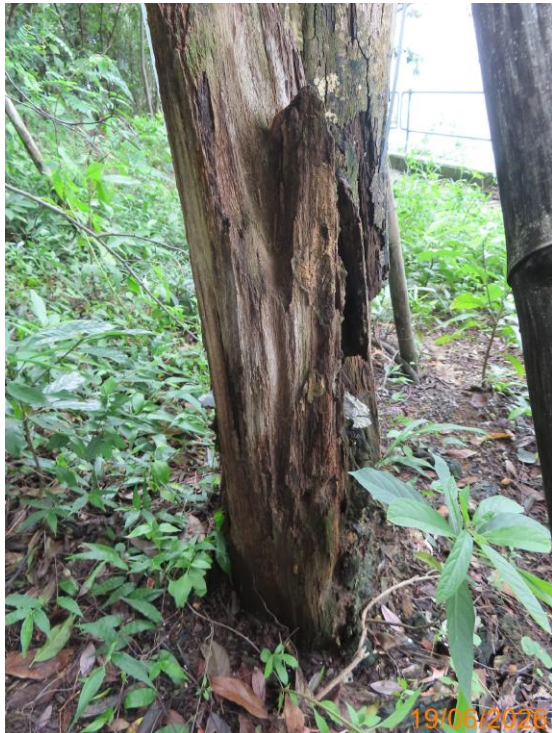
11: U041\_Dead stump

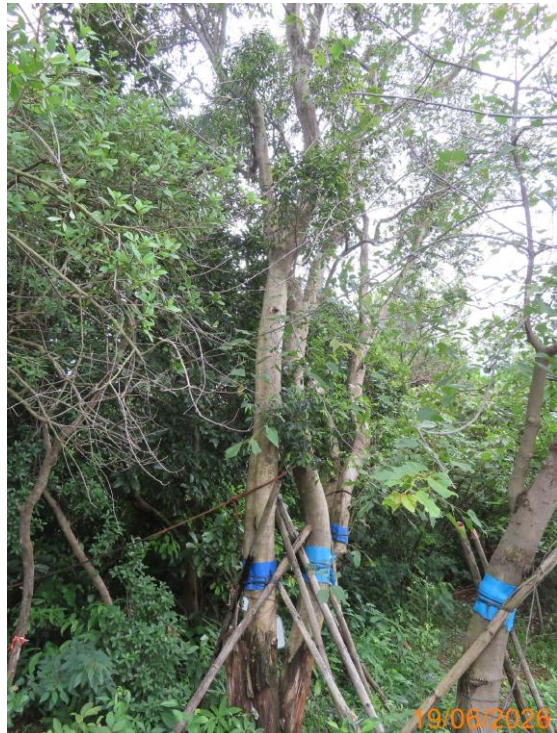
12: U041\_Trunk

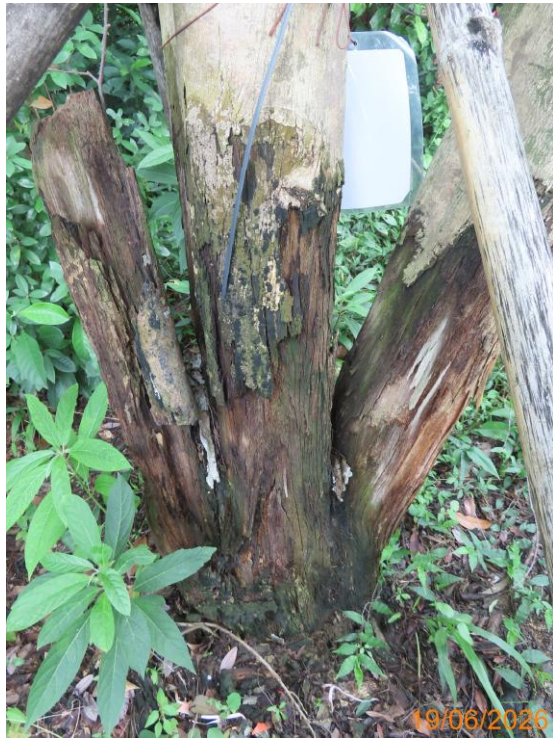
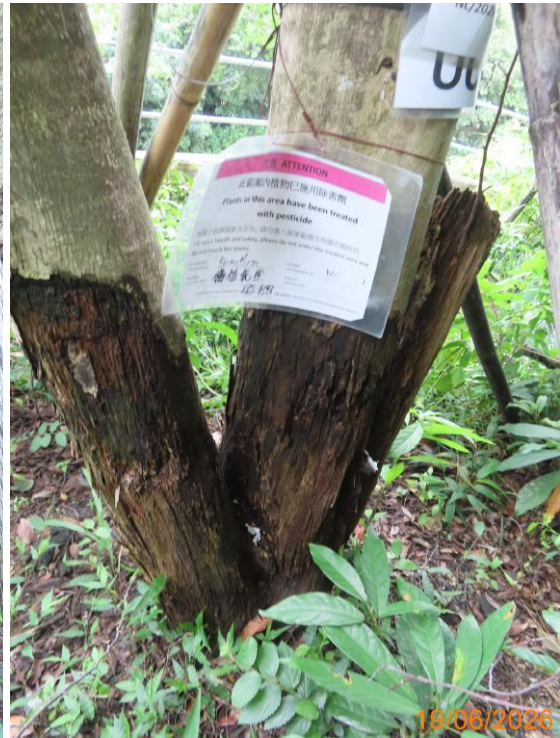
13: U041\_Wound damage at trunk union#1

14: U041\_Wound damage at trunk union#2

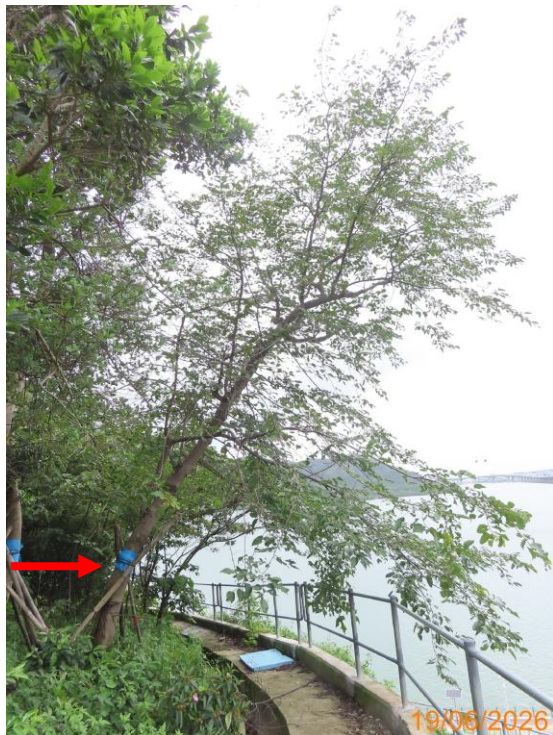
15: U042

| Tree No. | Species | | | Measurements | | | Amenity Value<br>(High(H) / Medium (M) / Low(L) | Tree Condition (Good(G) / Average(A) / Poor(P)) | | | Recommendation<br>(Retain / Transplant / Remove) | Findings | Remark |
|---|---|---|---|---|---|---|---|---|---|---|---|---|---|
| U042 | <i>Gmelina chinensis</i> | 石梓 | RPPHK | 6 | 150 | 2 | M | A | P | A | Retain | Large wound near trunk base with wound wood development. Trunk wound is decaying. | Located closed to cut slope. Application of insecticide and fungicide as preventive measure was conducted on 24 June 2026. Adjustment of trunk protection pad was conducted on 24 June 2026. |

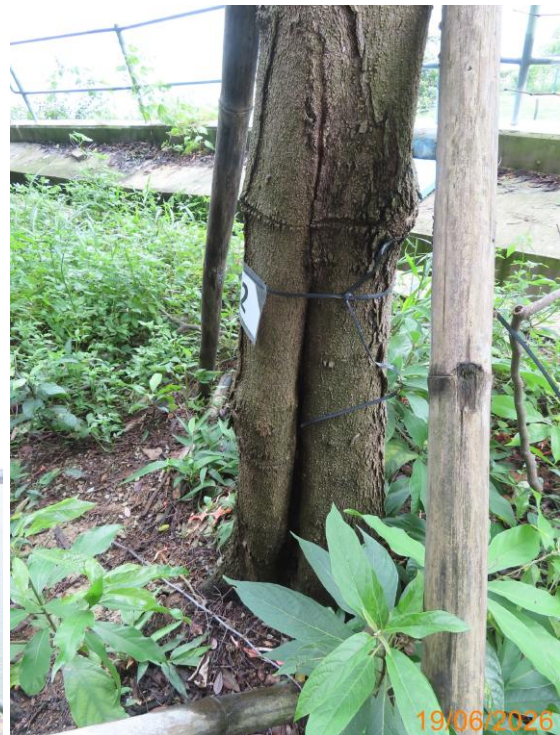
16: U042\_Wound on trunk base

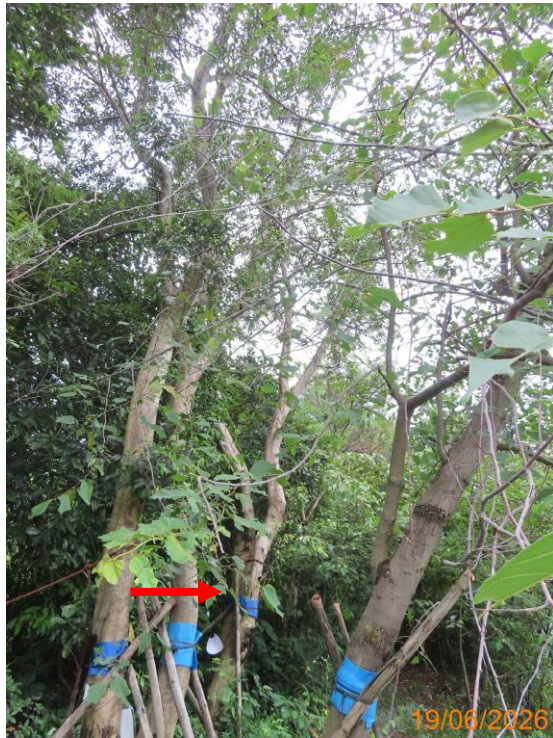
17: U043

| Tree No. | Species | | | Measurements | | | Amenity Value<br>(High(H) / Medium (M) / Low(L) | Tree Condition (Good(G) / Average(A) / Poor(P)) | | | Recommendation<br>(Retain / Transplant / Remove) | Findings | Remark |
|---|---|---|---|---|---|---|---|---|---|---|---|---|---|
| U043 | <i>Aquilaria sinensis</i> | 土沉香 | RPPHK;<br>Cap.586;<br>IUCN:VU | 9 | 310 | 4 | M | A | P | P | Retain | Crack on trunk base. Trunk wound significantly decayed. High trunk failure risk. | Located closed to cut slope and fenced off by 2m high barrier. Application of insecticide and fungicide was conducted on 24 June 2026. Adjustment of trunk protection pad was conducted on 24 June 2026. |

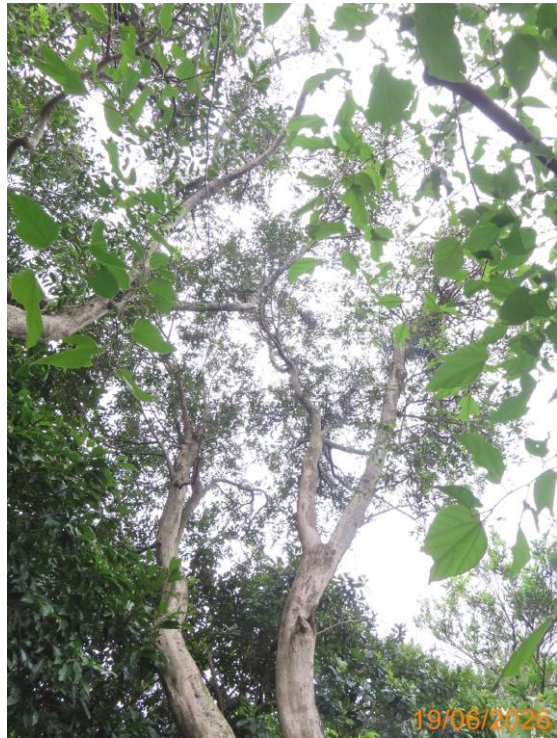
18: U043\_Crown

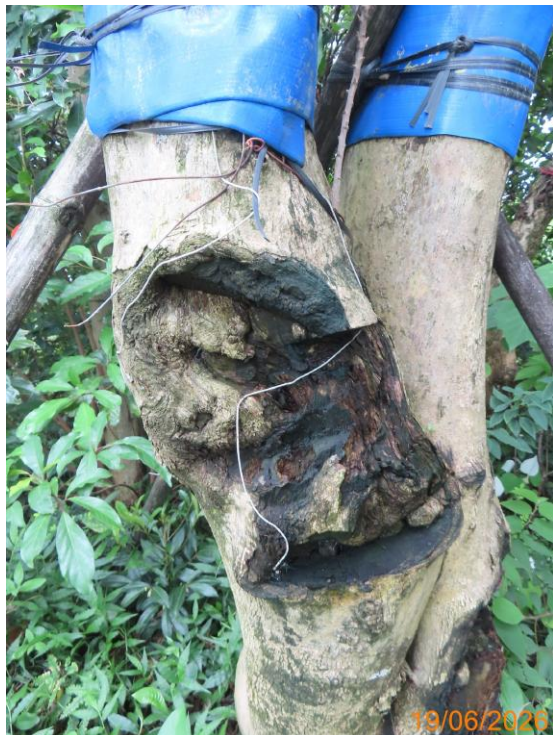
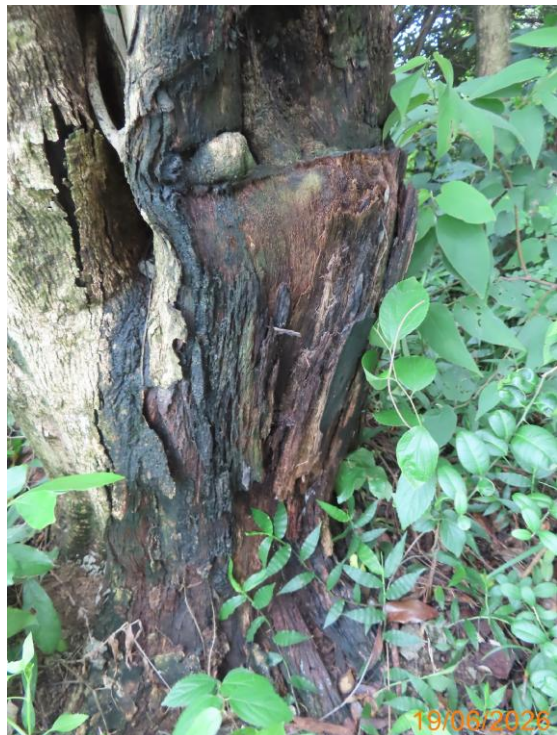
19: U043\_Wound on trunk#1

20: U043\_Wound on trunk#2
