**Tree Schedule for Survey of Plant Species of Conservation Importance**

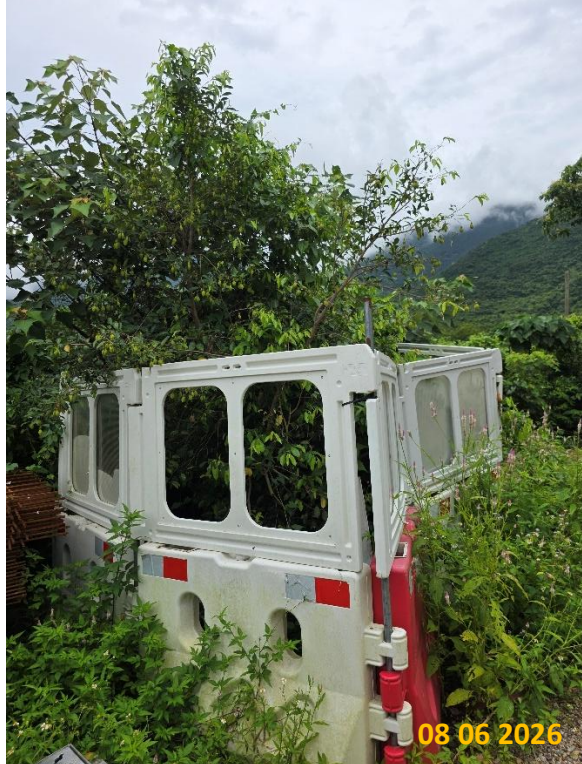
| A11 – Overall view | A11 – Crown condition. Foliage decreased. It is fruiting. |

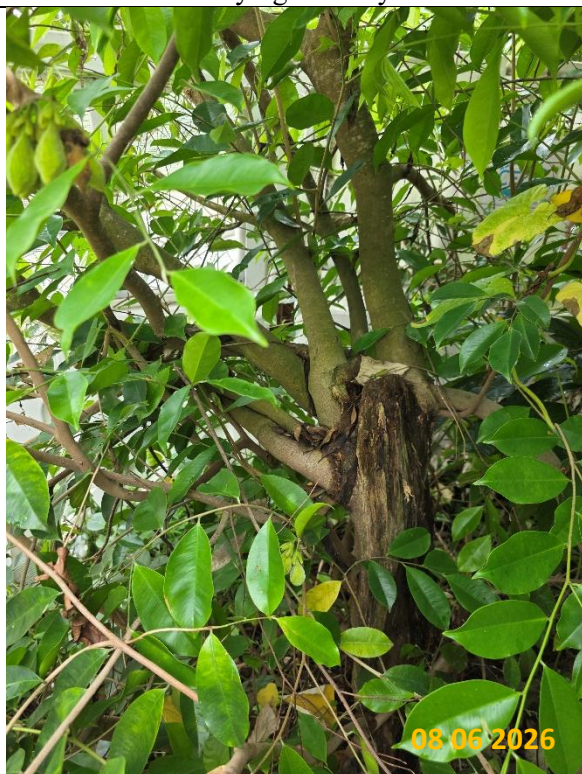
| A11 – Shoots are epicormic generated from cut trunk which is decaying severely | A11 - Soil condition |

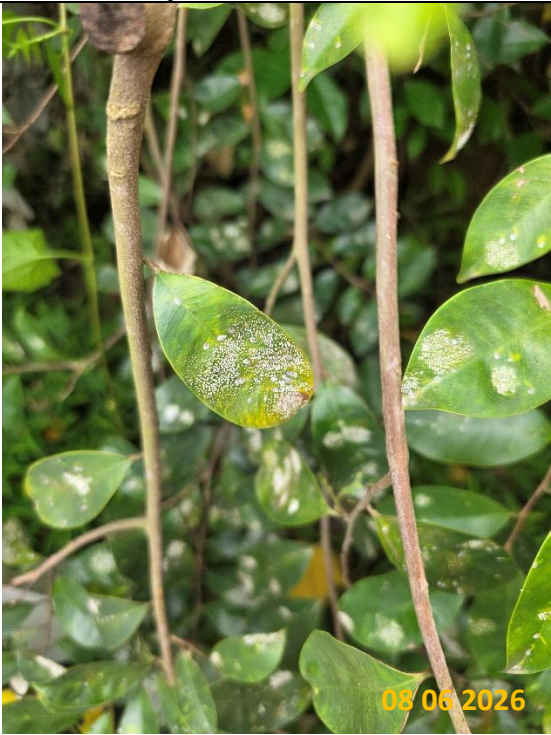
| <p>A11 – Insect pest observed</p> <p>08 06 2026</p> | <p>A11 – Fruiting</p> <p>08 06 2026</p> |

| No. | Species | | Conservation Status | Measurements | | | Tree Condition (Good(G) / Average(A) / Poor(P)) | | | Recommendation (Retain / Transplant / Remove) | Findings | Remark |
|---|---|---|---|---|---|---|---|---|---|---|---|---|
| A11 (T7521) | <i>Aquilaria sinensis</i> | 土沉香 | RPPHK; Cap.586; IUCN:VU | 190 | 3.5 | 1 | P | A | P | Retain | Insect infestation is moderate. Pest control was done on 10 June 2026.<br><br>Foliage density decreased, The tree is fruiting. | Root-plate movement (mentioned in previous monitoring report). Topped tree due to illegal felling on Aug 2023 (reported to police on 21 Aug 2023). Large decaying trunk wound. Foliage density reduced after inclement weather events on Aug and Sep 2025. Unknown physical damage is observed resulting in the breaking of some epicormic shoots on Nov 2025 (Cleaned). |

| <p>Pest control done on 10/06/2026</p> <p>10 06 2026</p> | <p>Weeding done on 10/06/2026</p> <p>10 06 2026</p> |

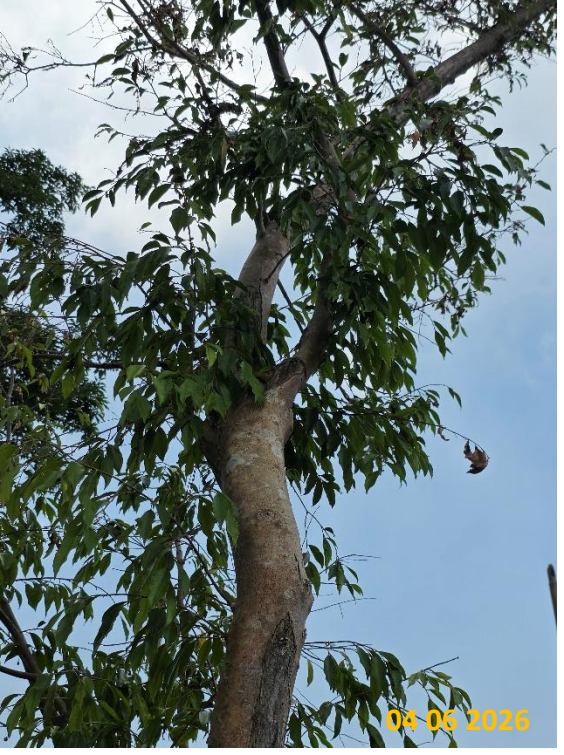
| A8 – Overall view | A8 – Pruning wound previously damaged by typhoon KOINU (Oct 2023) |

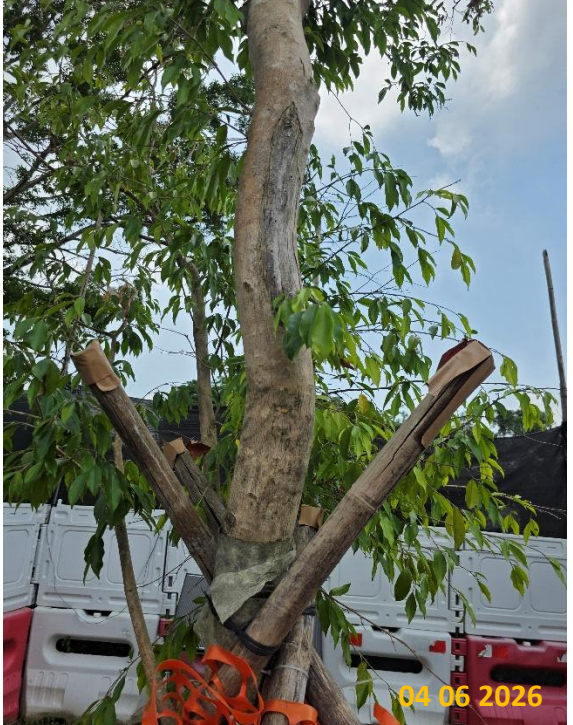
| A8 – Decaying wound on trunk | A8 – Trunk and root condition. |

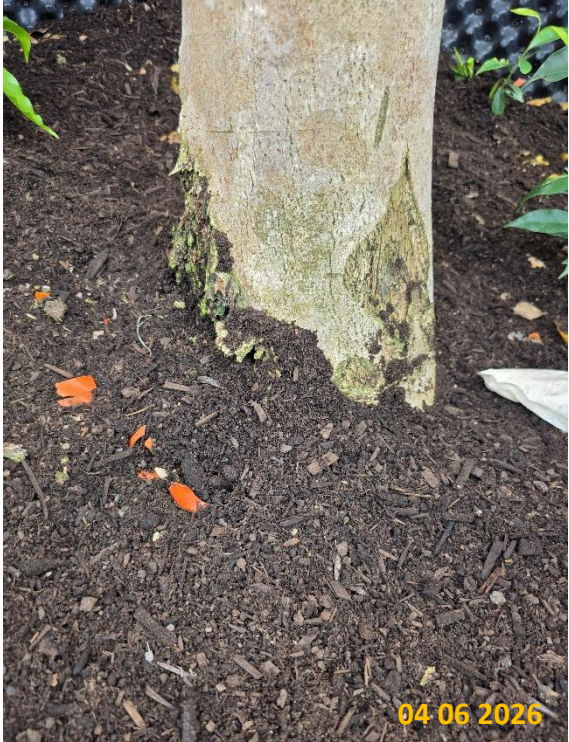
| <p>A8 – Decaying wound at trunk base<br/>(size: ~180mm x170mm)</p> <p>04 06 2026</p> | <p>A8 –Leaves chlorosis and thin. Some insect eggs were observed.</p> <p>04 06 2026</p> |

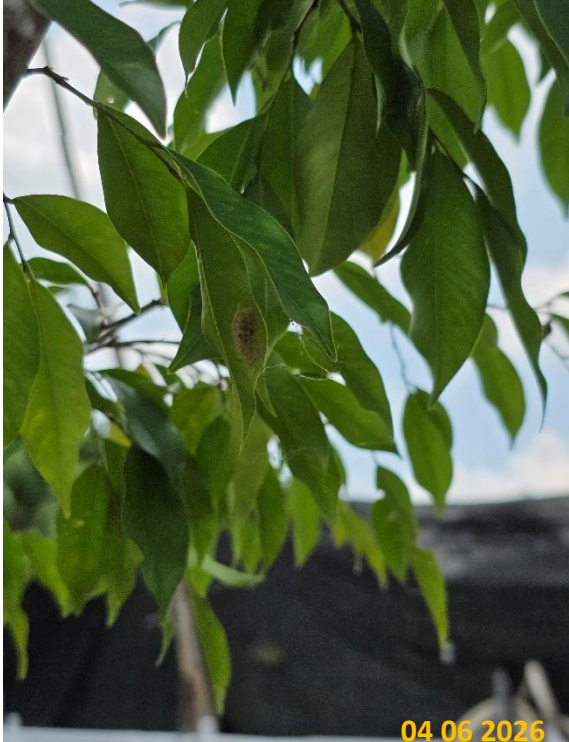
| <p>A8 – Insect pest was observed</p> <p>04 06 2026</p> | <p>A8 – Fruiting</p> <p>04 06 2026</p> |

| No. | Species | | Conservation Status | Measurements | | | Tree Condition (Good(G) / Average(A) / Poor(P)) | | | Recommendation (Retain / Transplant / Remove) | Findings | Remark |
|---|---|---|---|---|---|---|---|---|---|---|---|---|
| A8<br>(T8996) | <i>Aquilaria sinensis</i> | 土沉香 | RPPHK;<br>Cap.586;<br>IUCN:VU | 110 | 5 | 4 | P | P | P | Transplant | No obvious wound wood production. Fruiting. Severity of the insect feeding was high. Pest control was done on 27 June 2026. | Trunk wounds were observed before transplant operation. Shallow root. Sudden defoliation happened in May 2023 but recovered in Aug 2023. It was translocated to the temporary holding nursery on 29 Sep 2023. A branch (5cm) was broken due to typhoon in Oct 2023. Decaying wounds and exposed dead woods on trunk. The foliage density is low and further reduced after inclement weather events on Aug/Sep 2025. |

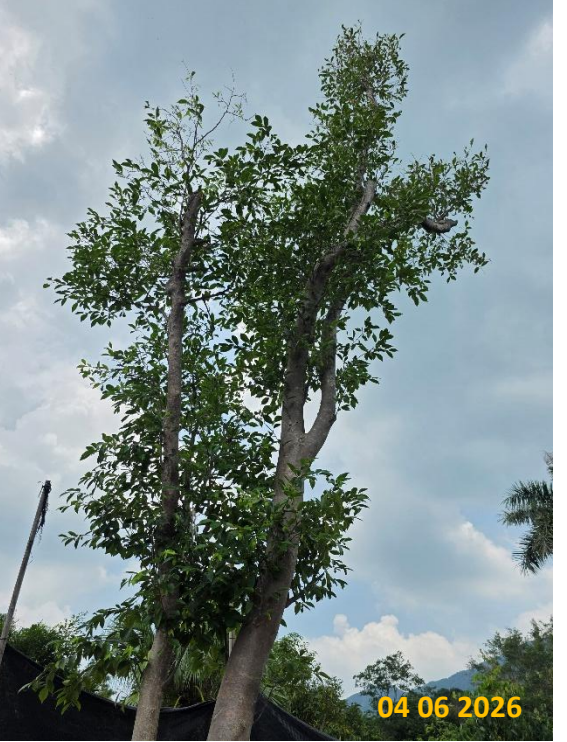
| A12 - Overall View | A12 - Dieback observed. |

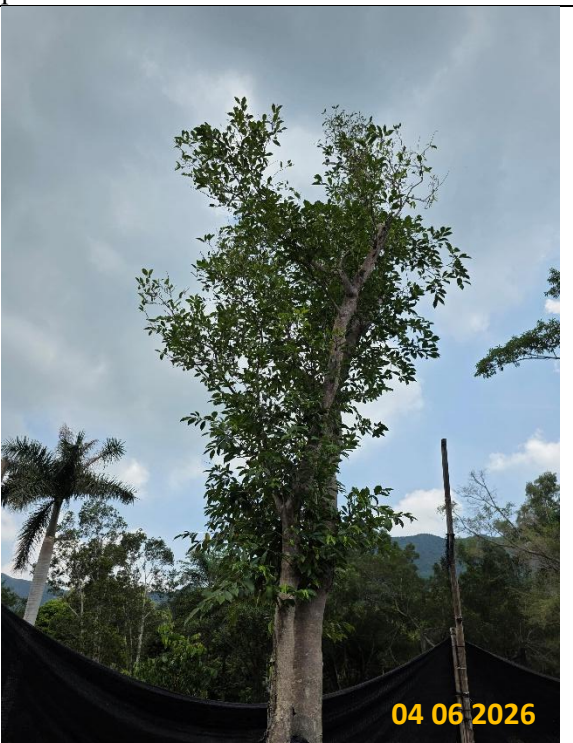
| A12 - Foliage density reduced significantly after previous inclement weather. | A12 – Trunk and root condition |

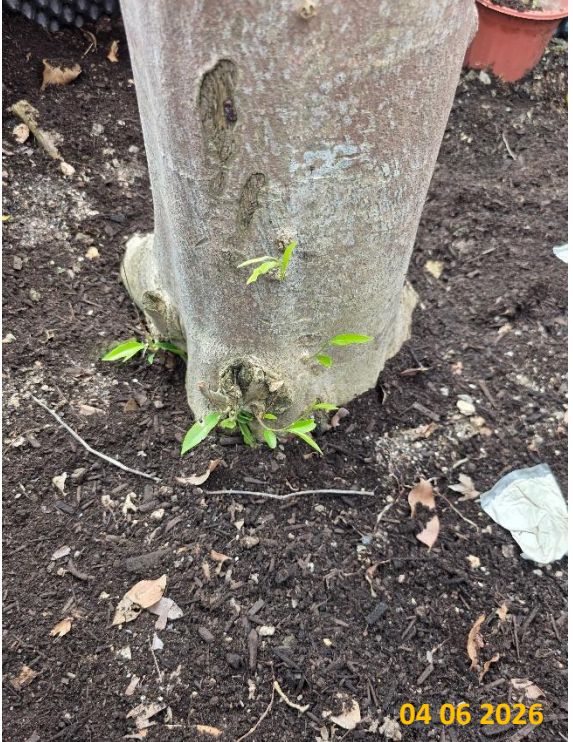
| <p>A12 – Wound at trunk base</p> <p>04 06 2026</p> | <p>A12 – Decaying wound on trunk</p> <p>04 06 2026</p> |

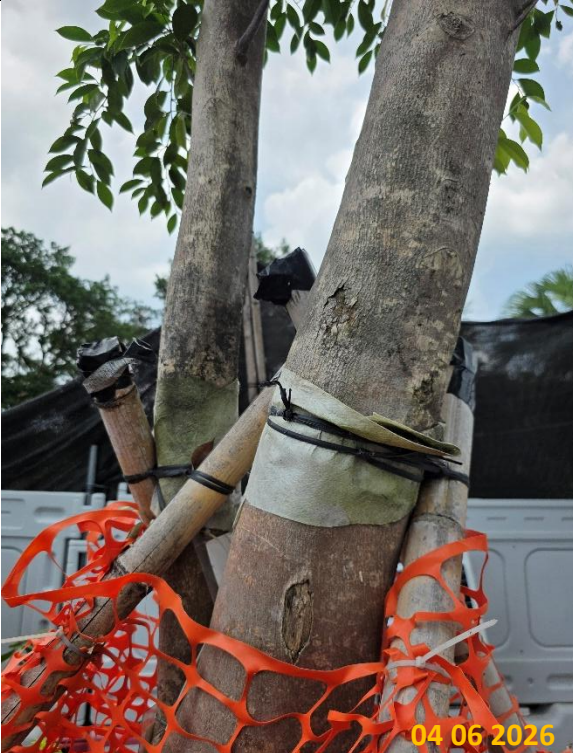
| <p>A12 – Epicormics on trunk. Decaying wound on Trunk.</p> <p>04 06 2026</p> | <p>A12 – Fruiting</p> <p>04 06 2026</p> |

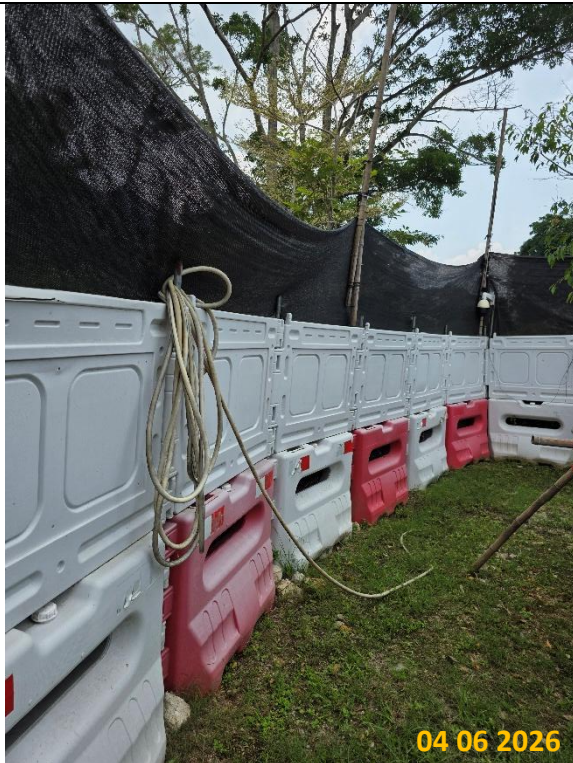
Fencing is in order during inspection
