CEDD Contract No. NL/2020/06

Tree Schedule for Survey of Plant Species of Conservation Importance

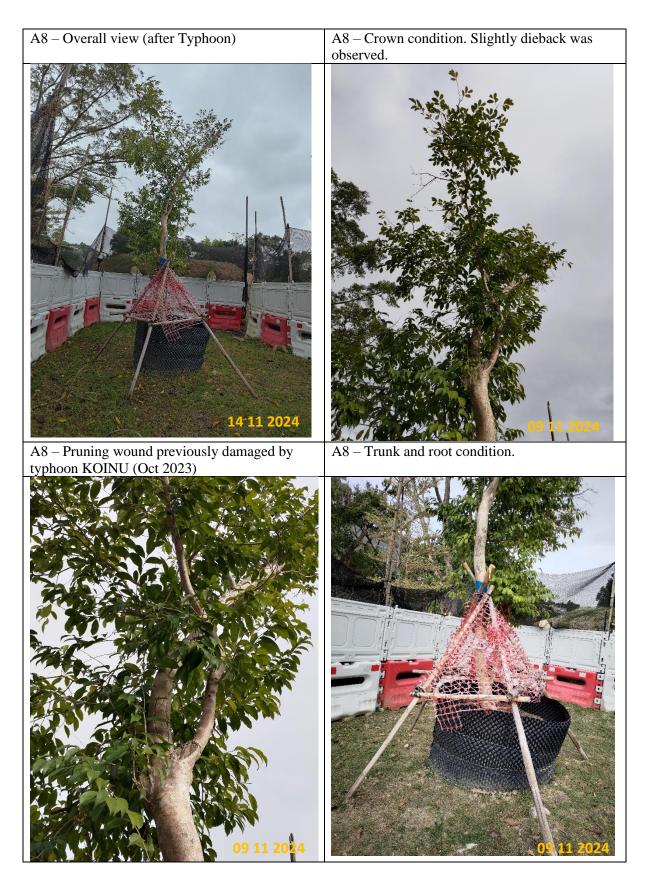
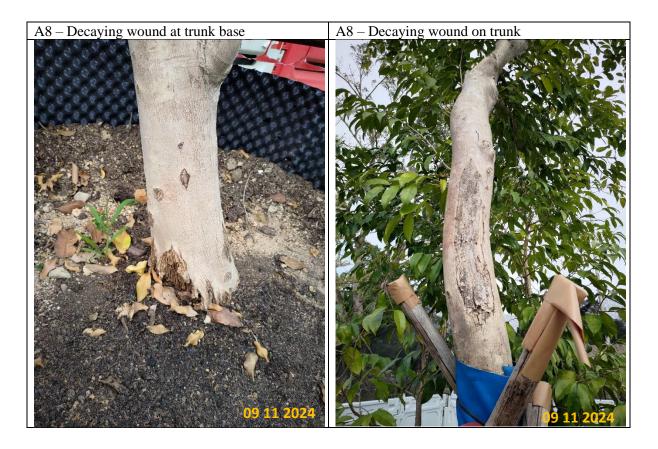
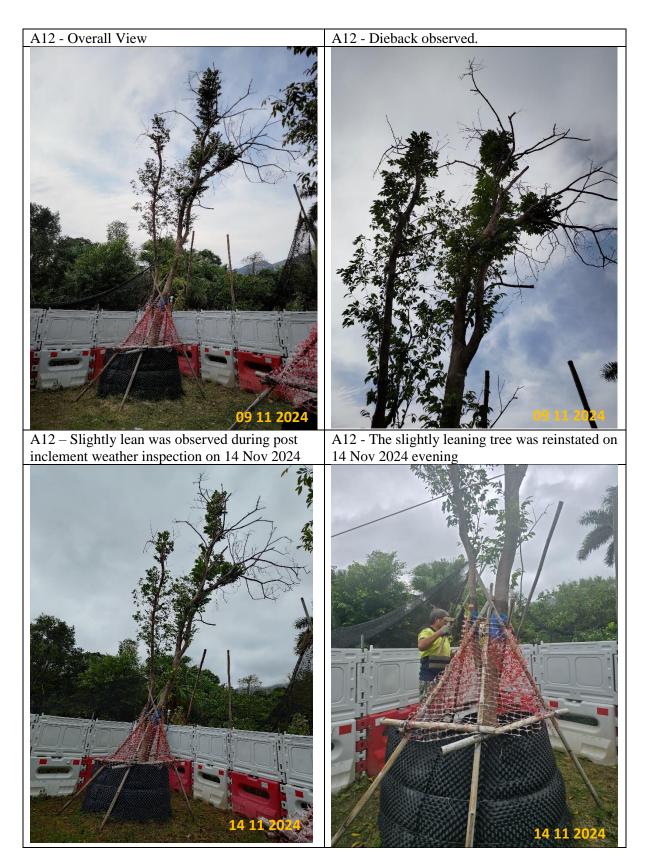
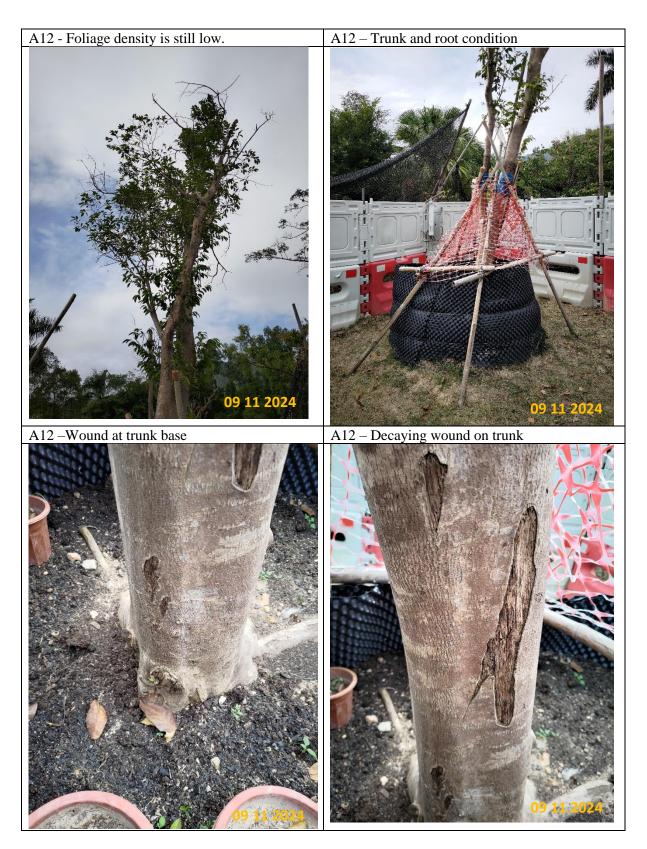
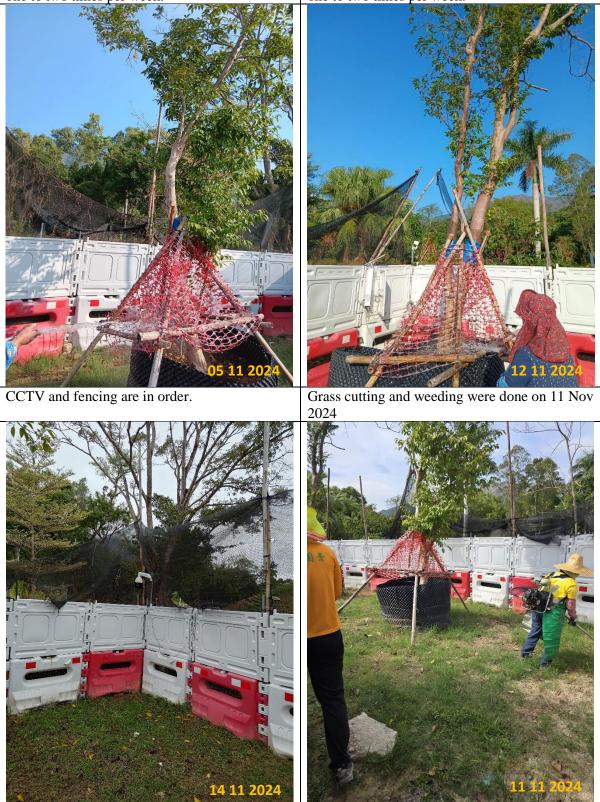
Manual watering was carried out for A8 during the reporting period. The watering frequency is one to two times per week. Manual watering was carried out for A12 during the reporting period. The watering frequency is one to two times per week.
