Tung Chung New Town Extension – Site Formation and Infrastructure Works at Tung Chung Valley, Phase 1

Tree Schedule for Survey of Plant Species of Conservation Importance

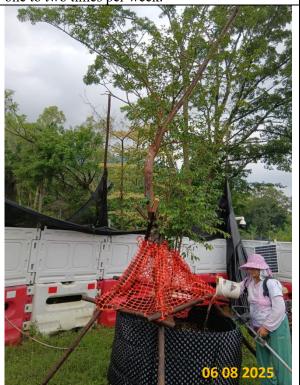
Manual watering was carried out for A12 during the reporting period. The watering frequency is one to two times per week.
