Tung Chung New Town Extension

3rd PLG Meeting
Date : 9 Dec 2019

Civil Engineering and
Development Department

**Contract No. NL/2017/03
Tung Chung New Town Extension -
Reclamation and Advance Works**

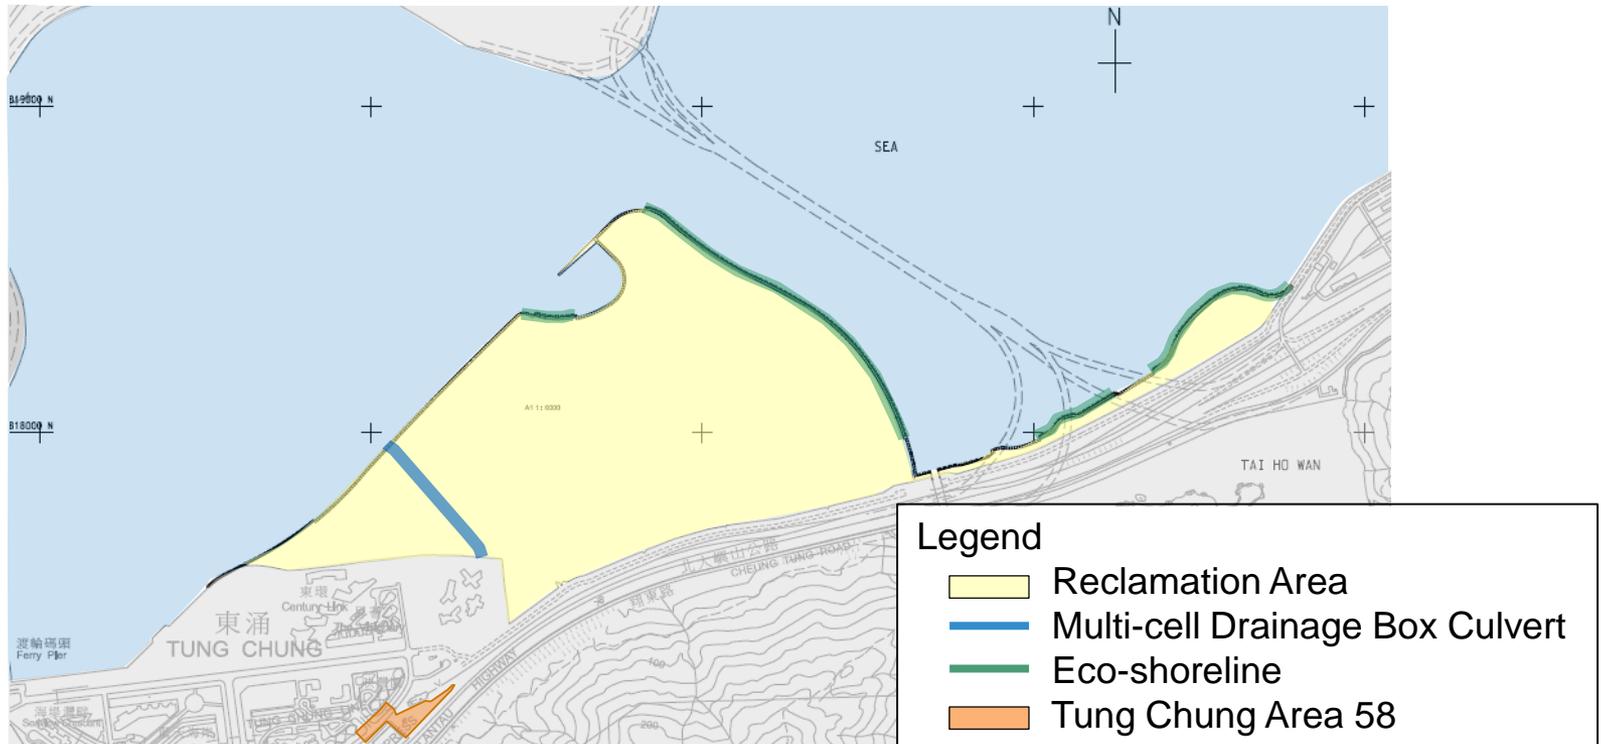
Contract NL/2017/03 Overview

- ① 130 hectares land reclamation by non-dredged method
- ② Construction of 4.9 km seawalls partly with eco-shorelines
- ③ Construction of 470m extension of multi-cell drainage box culvert
- ④ Site formation for future development in Tung Chung Area 58

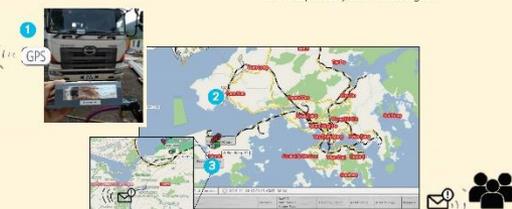
- 1 泥頭車安裝GPS系統，可以即時追蹤其位置。
Dump trucks are installed with a registered Global Positioning System (GPS) which allows the GPS signal to be transmitted to the control centre.
- 2 控制系統，即時監控泥頭車，公眾可隨時查詢其位置。
Date, time and travel route are recorded which allow round-the-clock monitoring of the routing of dump trucks.
- 3 泥頭車進入禁區，系統會發出警報，發給現場人員，系統會即時發出警報通知，以報警員調查。
Tung Chung Road is designated as a prohibited zone under this Project. If a dump truck engaged on site enters the prohibited zone, an automatic E-mail notification will be generated immediately to site supervisory staff.

Tung Chung New Town Extension is the first public works project to implement a real time tracking and monitoring system for dump trucks to detect illegal dumping activities by recording and monitoring the trucks' locations and traveling routes.

In addition, this project also prohibits the dump trucks from entering Tung Chung Road which is a route to access the ecologically sensitive south island sites. In case of a dump truck entering the prohibited zone, a warning notification will be sent automatically via electronic means to site supervisory staff for investigation.

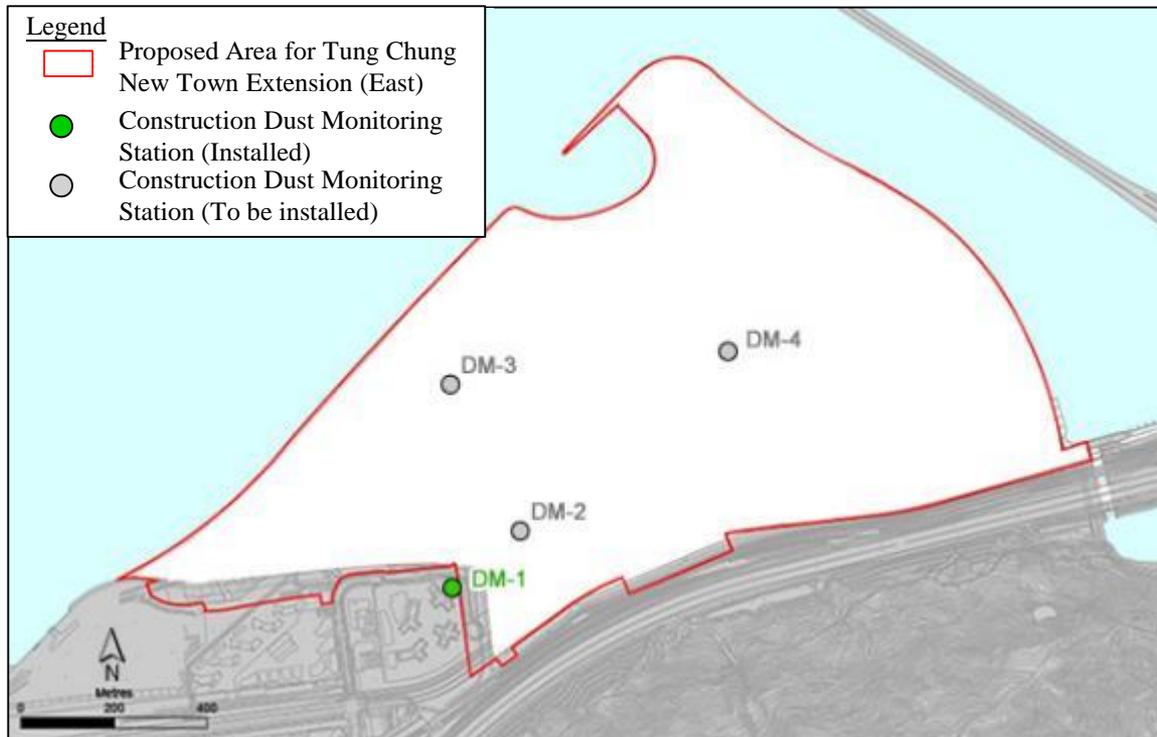
Frequency Three times every six days
Monitoring Parameter 1-hour Total Suspended Particulate

No project-related exceedance was recorded.

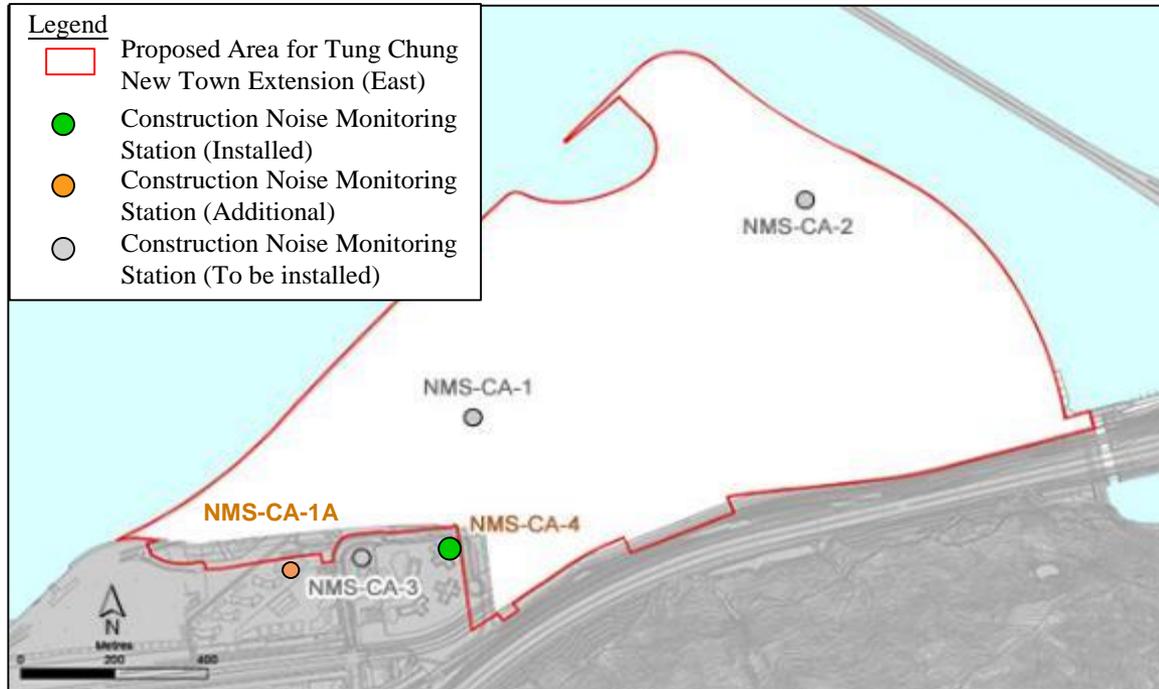
Frequency Once per week
Monitoring Parameter L_{eq} (30mins)

Results of noise monitoring indicated that noise levels were within acceptable level (75dBA)

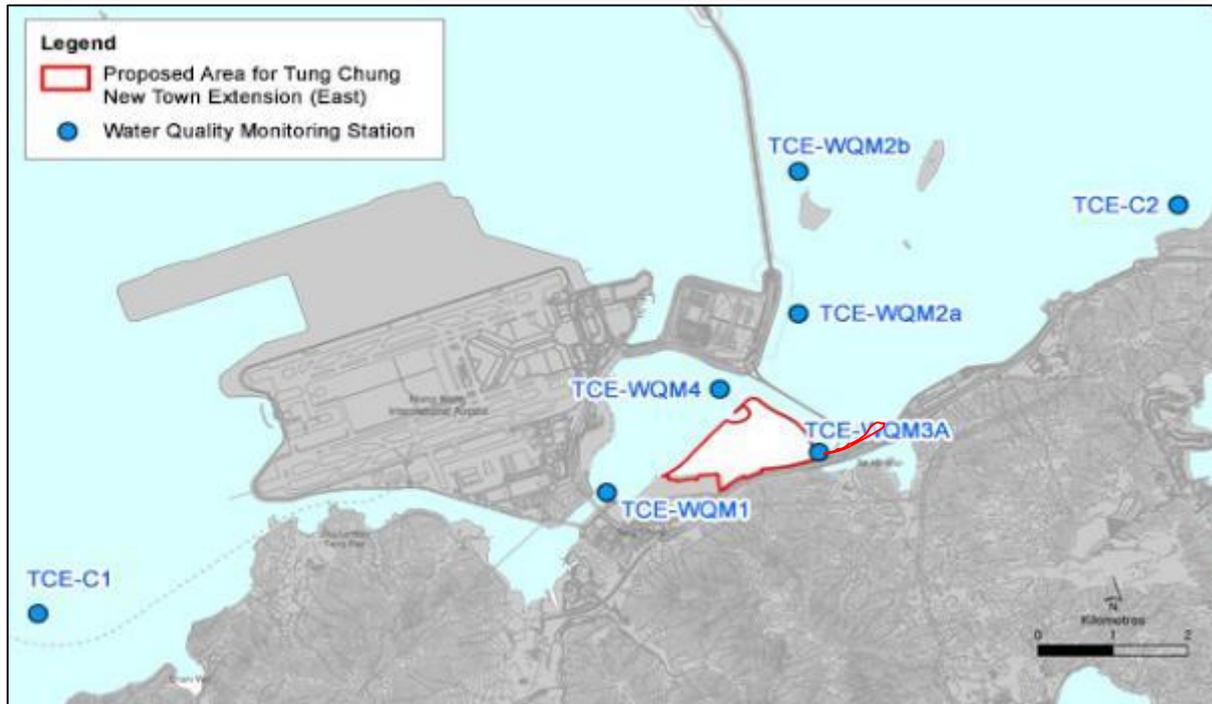
Frequency 3 times per week, at mid-flood & mid-ebb tides
Monitoring Parameter Dissolved Oxygen, pH Value, Salinity, Turbidity, Suspended Solids, Temperature

No project-related exceedance was recorded.

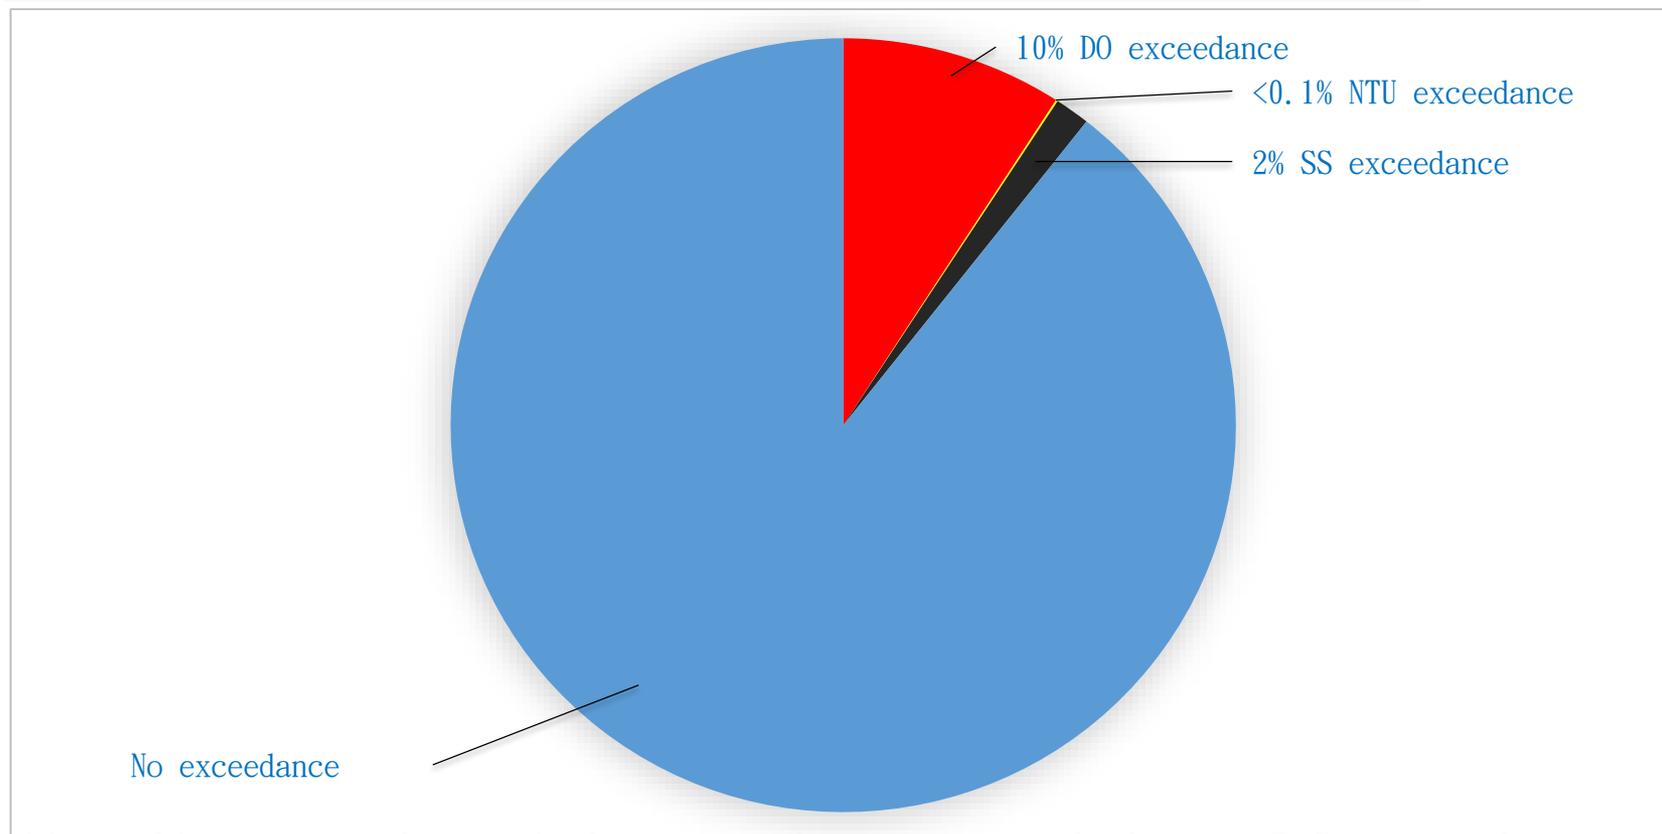
Exceedance Summary

Up to Nov 2019, the majority exceedances recorded were DO exceedances. Low levels of DO were recorded during 2018 summer period. Similar trend of lower levels of DO occurred again in 2019 summer period which suggested the changes could be due to seasonal fluctuation.

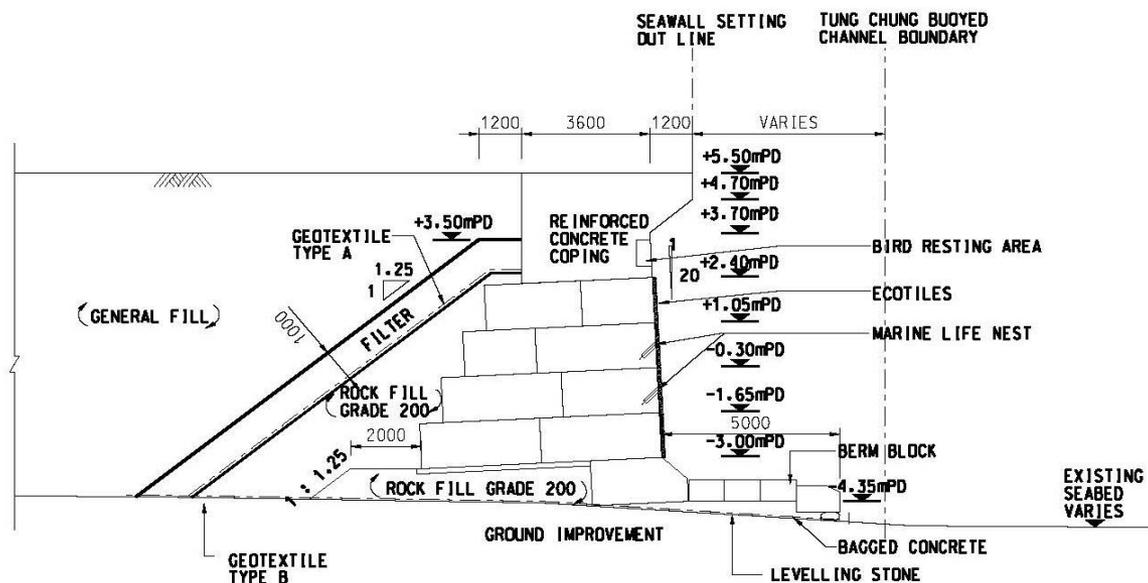
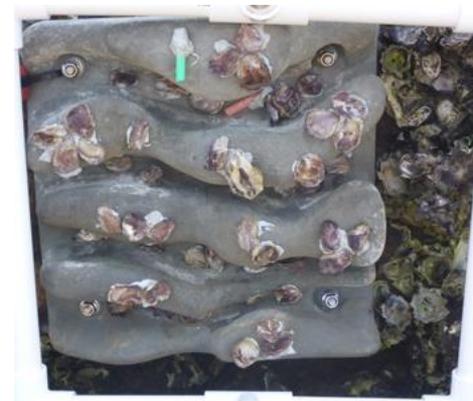
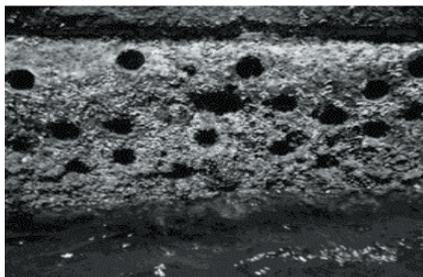
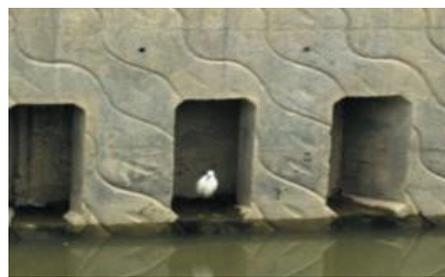
TYPICAL SECTION OF SEAWALL TYPE 2F

- Precast relief into seawall to provide micro-habitats
- Drilled holes and precast cavities provide refuge for larger sub-tidal, inter-tidal and terrestrial wildlife.

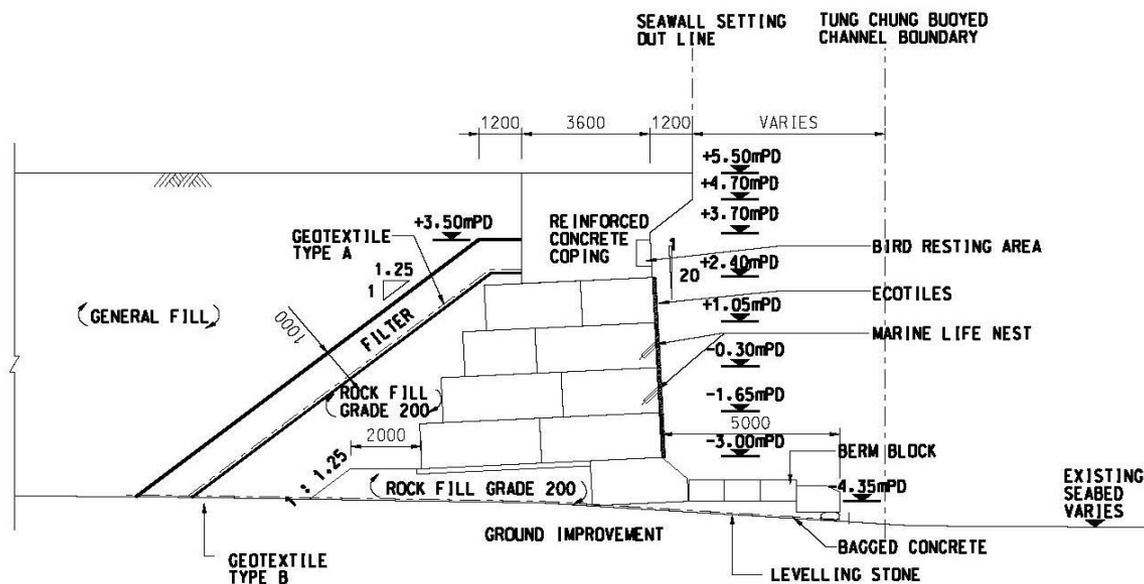
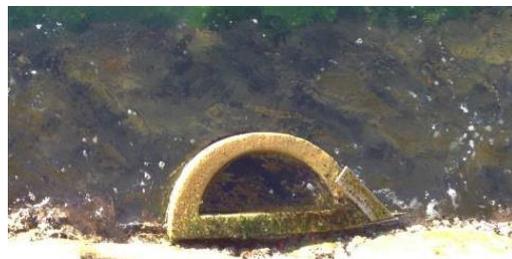
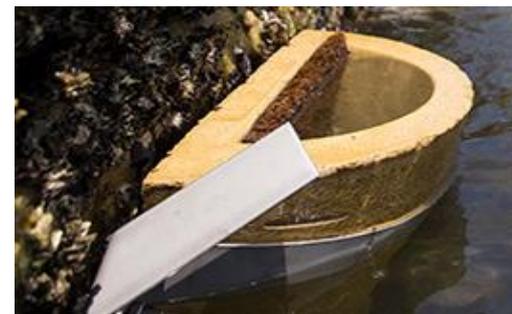
TYPICAL SECTION OF SEAWALL TYPE 2F

The Eco-pots shall be attached to the vertical eco-shoreline at 10m intervals with the top of the Eco-pot at +1.30mPD

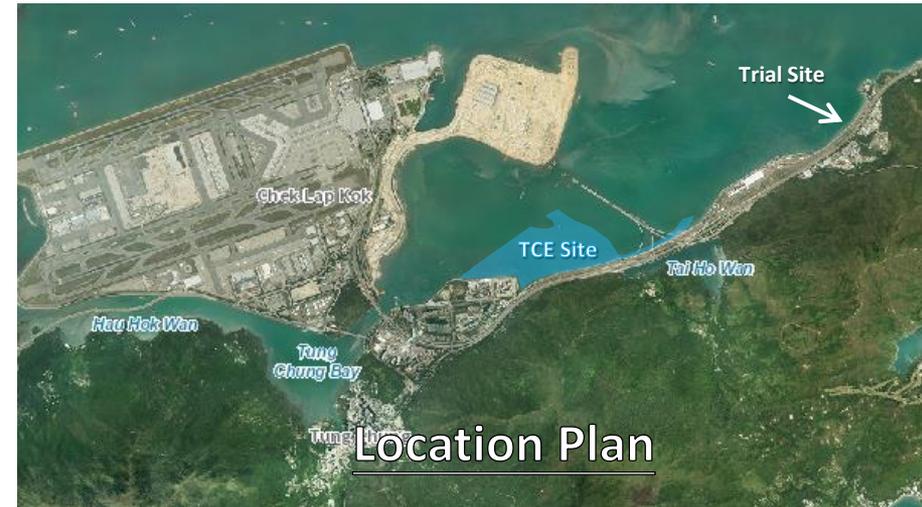
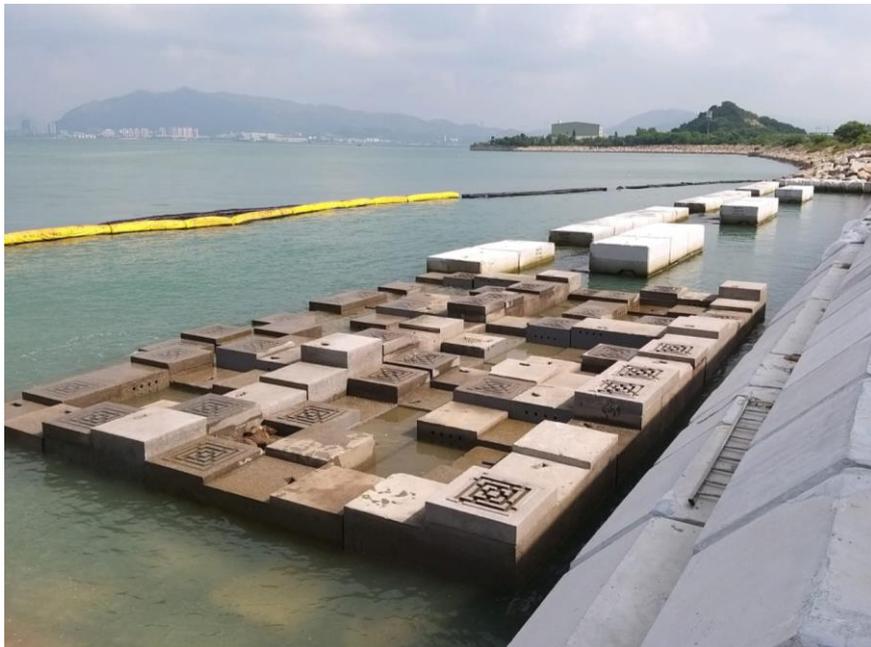
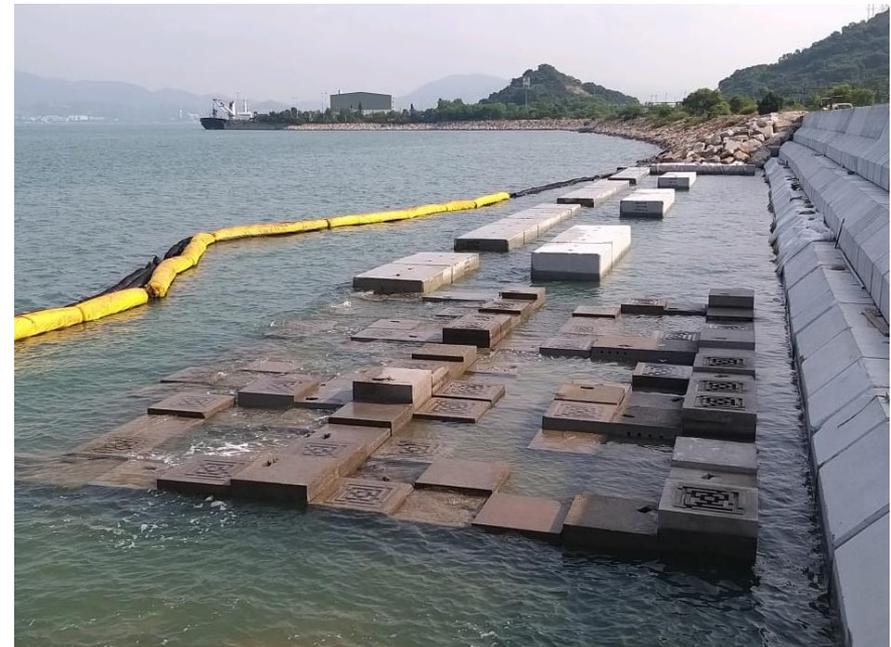
Eco-shoreline trial at Siu Ho Wan

- Modification of existing seawall
- Installation of bio-blocks
- Installation of mudflat and planting of mangroves
- Ecological monitoring until 2020

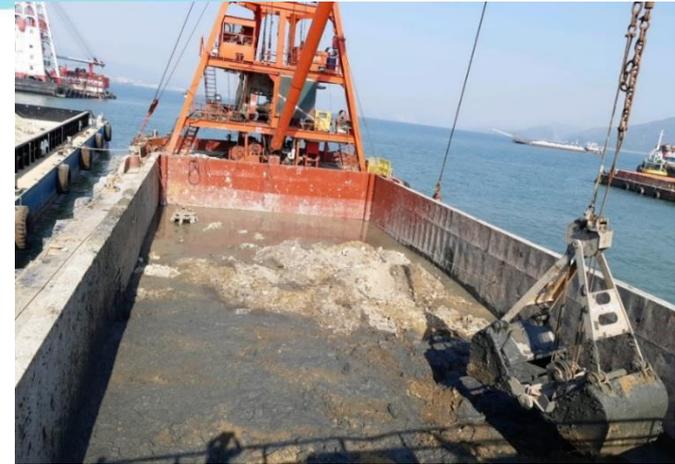
Mixing marine sediment with public fill

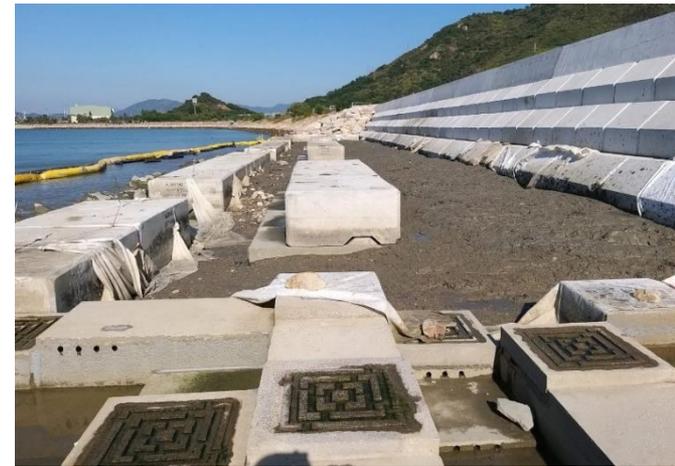
Soil-mix placed in mangrove eco-shoreline
