Tung Chung New Town Extension

11th PLG Meeting
Date : 22 October 2024

土木工程拓展署
CIVIL ENGINEERING AND
DEVELOPMENT DEPARTMENT

可持續大嶼辦事處
SUSTAINABLE LANTAU OFFICE

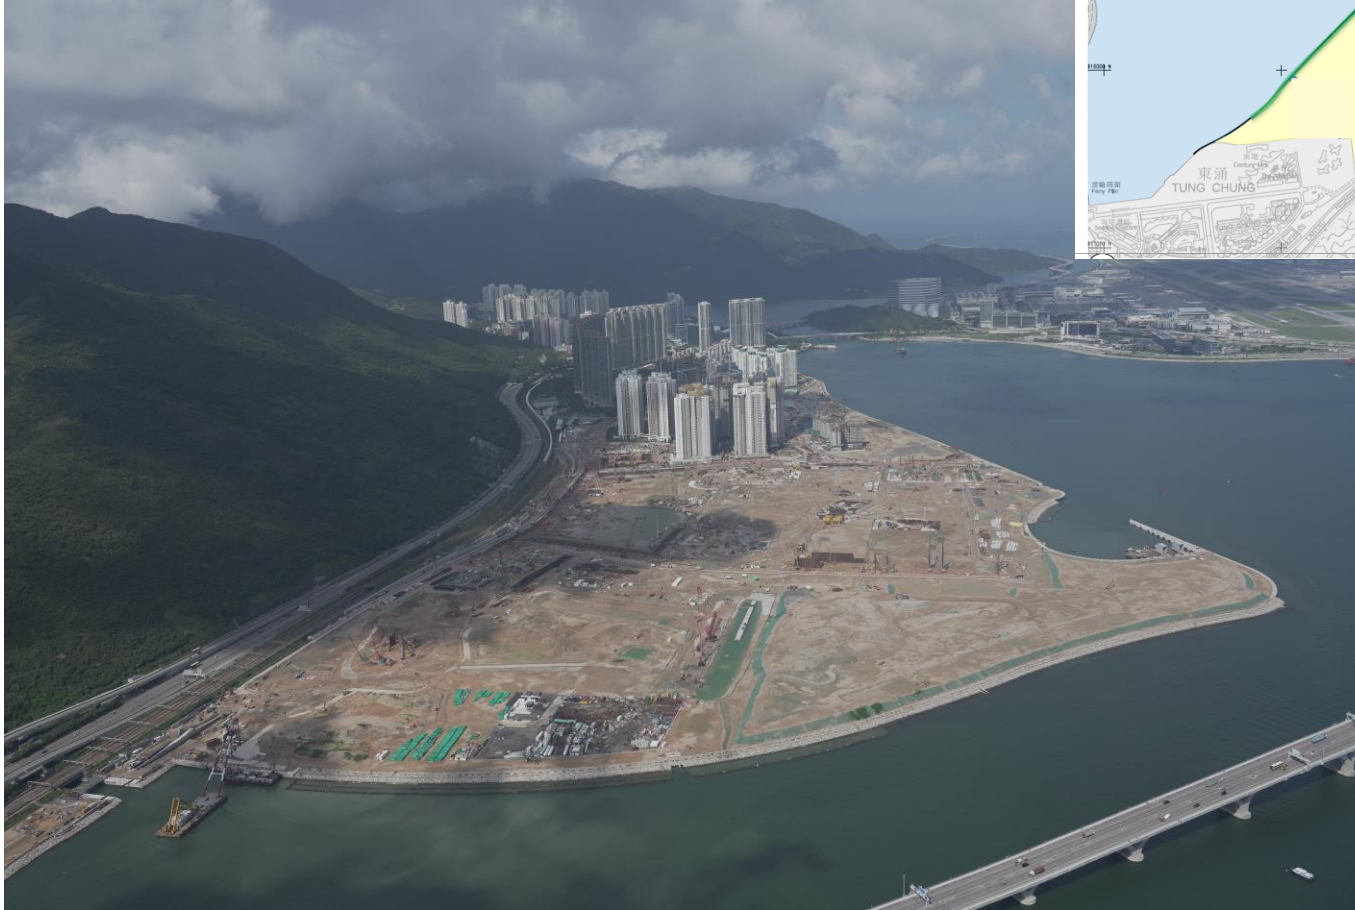
Tung Chung East Reclamation

- ① 130 hectares land reclamation by non-dredged method
- ② Construction of 4.9 km seawalls partly with eco-shorelines (3.8km)

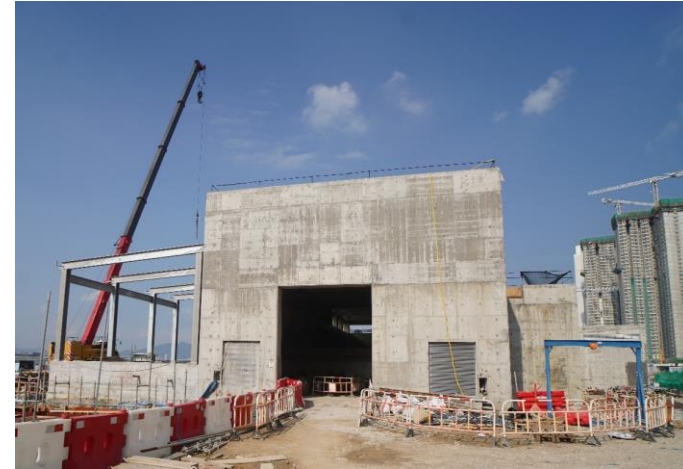
Salt Water Pumping Station (SWPS)

2021 Q4 to 2024 Q4

- E&M Works
- ABWF Works

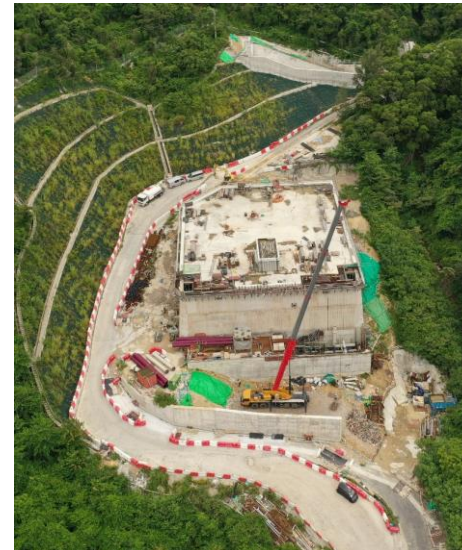
Salt Water Service Reservoir

2022 Q2 to 2024 Q4

- Watermain Laying
- E&M Works

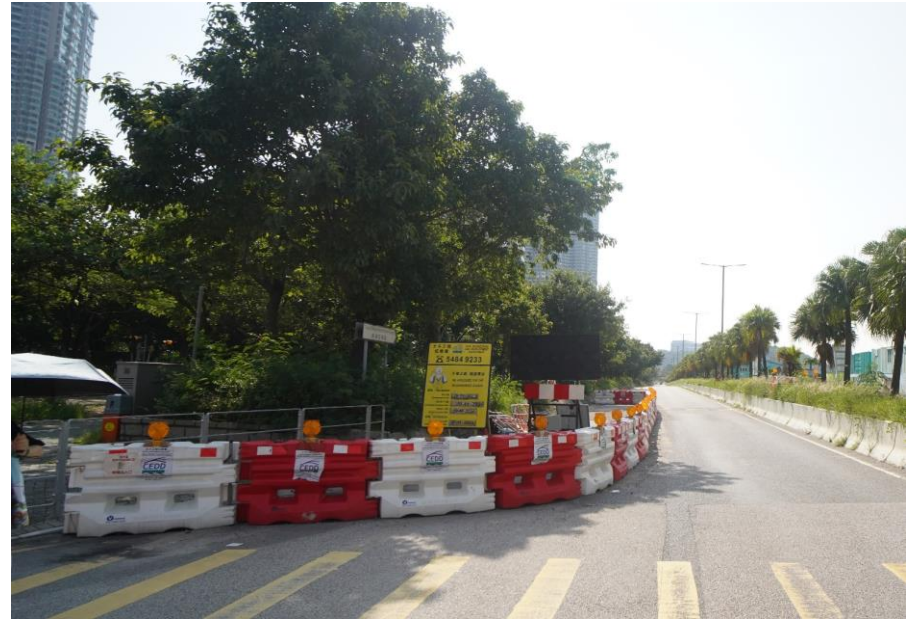
2021 Q4 to 2025 Q1

- TTA and traffic diversion
- Watermain Laying

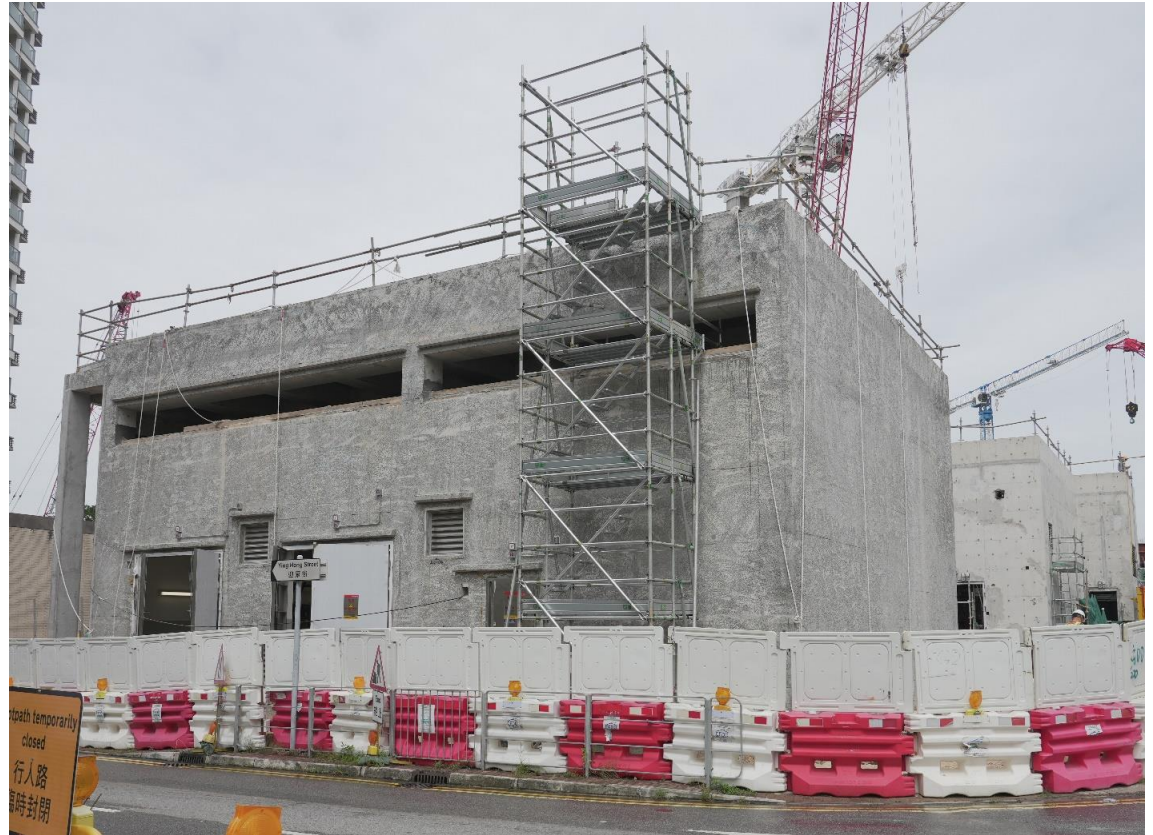
West Sewage Pumping Station (WSPS)

Construction Period
2021 Q3 to 2024 Q4

- ABWF works
- E&M Installation works

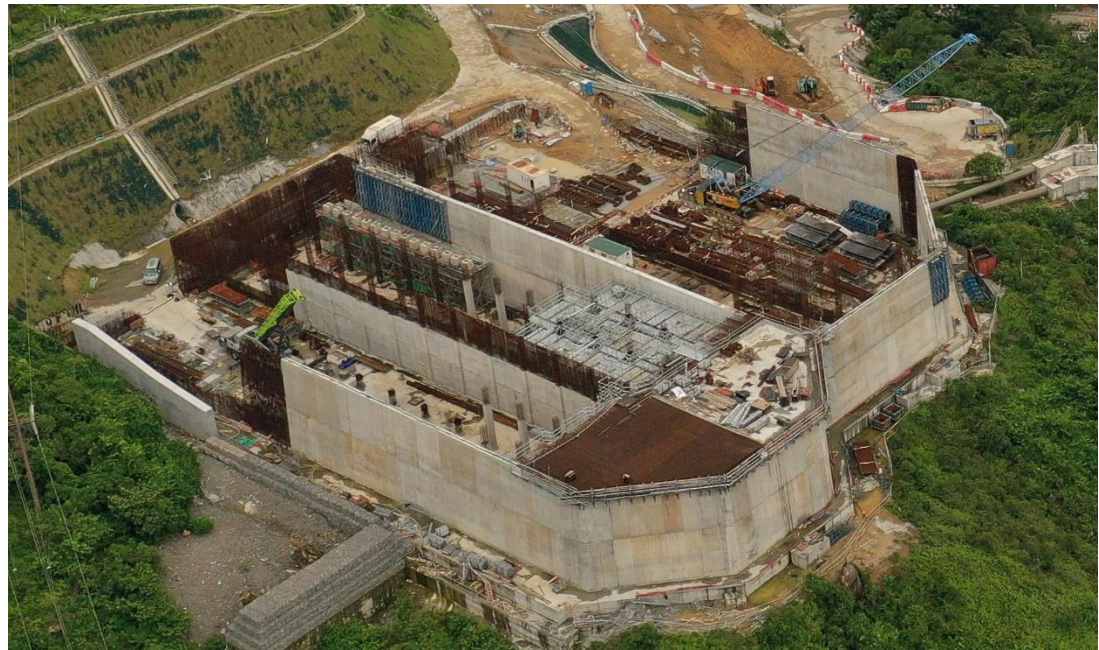
Fresh Water Service Reservoir

Construction Period
2022 Q2 to 2025 Q2

- R.C. structures
- Slope works

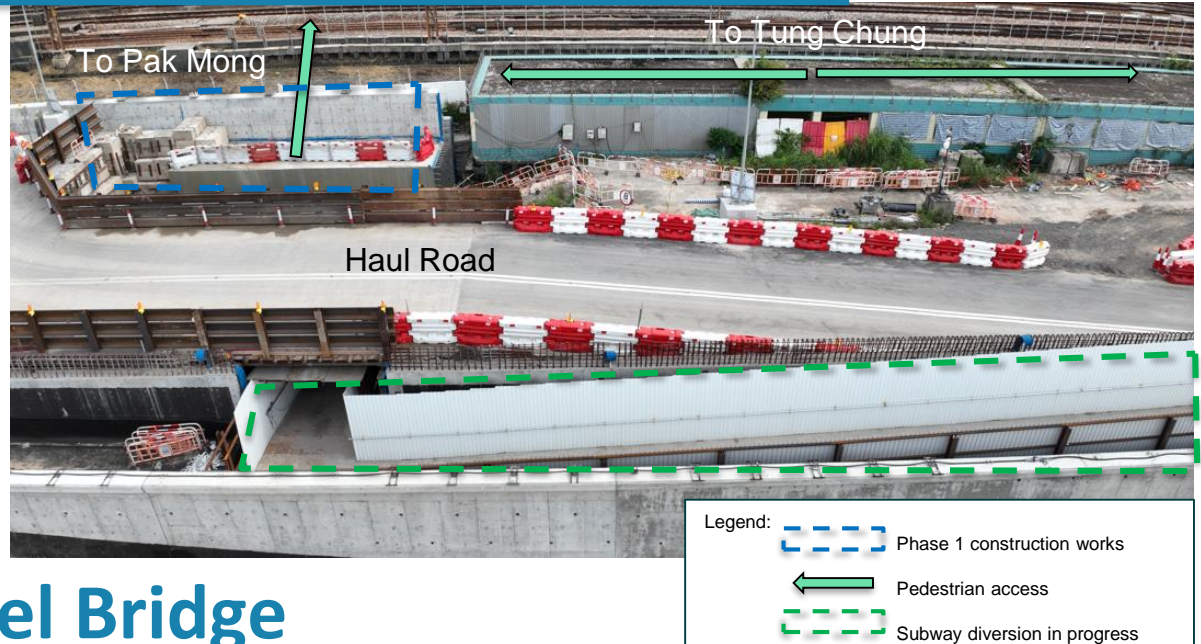
Pak Mong Subway Extension

Construction Period
2022 Q2 to 2025 Q4

- R.C. structure & Steel frame roof

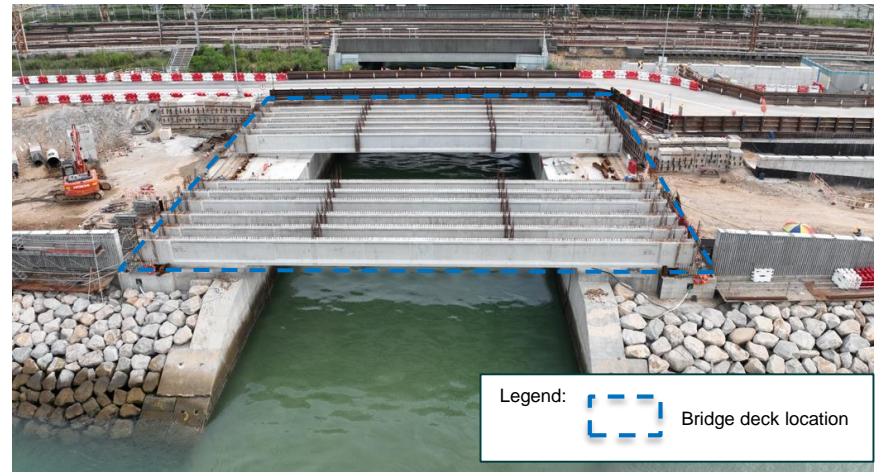
Pak Mong Channel Bridge

Construction Period
2023 Q1 to 2025 Q2

- Bridge construction

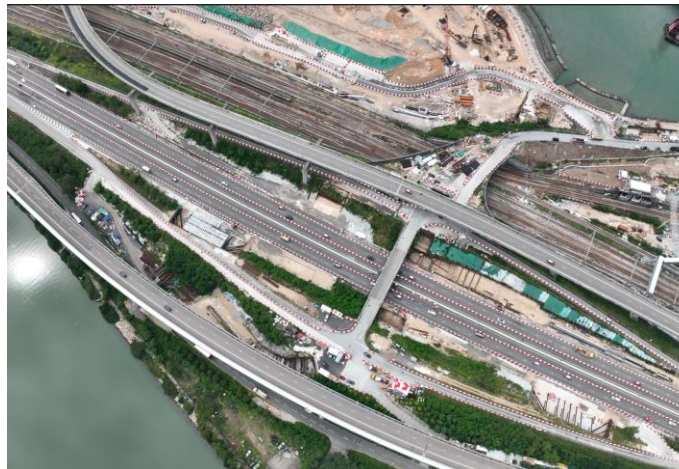
Construction of Tai Ho Interchange

2022 Q3 to 2025 Q4

- Sign gantry
- Piling works
- R.C. structure
- Bridge construction
- Temporary Traffic Arrangement for sign gantry footing construction

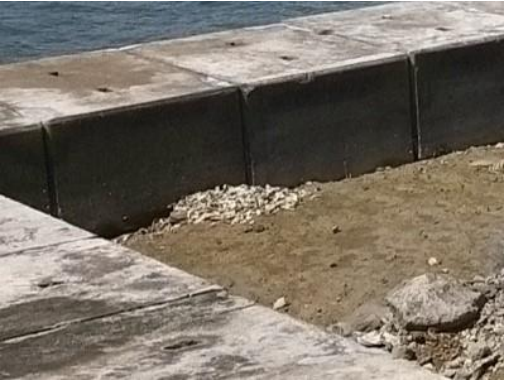
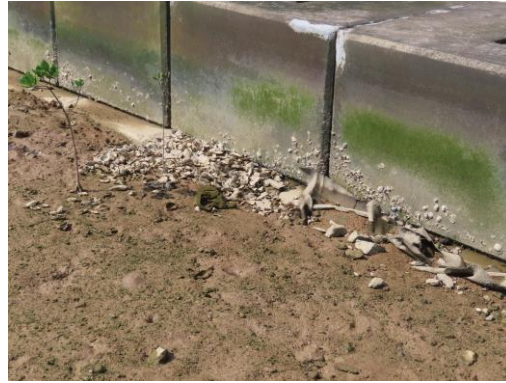
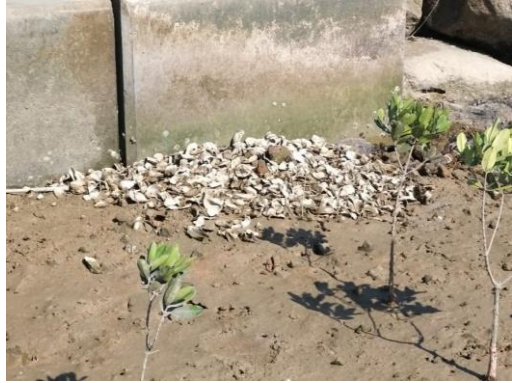
Oyster Bags at Lower Terrace of Mangrove Eco-shoreline

Location	ES1	ES3W	ES3E
No. installed	5	17	18
Installed in Jan. 2024

- The hemp net bag exposed to seawater degraded in about 5 months after installation. The oyster shells remain at the eco-shoreline.

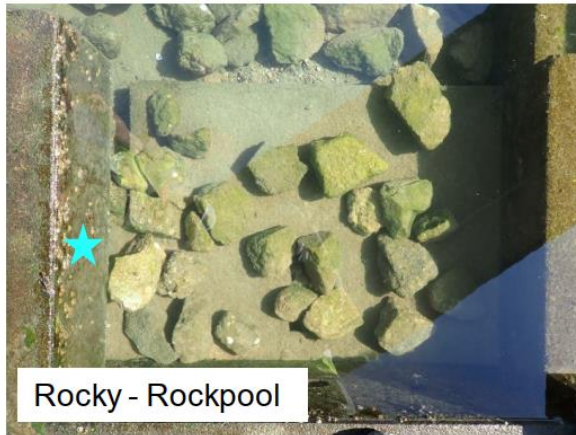
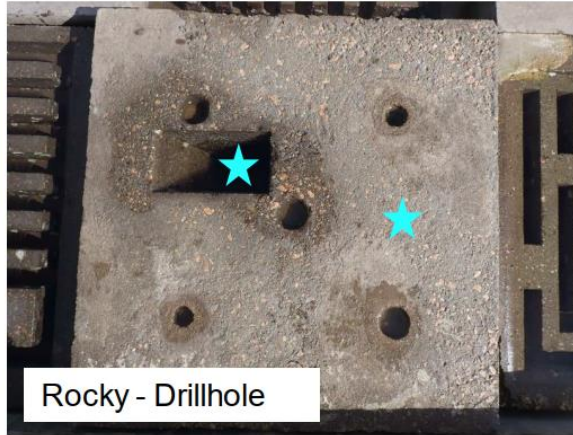
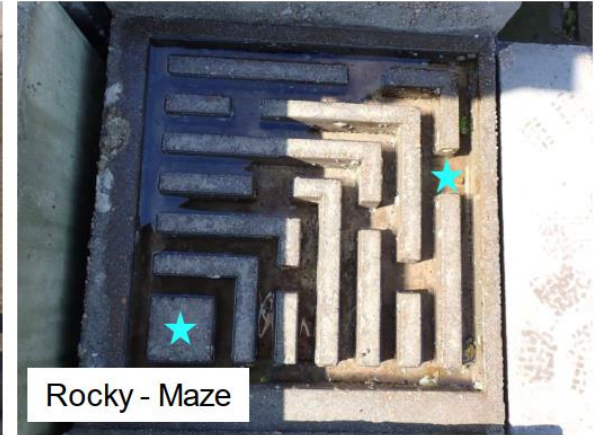
- Location for Temperature Loggers at Rocky Eco-shoreline

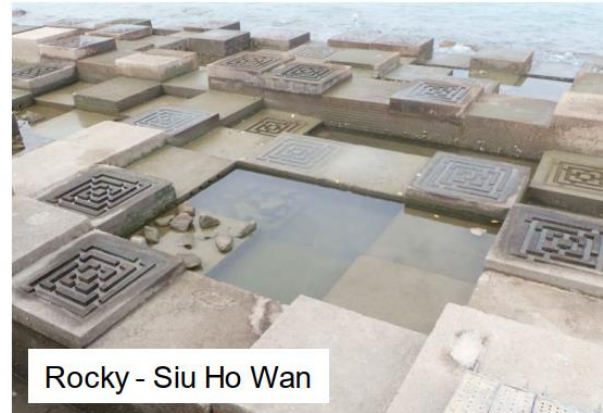
- Location for Temperature Loggers at Reference Point and Siu Ho Wan for Rocky Eco-shoreline

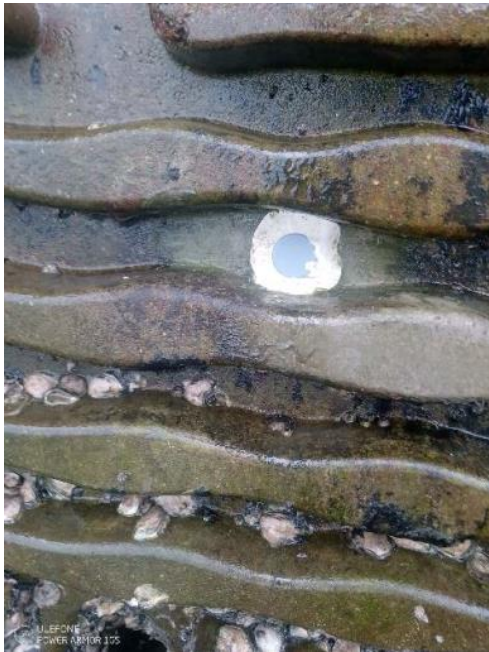
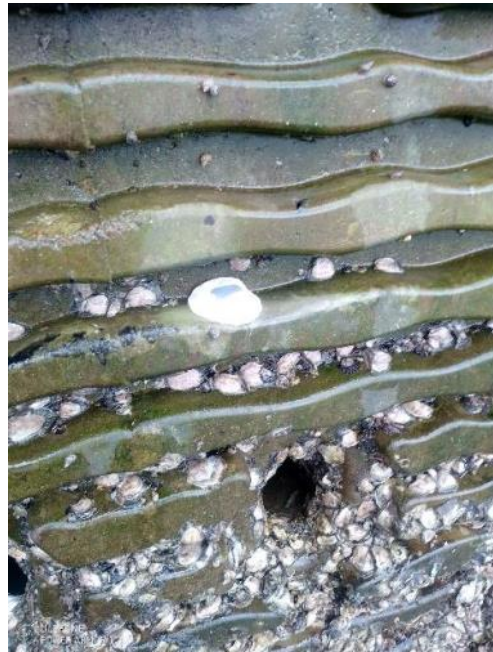
at Shaded surface of the Crevices

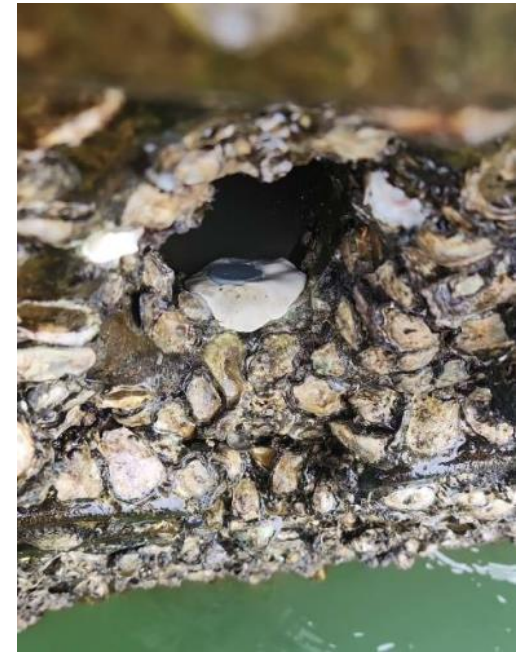
at water-holding drillhole
