# **Tung Chung New Town Extension**

12<sup>th</sup> PLG Meeting Date: 6 June 2025

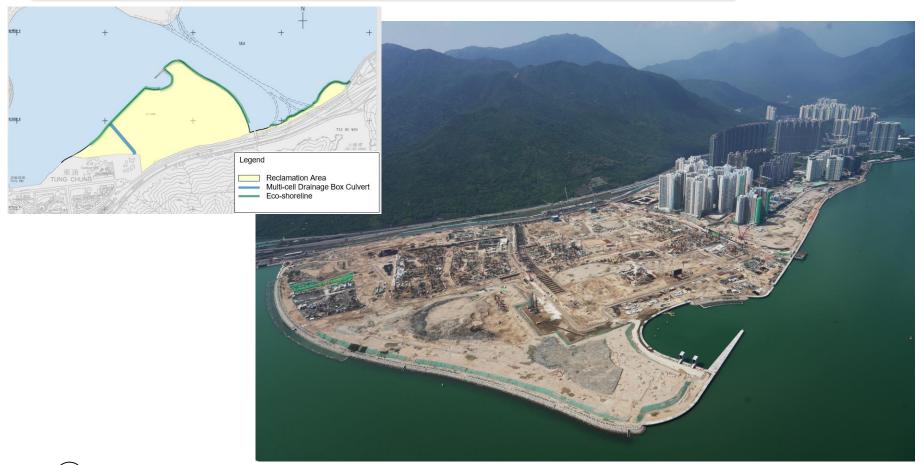
# **Tung Chung East Reclamation (Completed)**

- $^{(1)}$  130 hectares land reclamation by non-dredged method
- ② Construction of 4.9 km seawalls partly with eco-shorelines (3.8km)

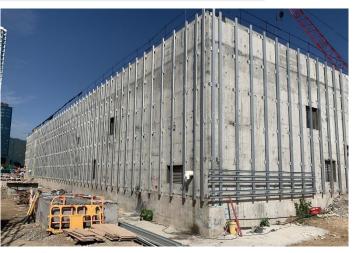
# Salt Water Pumping Station (SWPS)

# Construction Period 2021 Q4 to 2025 Q3

- E&M Works
- ABWF Works

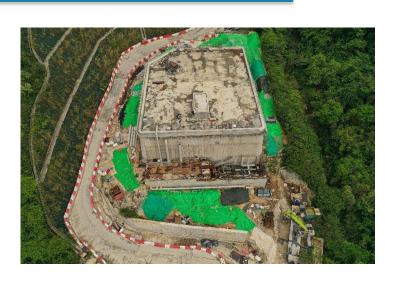
### **Salt Water Service Reservoir**

# Construction Period 2022 Q2 to 2025 Q3

E&M Works

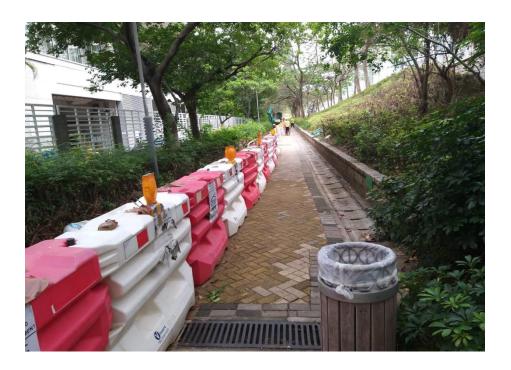
# **Watermain Laying**

Construction Period 2021 Q4 to 2025 Q3

- TTA and traffic diversion
- Watermain Laying

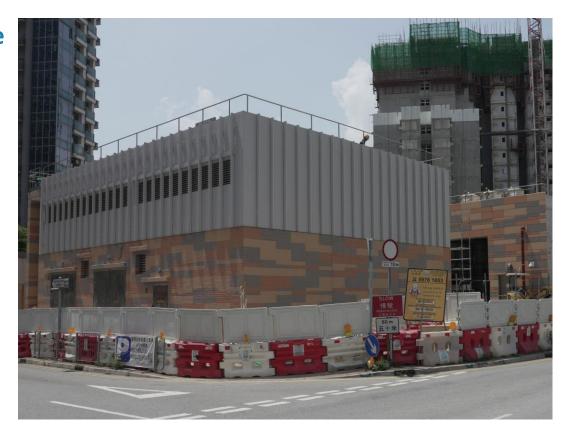
## **West Sewage Pumping Station (WSPS)**

# **Anticipated Commissioning Date** 2025 Q3

- ABWF works
- T&C works

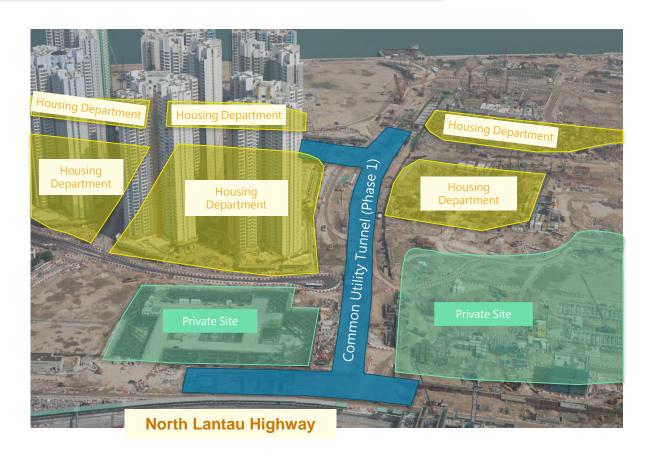
# **Common Utility Tunnel (CUT) (Phase 1)**

# Construction Period 2021 Q3 to 2025 Q3

- Underground R.C. structures
- Backfilling Works

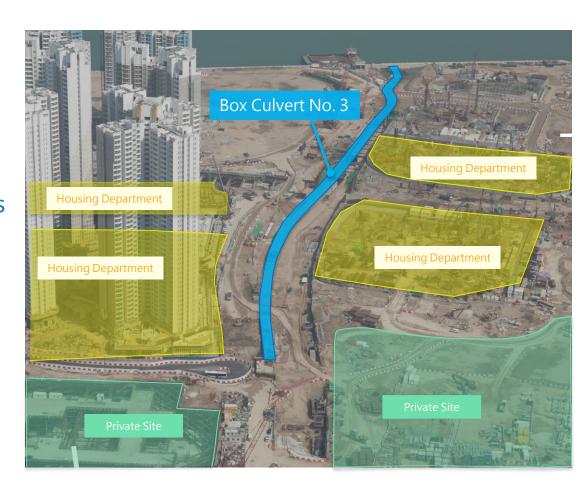
#### **Box Culvert No. 3**

Construction Period 2023 Q4 to 2025 Q3

- Precast Units Installation
- Underground R.C. structures

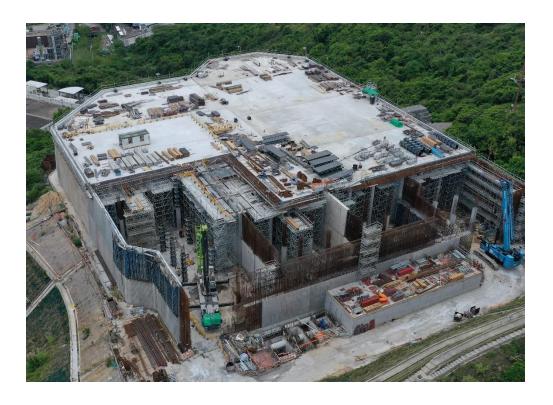
#### **Fresh Water Service Reservoir**

# Construction Period 2022 Q2 to 2025 Q4

- R.C. structures
- Slope works

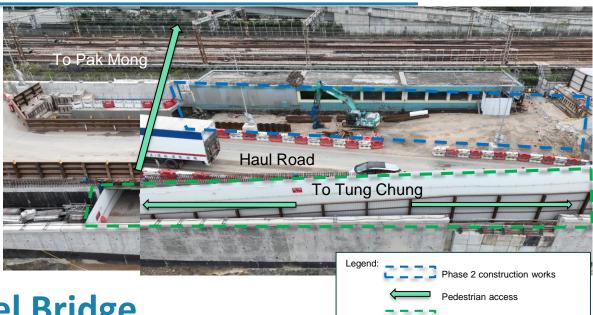
# **Pak Mong Subway Extension**

**Construction Period** 2022 Q2 to 2026 Q1

- R.C. structure
- Demolition of existing subway

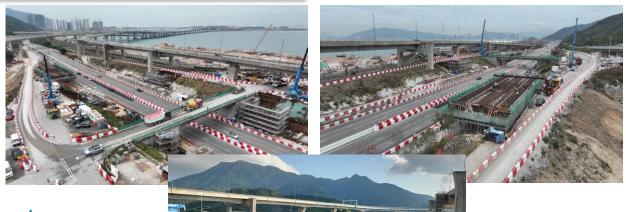
# **Construction of Tai Ho Interchange**

#### Construction Period 2022 Q3 to 2026 Q1 Related Works

- R.C. structure
- Bridge erection
- Temporary Traffic
   Arrangement for road and drainage works

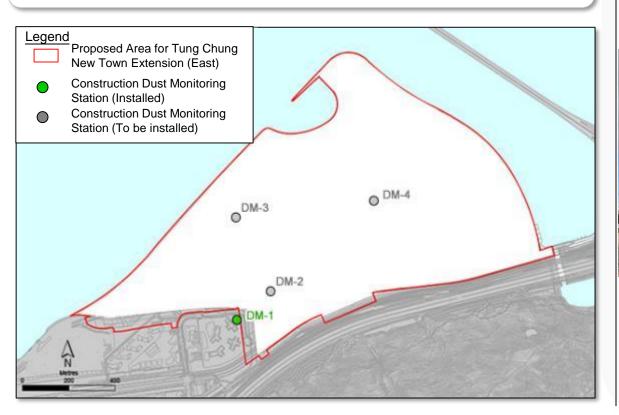
Dust monitoring near Ying Tung Estate (DM-1)

Frequency Three times every six days

Monitoring Parameter 1-hour Total Suspended Particulate

No project-related exceedance was recorded.

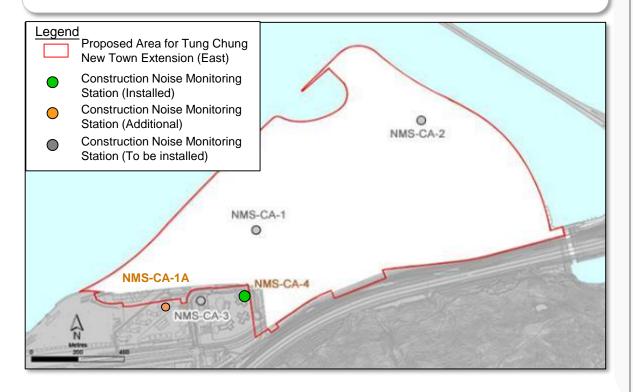
Noise monitoring near Ying Tung Estate (NMS-CA-4)

Results of noise monitoring indicated that noise levels were within acceptable level (75dBA)

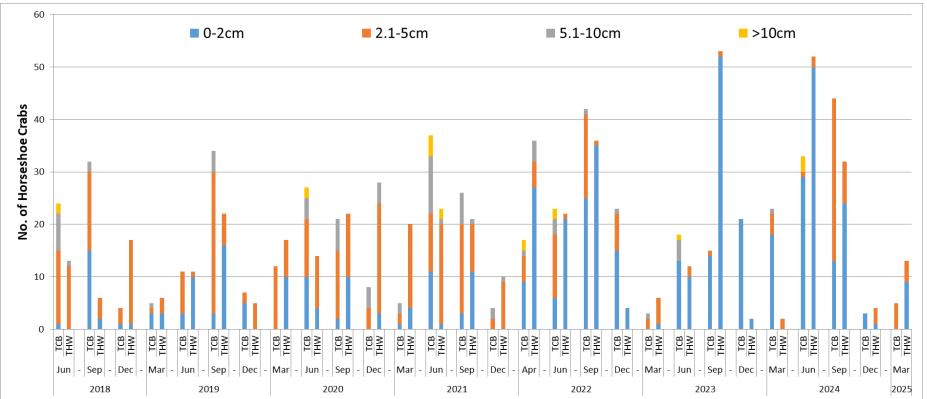
#### **Size (Prosomal Width) of Horseshoe Crabs**

- Numbers of horseshoe crabs varied over time and were generally higher in summer period (May Sep)
- Small juvenile horseshoe crabs (prosomal width <2 cm) were recorded during all impact monitoring since Sep 2018

Baseline (May-Jun 18) Post-Construction Monitoring (Dec 2023)

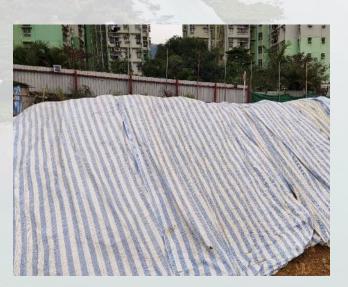
Covering excavated stockpiles by impervious sheeting

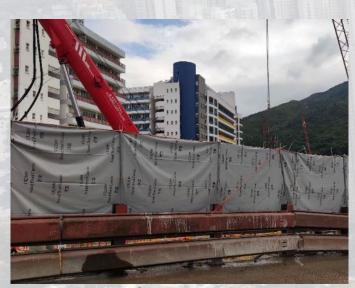
Deployment of noise barrier

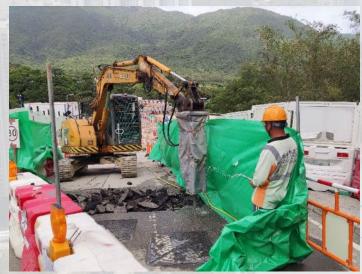
Wrapping of breaker tip with noise acoustic material

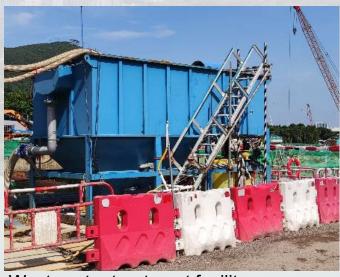
Wastewater treatment facility

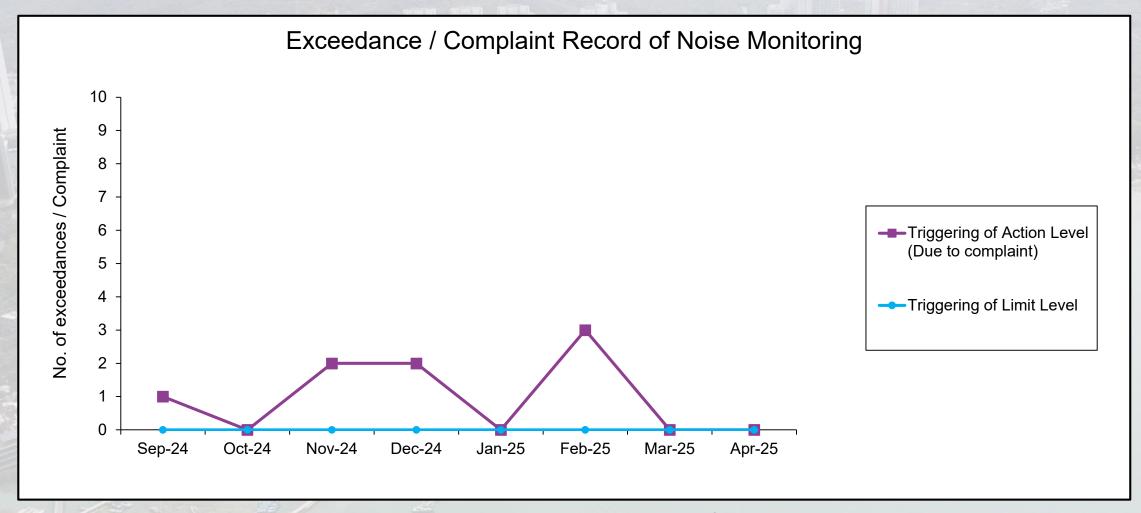
Statistics of Exceedance from Sep 2024 to Apr 2025

Exceedance as recorded in the reporting period was due to the receipt of noise complaint

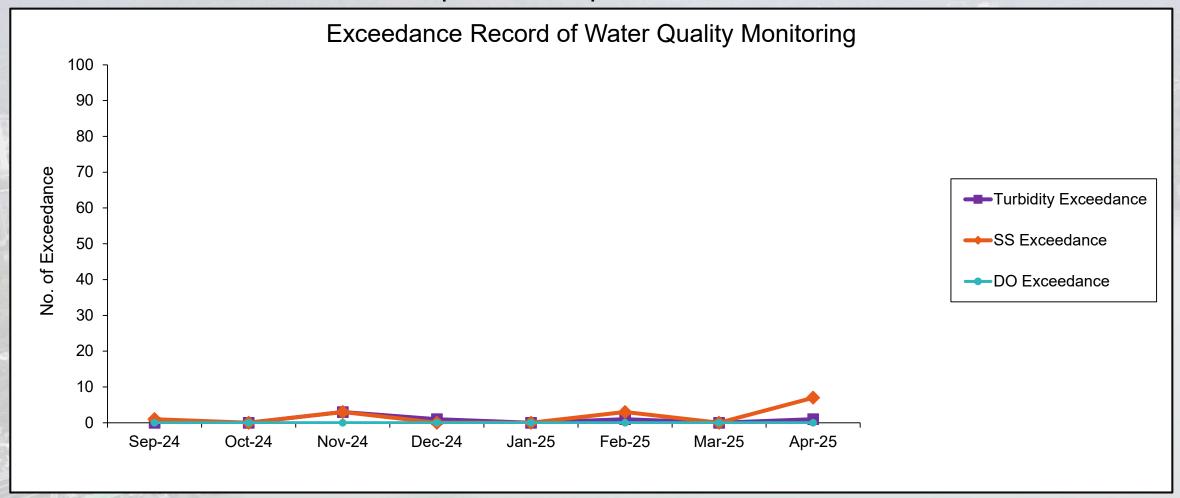
Statistics of Exceedance from Sep 2024 to Apr 2025

- 1. Impact monitoring is carried out at seven stations for three times per week.
- 2. Exceedances as recorded in the reporting period were mainly due to the inclement weather.
- 3. The implementation of environmental mitigation measures by Contractor was in general satisfactory and no deficiencies in practices were observed.

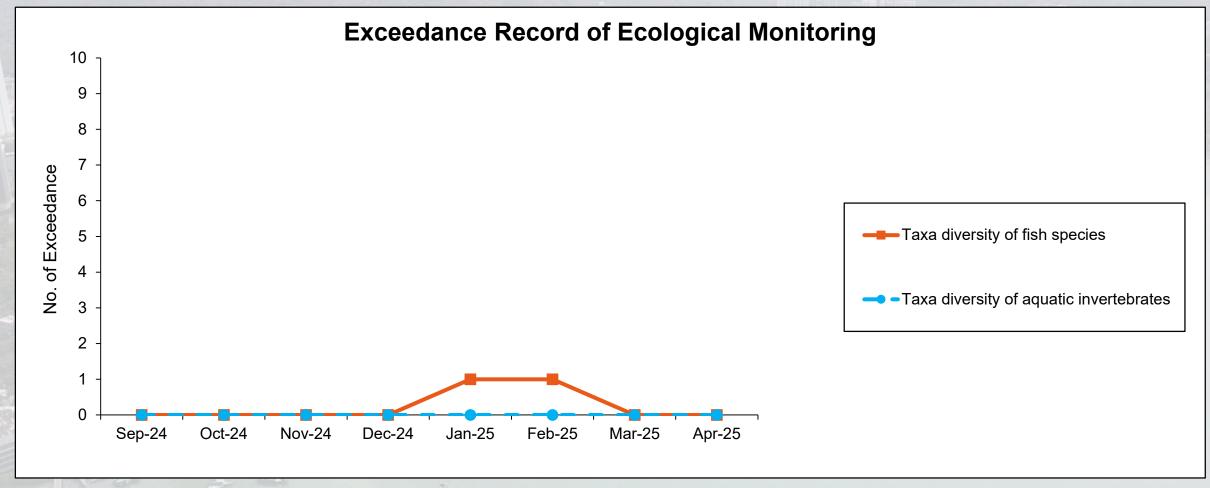
Statistics of Exceedance from Sep 2024 to Apr 2025

- 1. Exceedances as recorded in the reporting period were mainly due to seasonal variation.
- 2. The implementation of environmental mitigation measures by Contractor was in general satisfactory and no deficiencies in practices were observed.
