# Tung Chung New Town Extension

7<sup>th</sup> PLG Meeting  
Date : 23 August 2022

土木工程拓展署  
CIVIL ENGINEERING AND  
DEVELOPMENT DEPARTMENT

可持續大嶼辦事處  
SUSTAINABLE LANTAU OFFICE

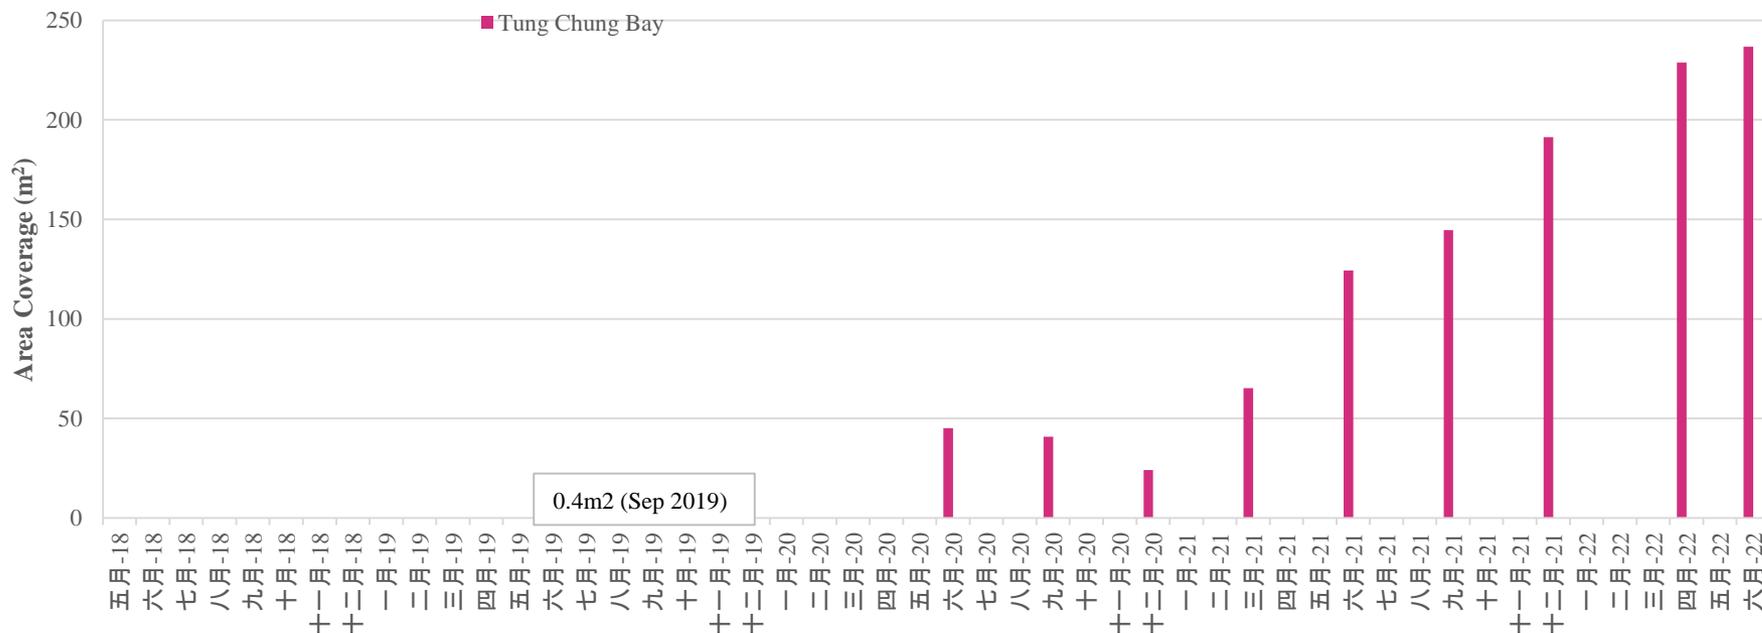
**Seagrass Area Coverage Recorded at Tung Chung Bay**

- No seagrass was recorded at all monitoring locations during the TCE baseline monitoring (2018)
- Throughout TCE ecological monitoring, seagrass was only observed at TCB3 (but not at other monitoring stations).

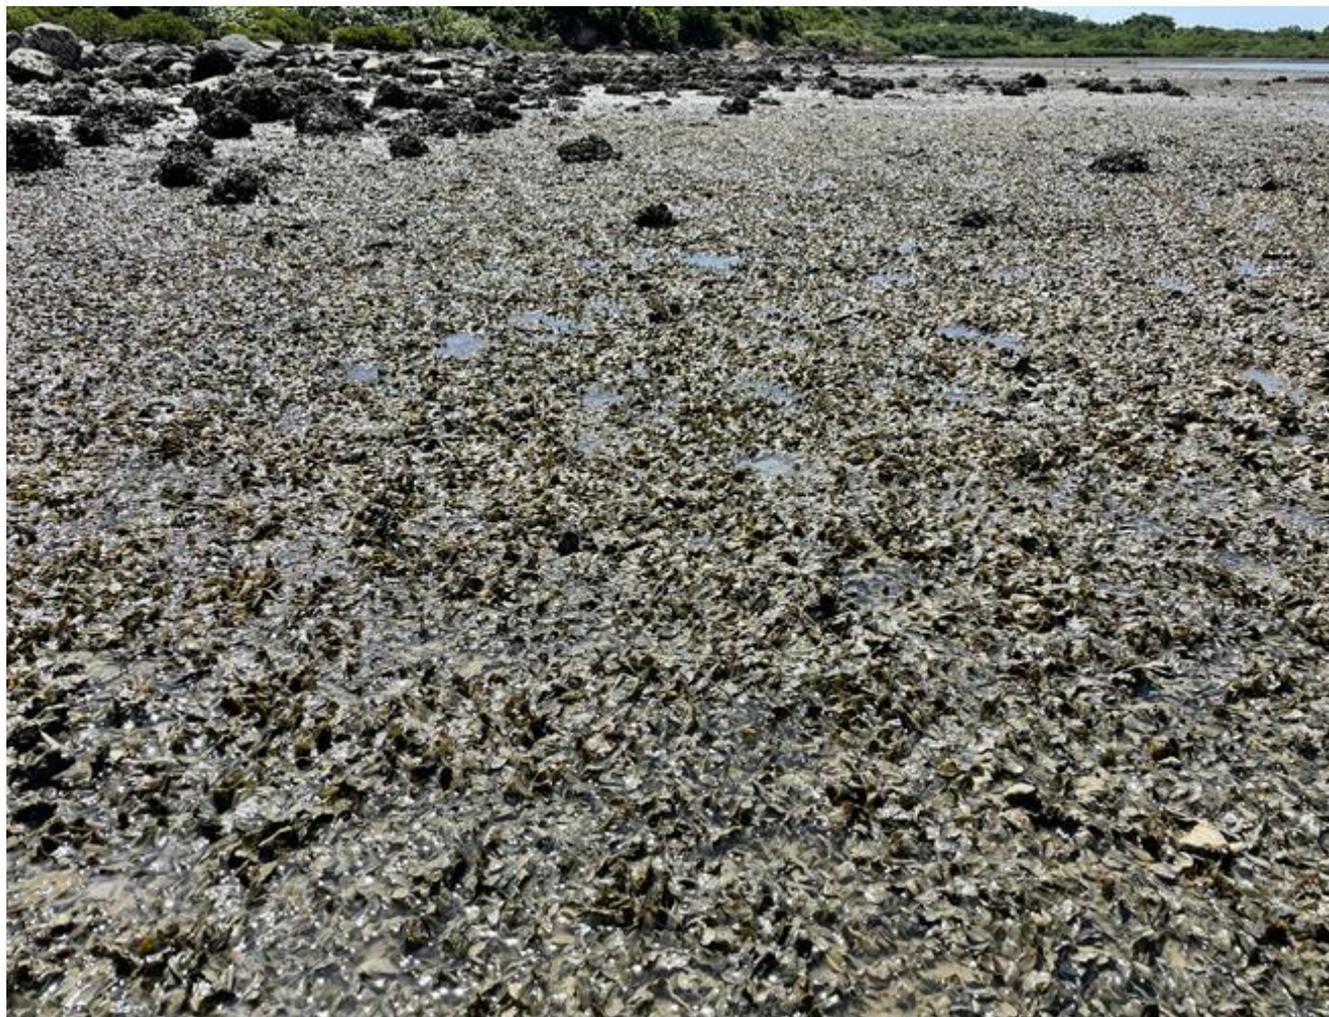
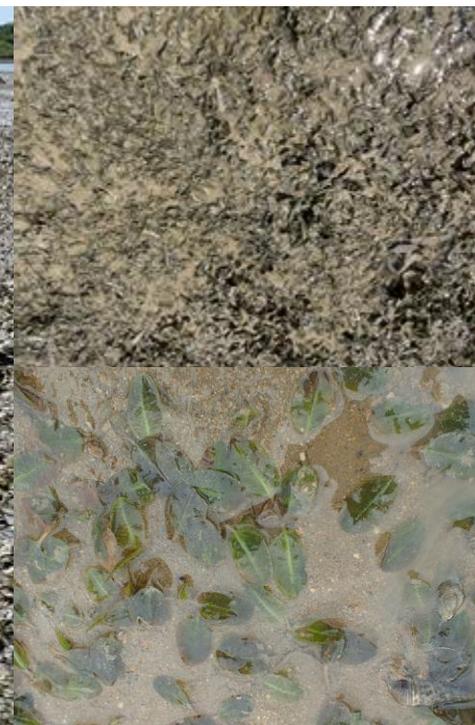
Seagrass patch  
observed in Tung Chung  
Bay (*Halophila ovalis*)

- Refer to HZMB report (Jun 2019) that seagrass bed could disappear for certain period of time then recolonize.
- Seagrass is important to coastal/marine ecosystem. It helps to stabilize the coastlines and sediments, and serve as shelters, feeding grounds and food sources for a variety of animals such as fishes, crabs, gastropods and horseshoe crabs.
- Hence, the occurrence and disappearance of seagrass has no direct linkage to TCNTE project.

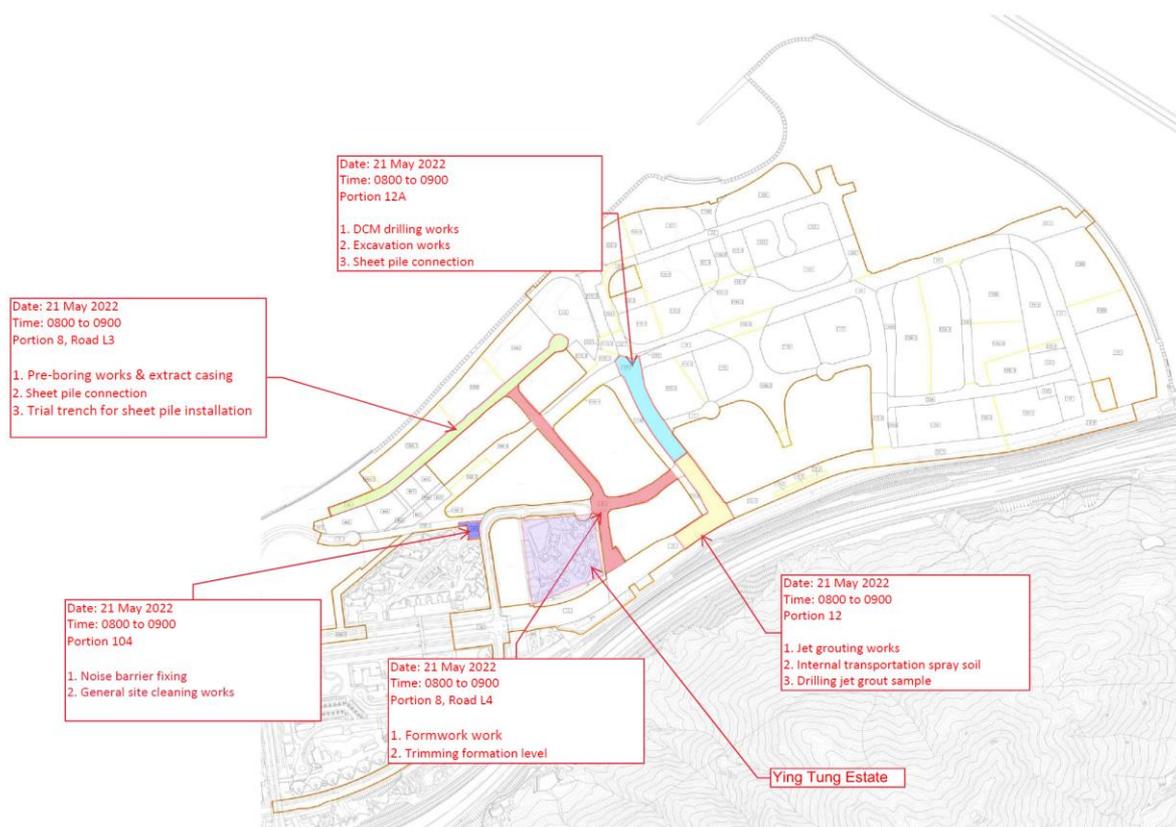
Work Activities and Location Plan for Complaint Case: N09/MP/00009672-22

- TCE Case Logbook reference (C3/20220527/017)
- EPD (ref: N09/MP/00009672-22)
- Complaint on percussive piling (PP) noise at 8:00am referred by EPD
- Site diary log (C1, C2 and C3) and CNP regulation requirement confirmed no PP during the complaint time
- Construction activities clearly recorded provided information which suggested the noise could be contributed by other sources (Other HD Projects etc.)

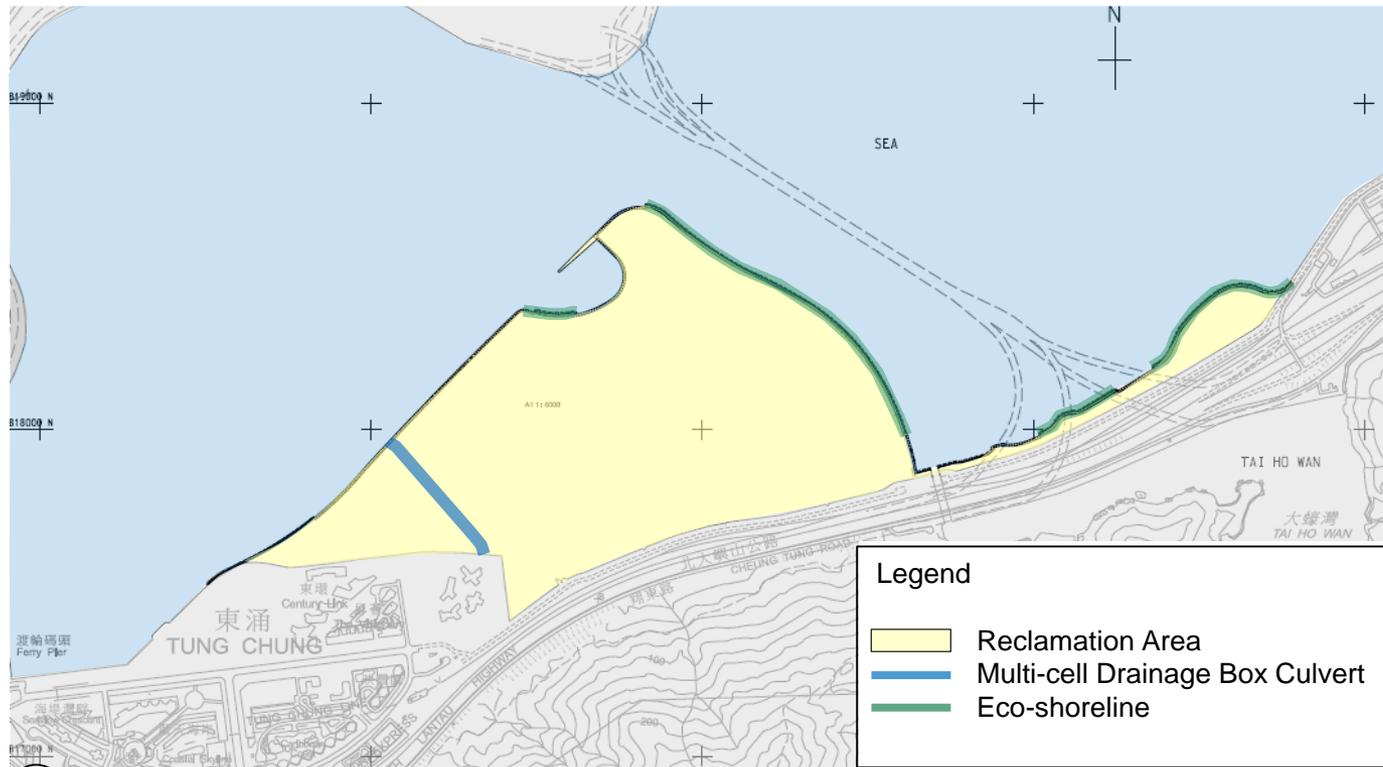
- ① 130 hectares land reclamation by non-dredged method
- ② Construction of 4.9 km seawalls partly with eco-shorelines
- ③ Construction of 470m extension of multi-cell drainage box culvert

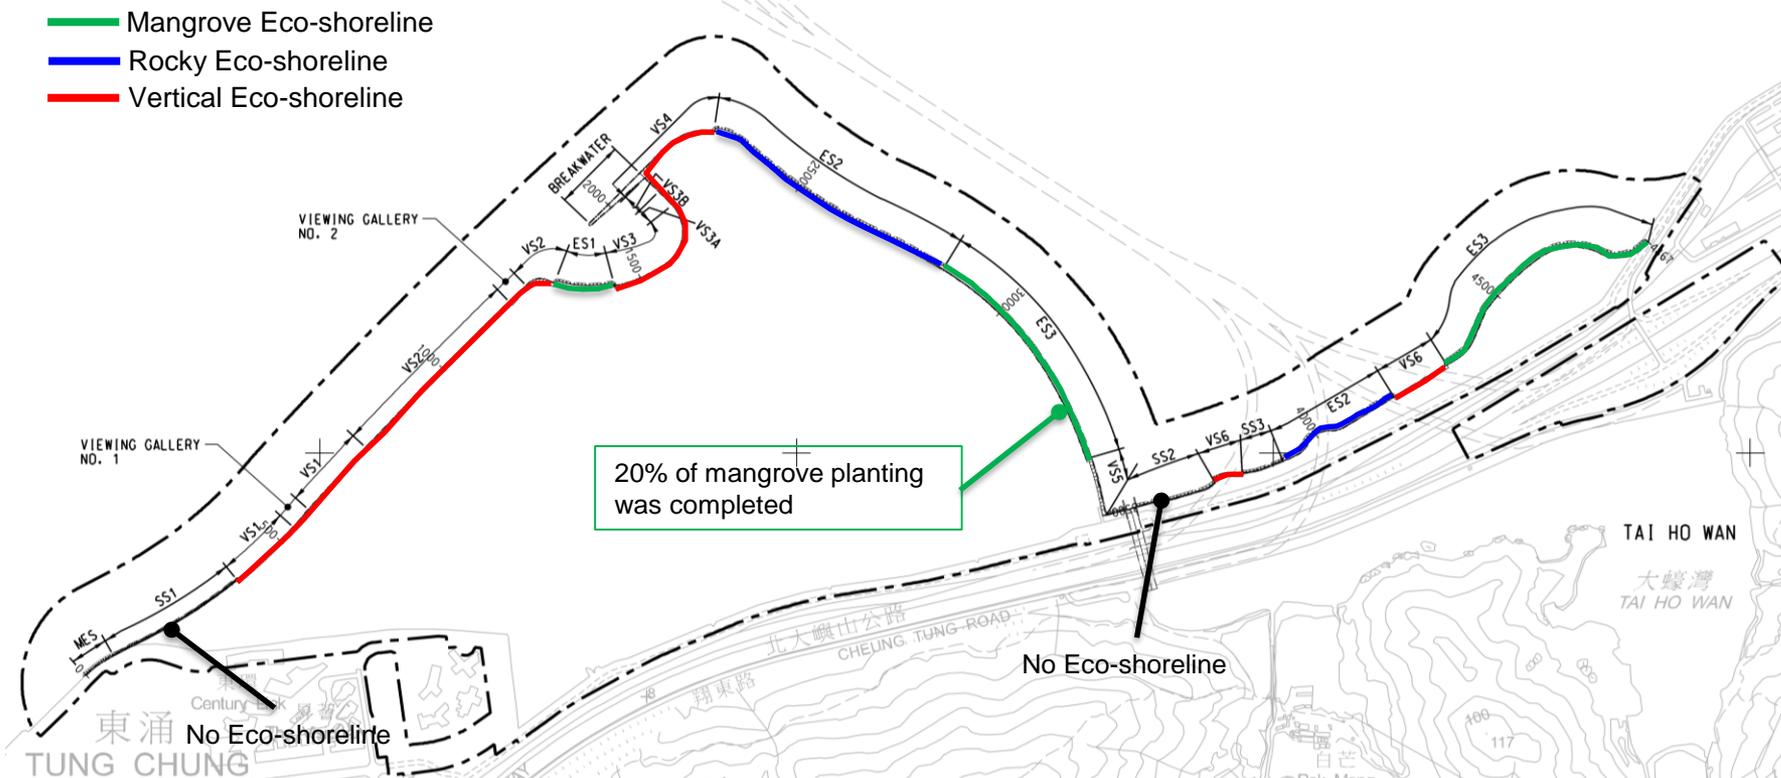
Type of Eco-shoreline	Length (km)	Status
Mangrove Eco-shoreline	1.2	20% completed
Rocky Eco-shoreline	0.8	Precasting in progress
Vertical Eco-shoreline	1.8	100% completed

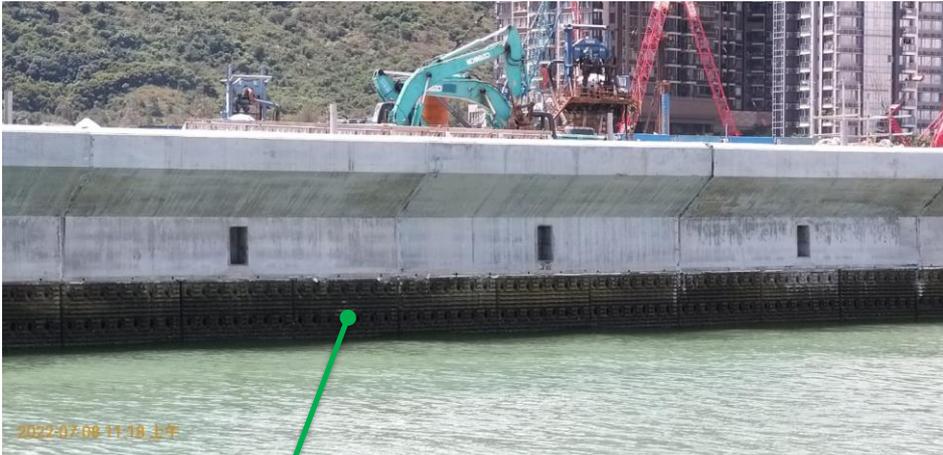
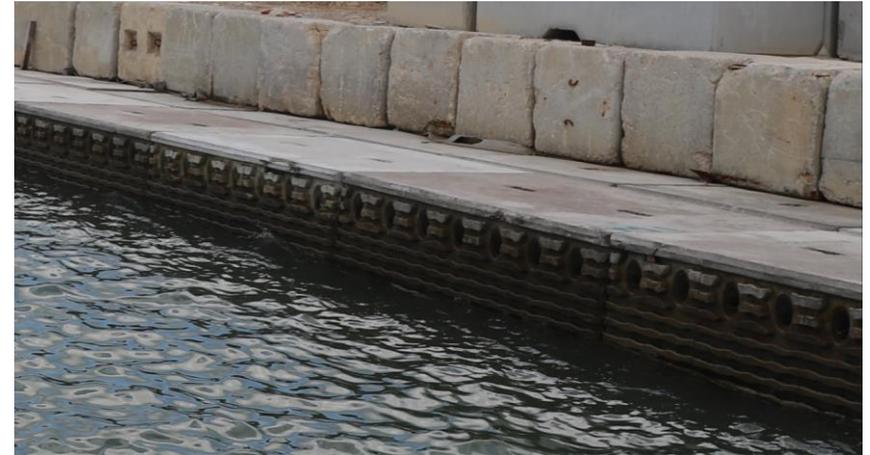
Thin film of algae observed

General View of Vertical Eco-shoreline

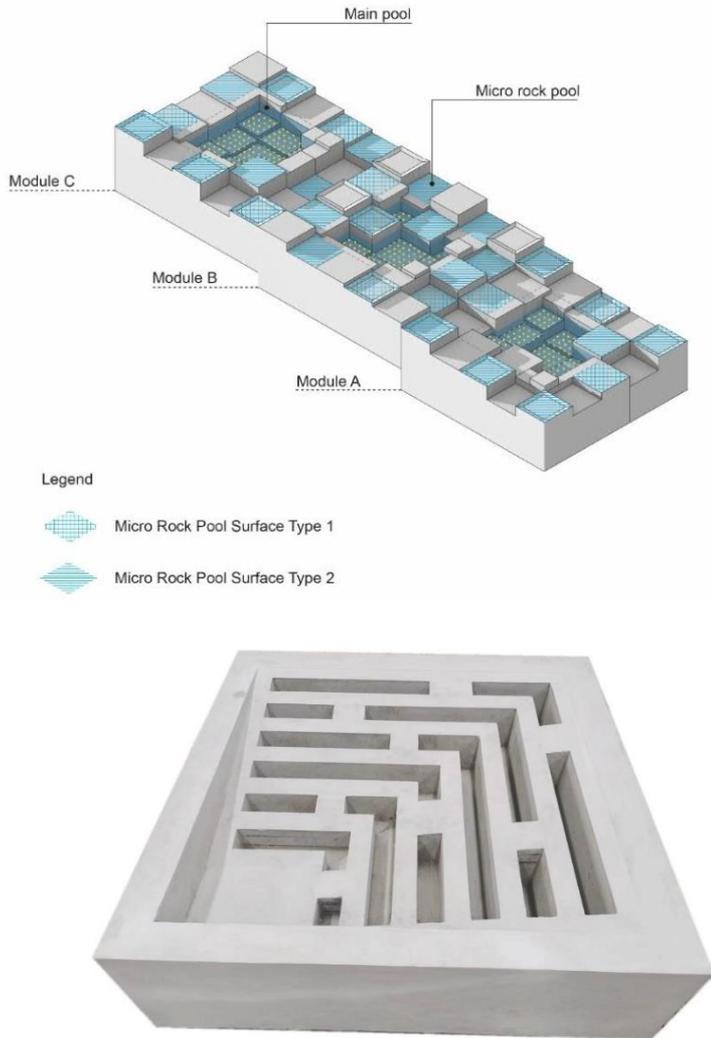
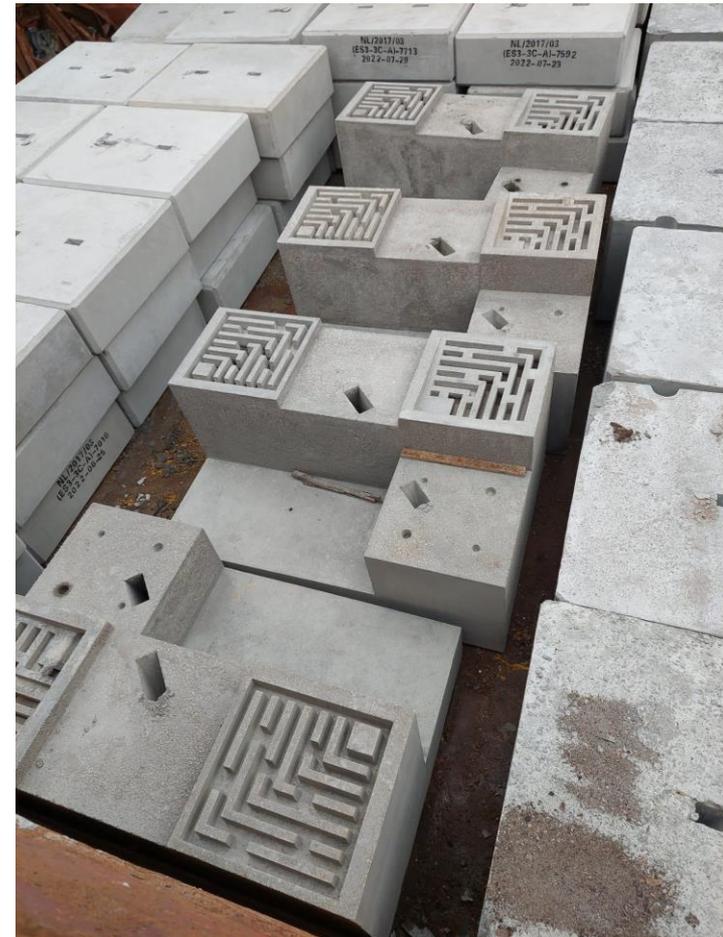
- Precasting of bio-concrete block in progress

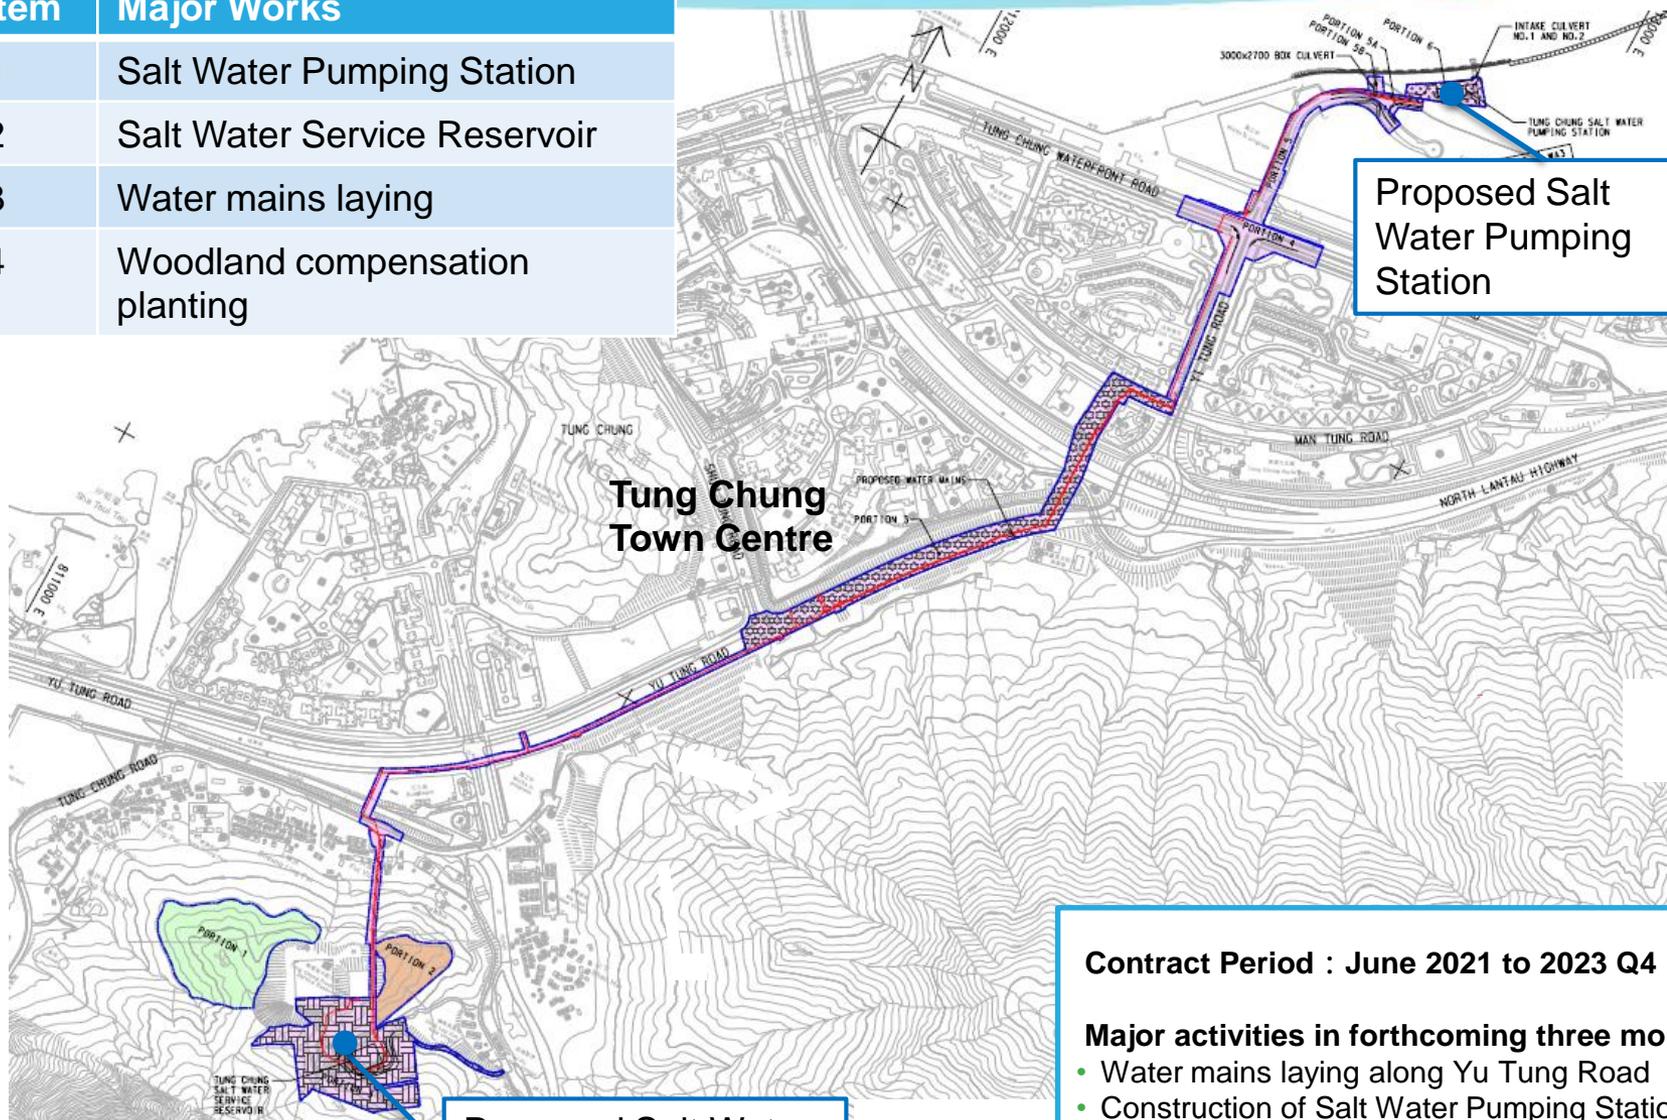
Item	Major Works
1	Salt Water Pumping Station
2	Salt Water Service Reservoir
3	Water mains laying
4	Woodland compensation planting

Proposed Salt Water Pumping Station

Proposed Salt Water Service Reservoir

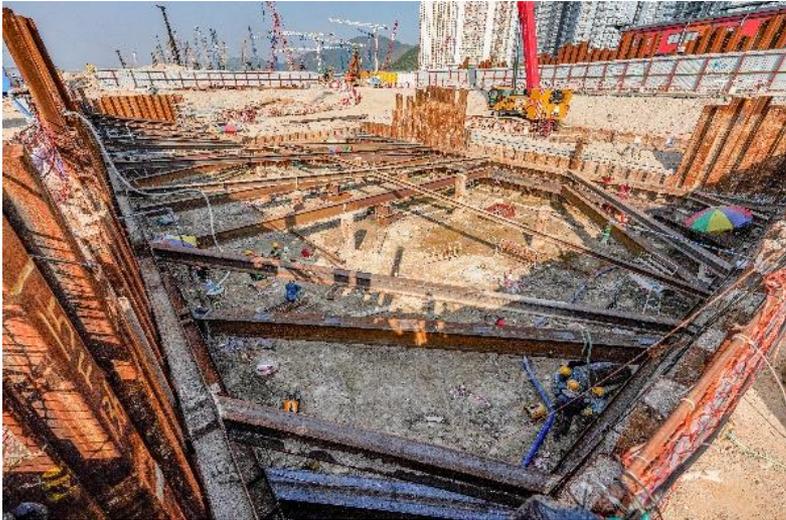
ELS Works for Pumping Station in progress

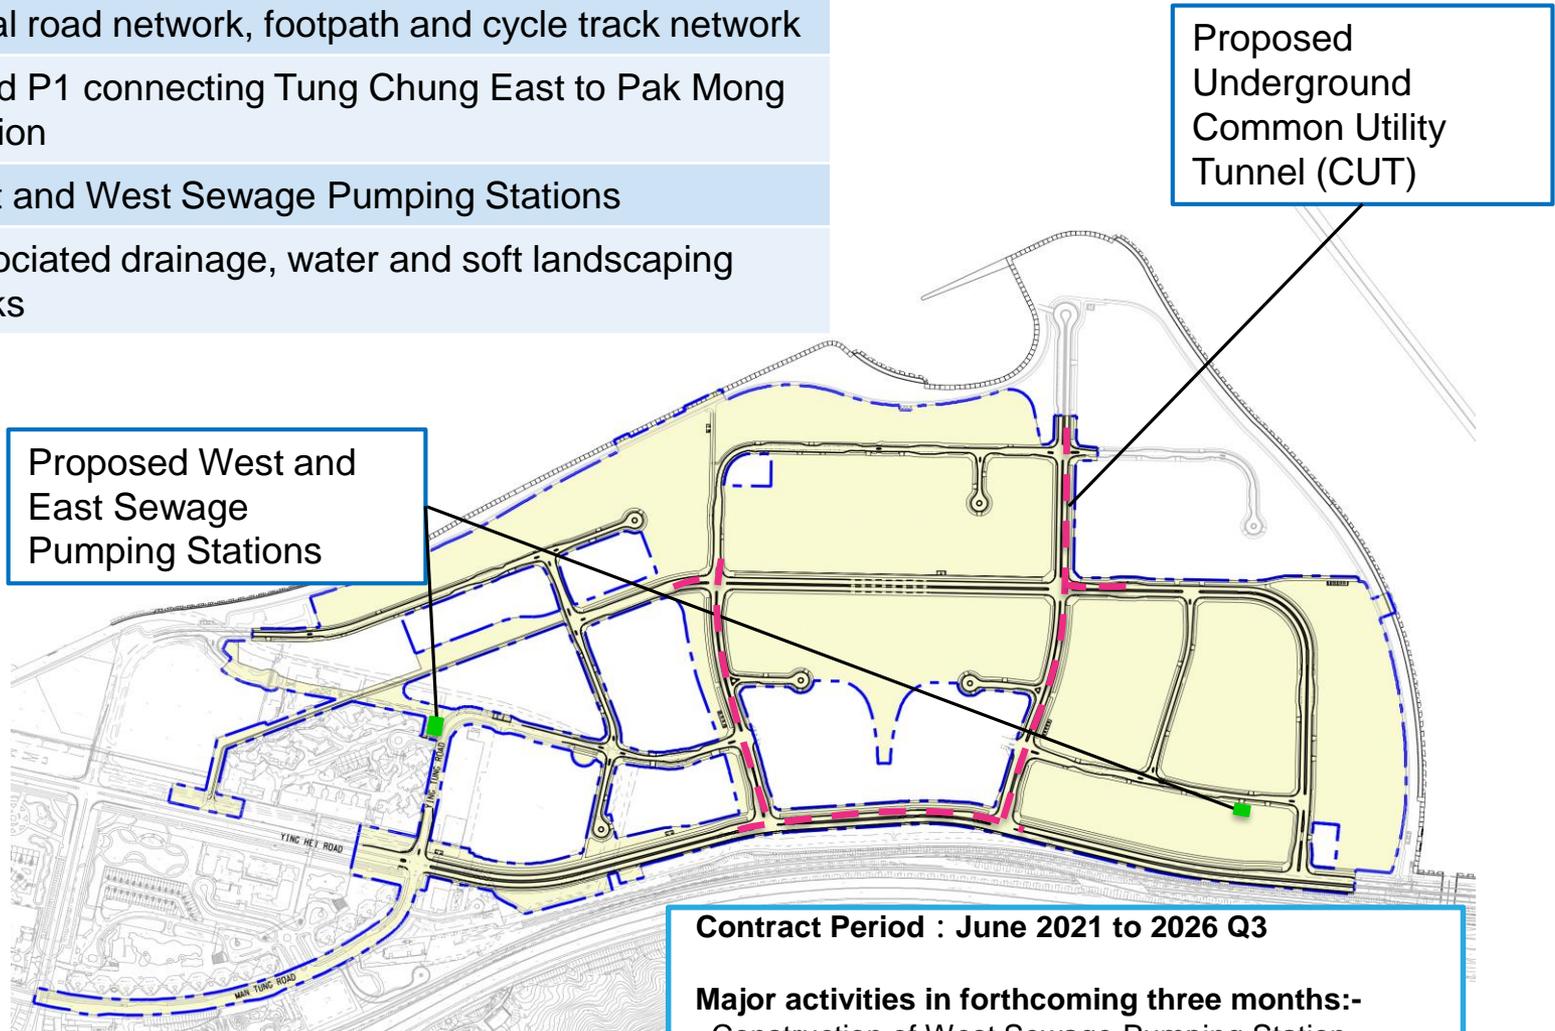
Item	Major Works
1	Local road network, footpath and cycle track network
2	Road P1 connecting Tung Chung East to Pak Mong section
3	East and West Sewage Pumping Stations
4	Associated drainage, water and soft landscaping works

Proposed  
Underground  
Common Utility  
Tunnel (CUT)

Proposed West and  
East Sewage  
Pumping Stations

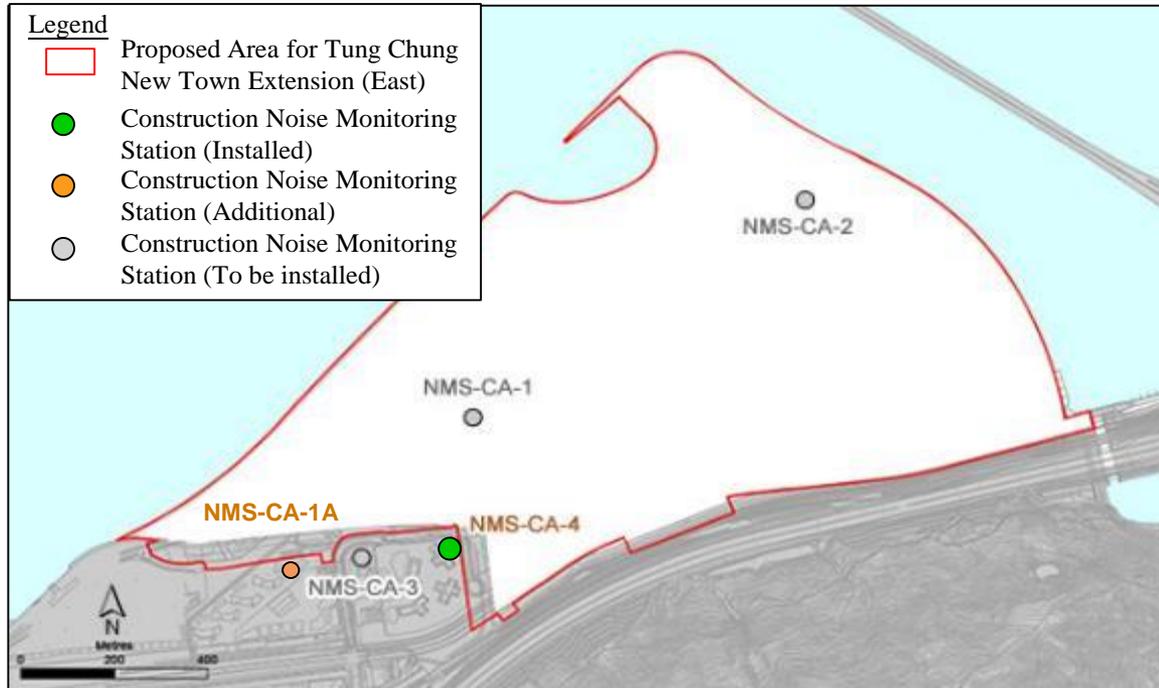
Noise monitoring near Ying Tung Estate  
(NMS-CA-4)

**Frequency** Once per week  
**Monitoring Parameter**  $L_{eq}$  (30mins)

Results of noise monitoring indicated that noise levels were within acceptable level (75dBA)

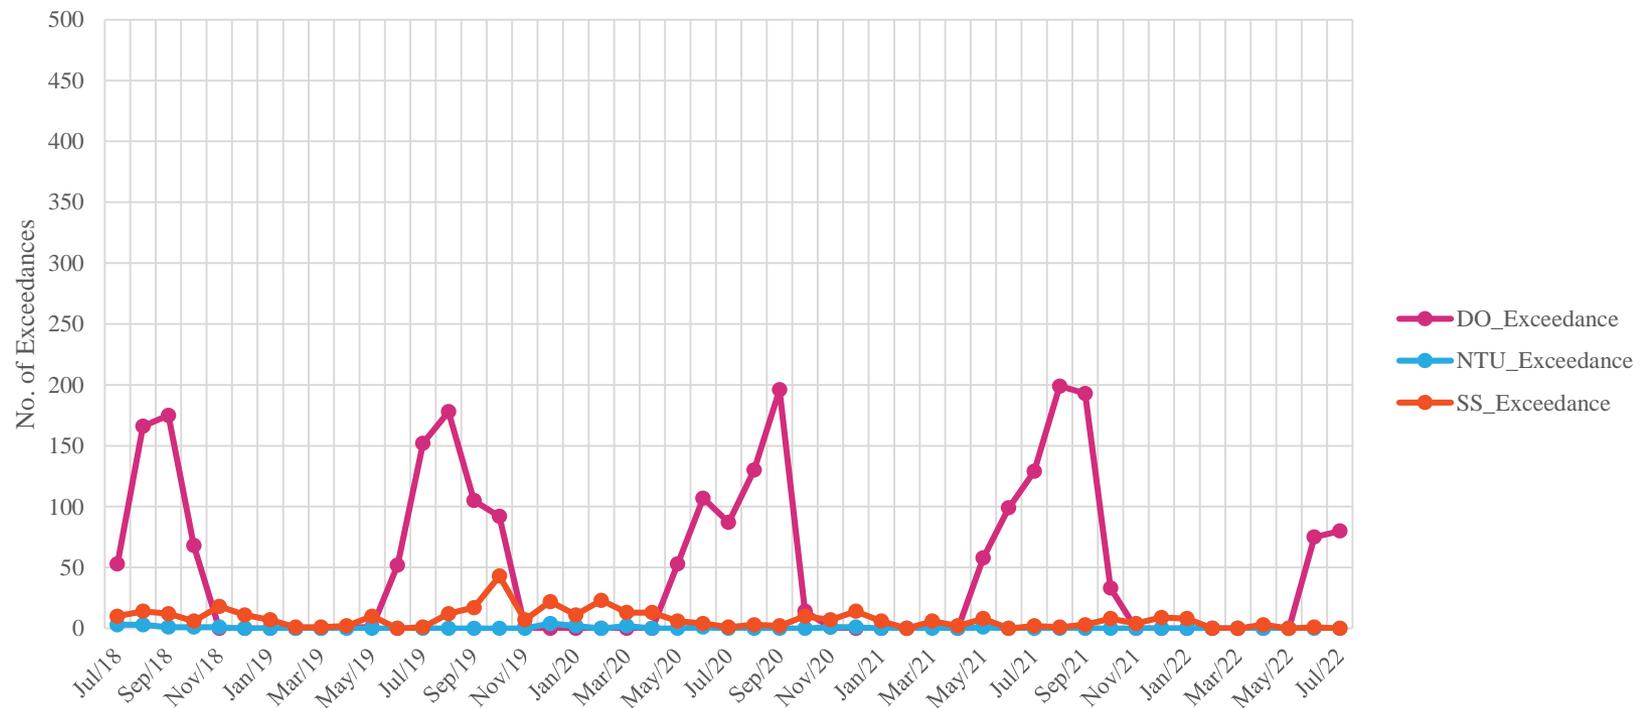
**Tung Chung New Town Extension - Reclamation and Advance Works**  
Exceedance Record of Water Quality Monitoring

The majority exceedances recorded were DO exceedances. Low levels of DO were recorded during summer period. This trend suggested the changes should be due to seasonal fluctuation.

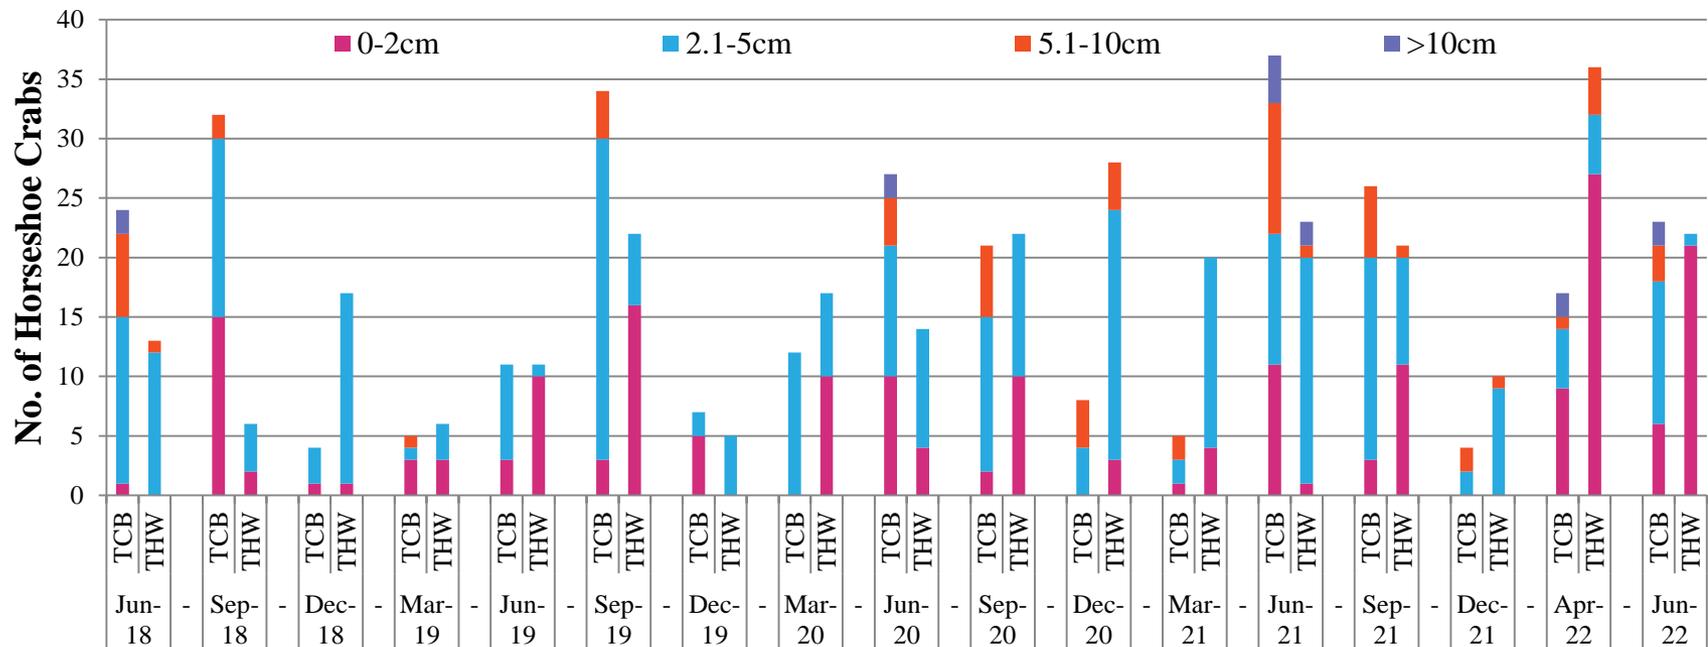
- Numbers of horseshoe crabs varied over time and were generally higher in summer period (May – Sep)
- Small juvenile horseshoe crabs (prosomal width <2 cm) were recorded during all impact monitoring since Sep 2018

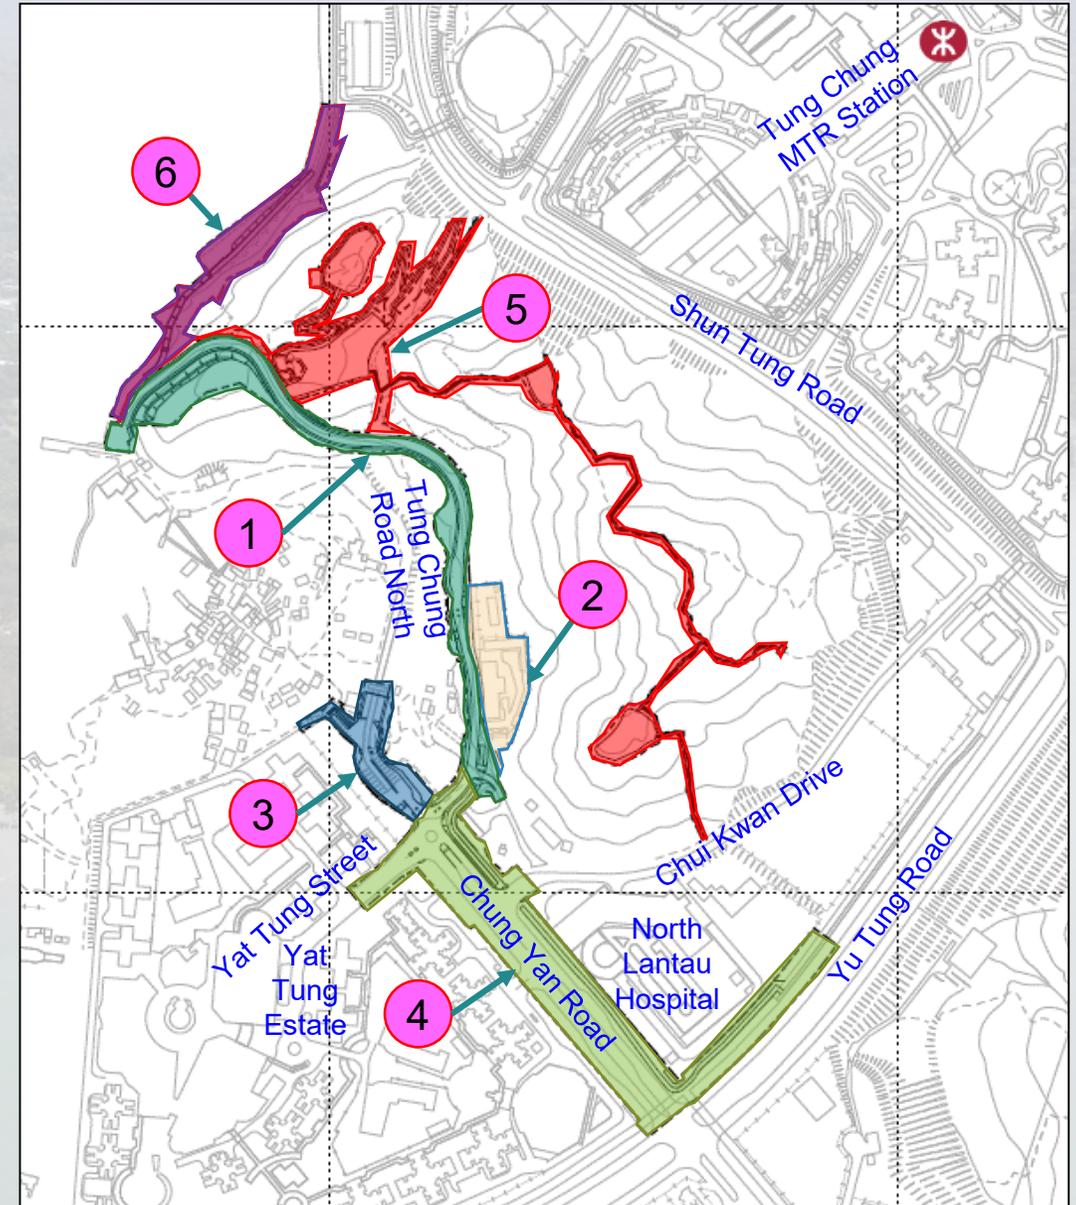
1. Slope cutting and installation of soil nails in progress.
2. Sheet piling works for underground utilities works in progress.

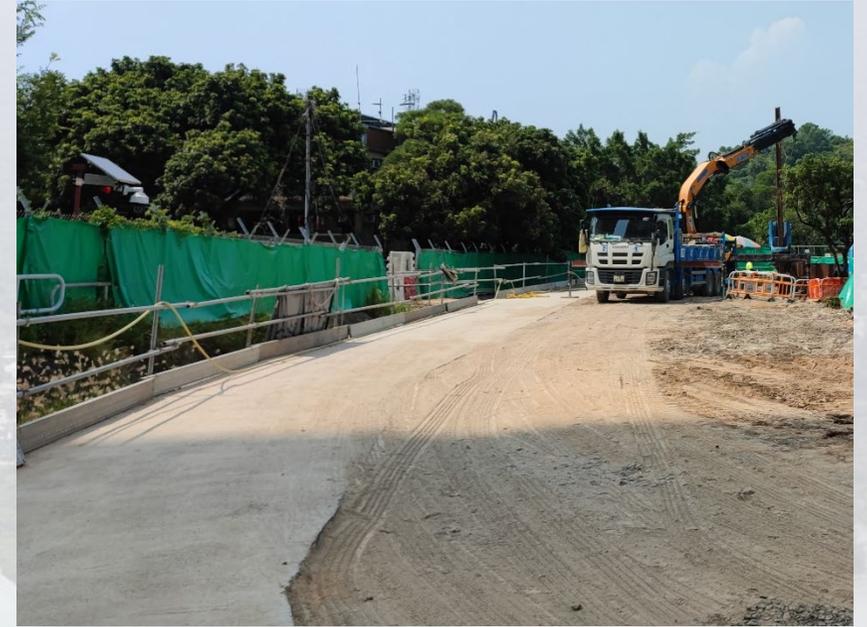
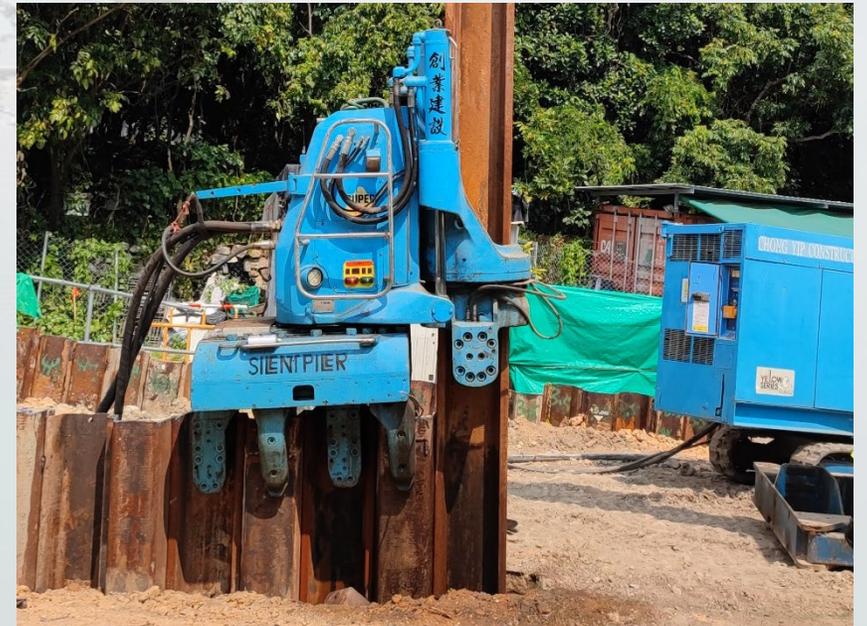
1. Temporary drainage diversion completed.
2. Sheet piling works for retaining wall construction in progress.
3. Environmentally friendly construction method for sheet piling works adopted.

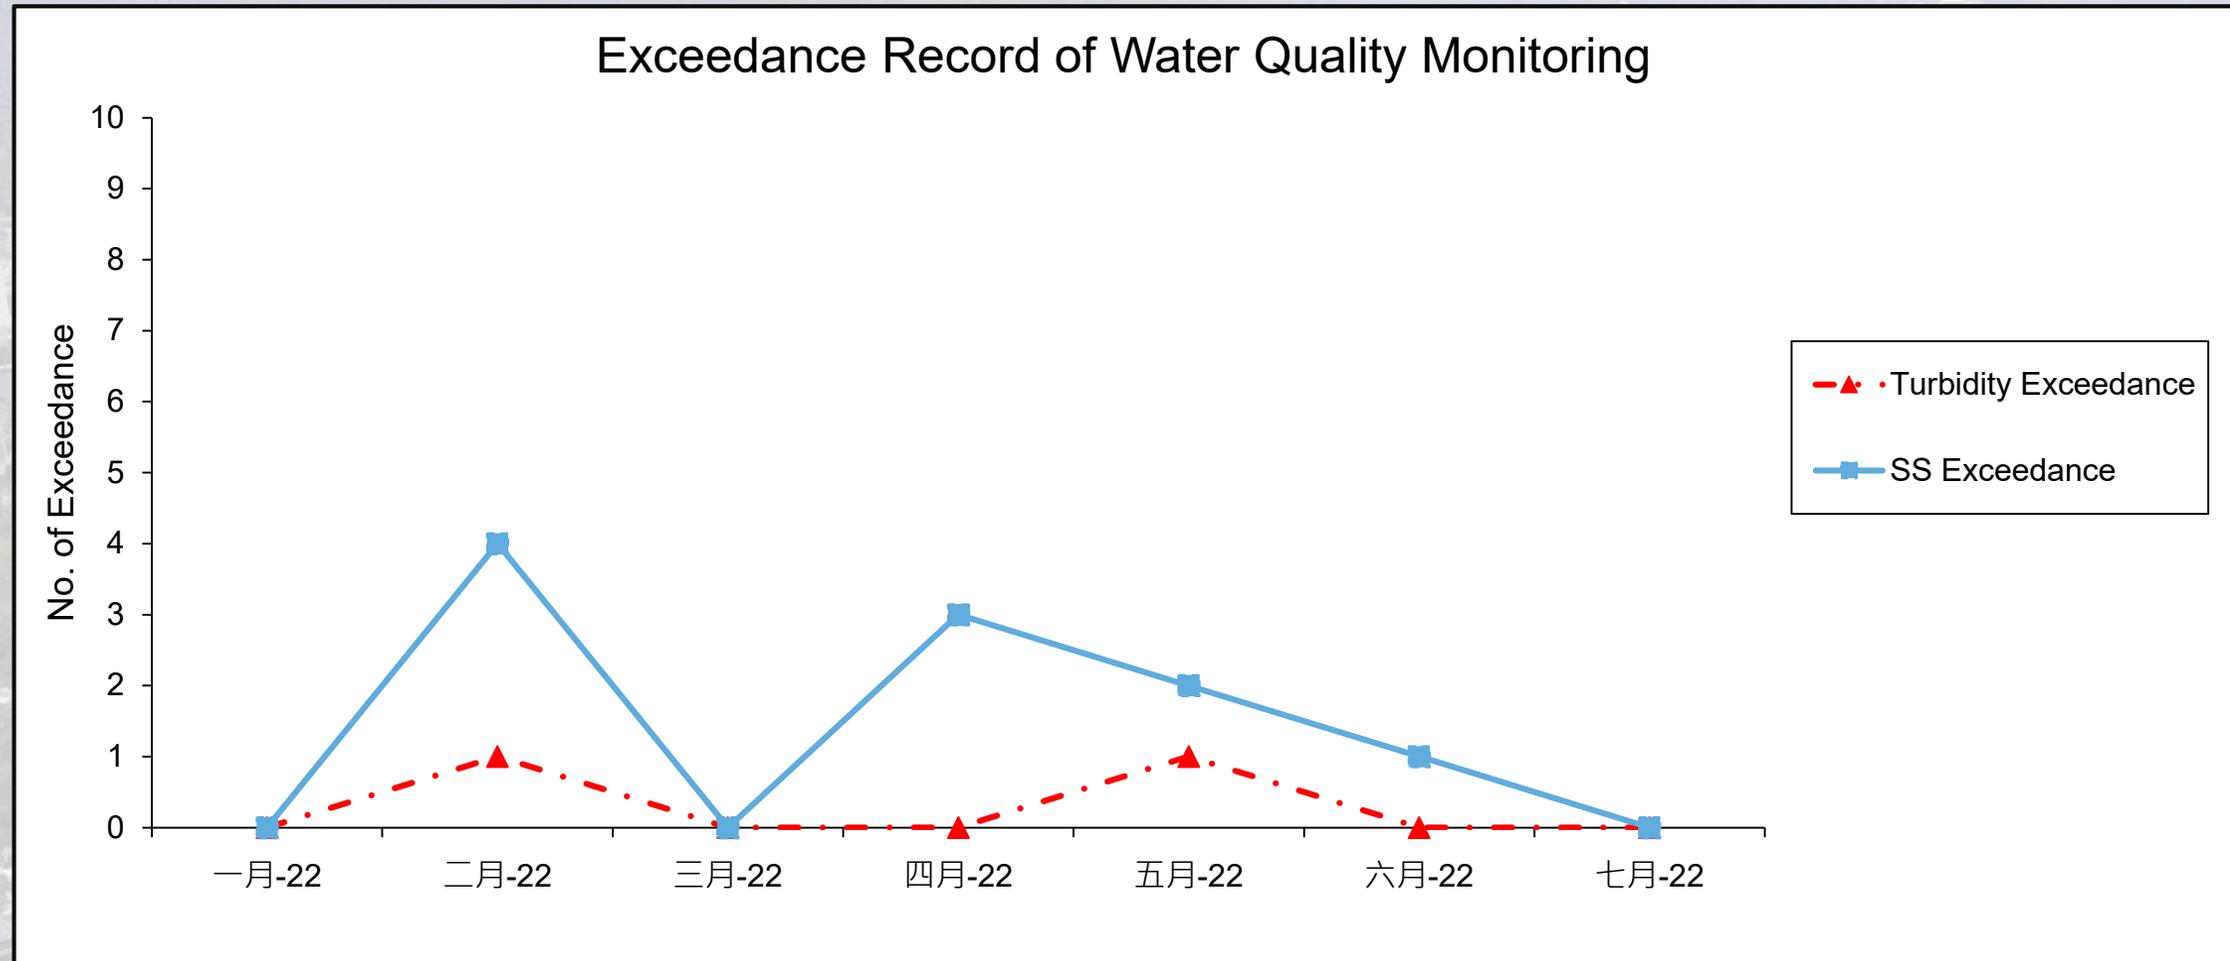
Statistics of Exceedance from Jan 2022 to Jul 2022

SS measurement was the majority exceedances as recorded in the reporting period which were due to inclement weather and river clearance works carried out by other contractor.
