Agreement No. CE 64/2020 (EP) Environmental Team for Tung Chung New Town Extension (West) – Design and Construction

Monthly Environmental Monitoring & Audit Report for January 2023

Environmental Permit No. EP-519/2016

Tung Chung New Town Extension (West)

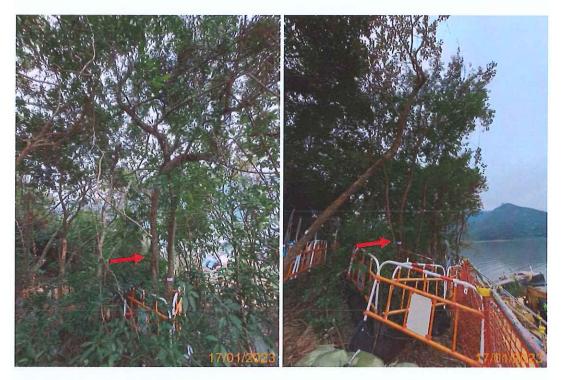
- Dust Emission
- Handling and storage of C&D materials generated from construction activities
- Noise from plant operation
- Emission of dark smoke from PMEs
- Efficiency of wastewater and drainage management
- Tree Protection

- Good site practices
- Regular water spraying on stockpiles
- Provide tarpaulin sheets coverage on stockpiles
- Sorting and reuse of C&D materials as far as practicable
- Use of QPME and noise barrier/acoustic mat
- Regular maintenance of PMEs
- Implementation of wastewater and drainage management
- Retain and protect all existing trees and vegetation within the study area which are not directly affected by the works
