Agreement No. CE 64/2020 (EP) Environmental Team for Tung Chung New Town Extension (West) – Design and Construction

Monthly Environmental Monitoring & Audit Report for March 2023

April 2023

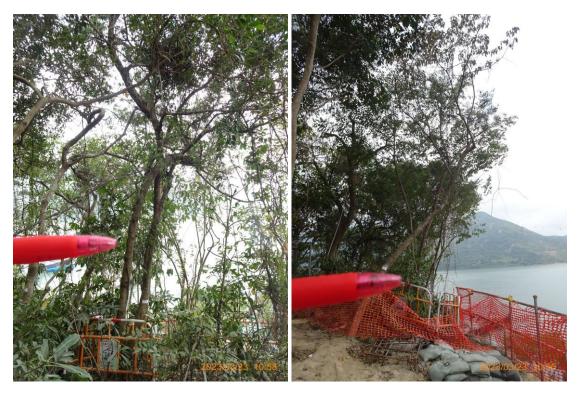
1: T8217 2: T8231

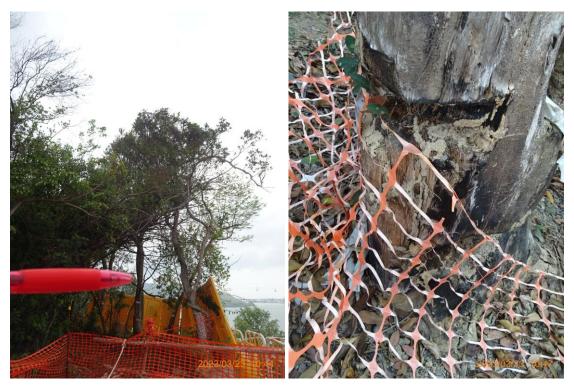
Monthly monitoring of the in-situ preserved plant species of conservation importance by the Qualified Botanist (QB) appointed under Contract 5 and Contract 6 respectively were implemented in the reporting period. Old termite track were recorded at the individuals of *Aquilaria sinensis* and *Gmelina chinensis* (Tree No. U041 and U042) under Contract 5. No active termite was recorded and application of pesticide was not necessary. The condition of the concerned plant would be monitored by the QB appointed under Contract 5.

3: U041_Old termite track

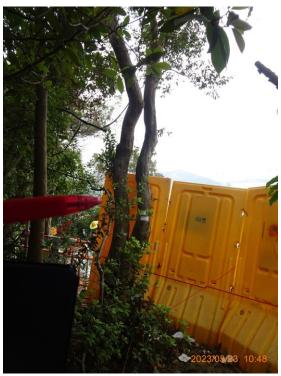
6: U042_Old termite track

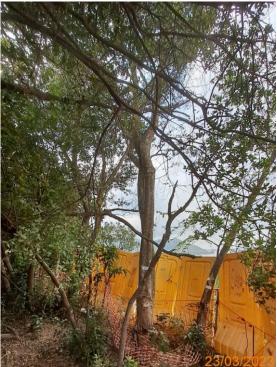
8: Temporary protective fencing for U041, U042 and U043 (1)

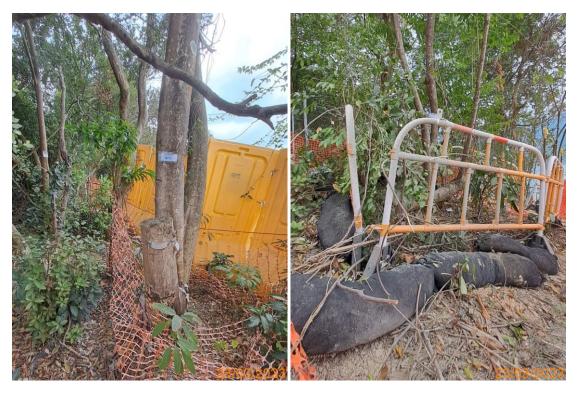
9: Temporary protective fencing for U041, U042 10: Protective fence sealed by silt rock composed and U043 (2)

of wood chip
