**Agreement No. CE 64/2020 (EP)
Environmental Team for
Tung Chung New Town
Extension (West) –
Design and Construction**

Monthly Environmental Monitoring & Audit Report
for May 2026

June 2026

Tung Chung New Town Extension (West)

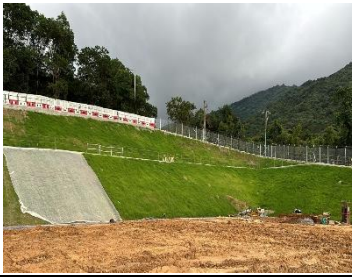
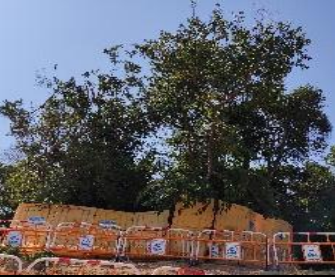
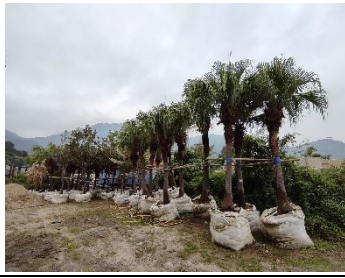
Table 7.3: Examples of Landscape and Visual Mitigation Measures

<p>Landscaping on Slopes</p>	<p>General view of tree protection zone for retained tree</p>	<p>Transplanting of existing trees to temporary nursery site</p>

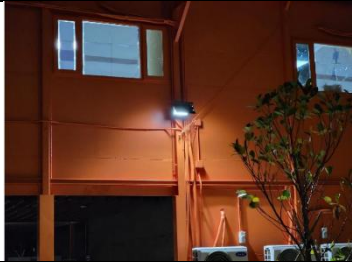
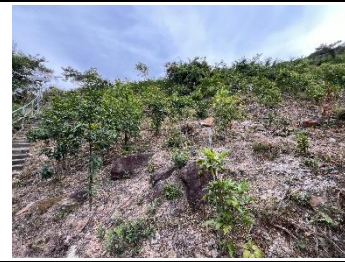
<p>Control of night-time lighting using light hooding</p>	<p>Protection of Natural Rivers and Streams</p>	<p>Compensatory Planting and Woodland Restoration</p>

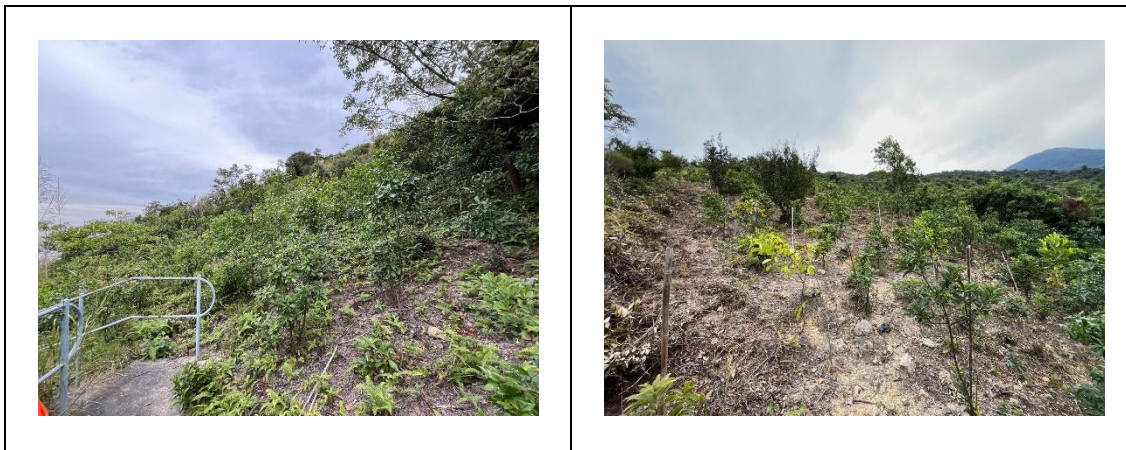
Table 7.6: Photos of the Compensation Woodland Planting

Compensation Woodland Planting was completed in May 2022. With the approval from EPD on the monitoring proposal in October 2022, the monitoring for Compensation Woodland was commenced in November 2022 and completed in November 2025. Photos of the Compensation Woodland planting are shown in **Table 7.6**.

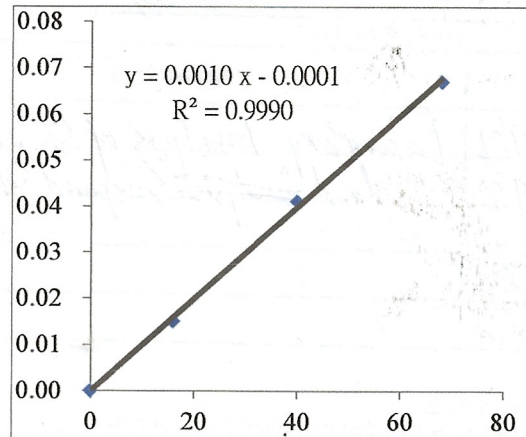
Slope (K-factor): 0.0010(mg)/Count
Correlation Coefficient (R): 0.9995
Date of Issue: 2-Jun-2025

1. Strong Correlation (>0.8)
2. Factor 0.0010(mg)/Count should be applied for TSP monitoring

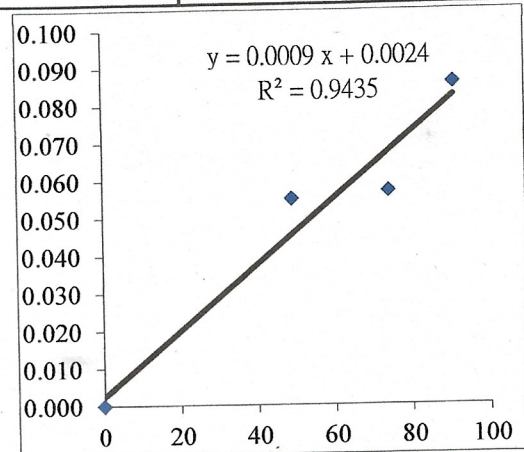
Slope (K-factor): 0.0009(mg)/Count
Correlation Coefficient (R): 0.9713
Date of Issue: 4-May-2026

- 1. Strong Correlation (>0.8)
- 2. Factor 0.0009(mg)/Count should be applied for TSP monitoring

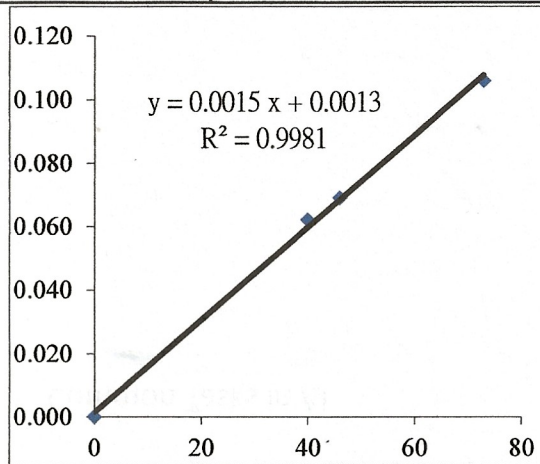
Slope (K-factor): 0.0015(mg)/Count
Correlation Coefficient (R): 0.9991
Date of Issue: 18-Oct-2025

1. Strong Correlation (>0.8)
2. Factor 0.0015(mg)/Count should be applied for TSP monitoring

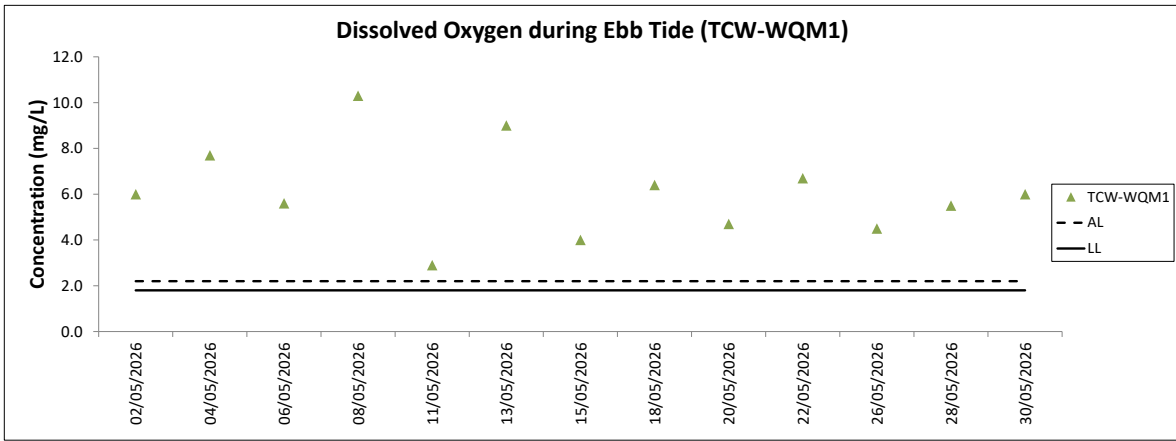
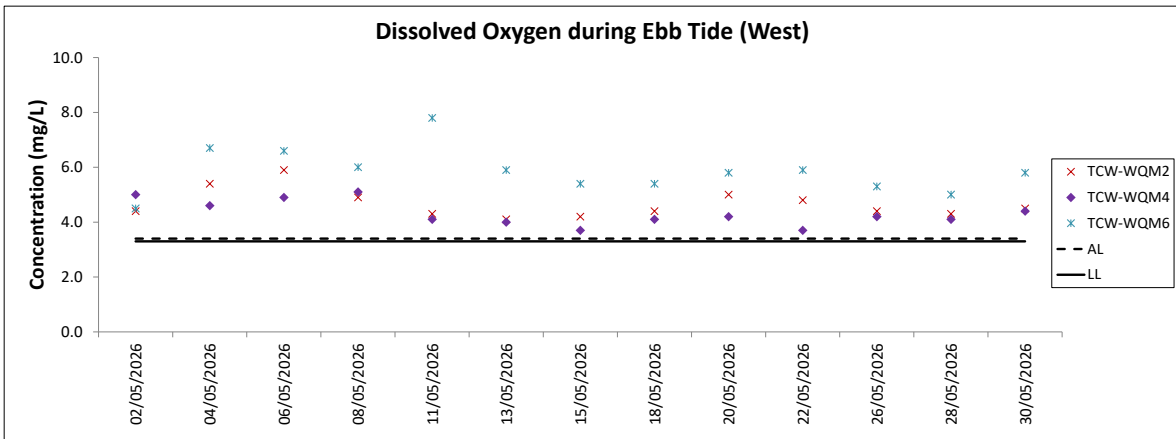
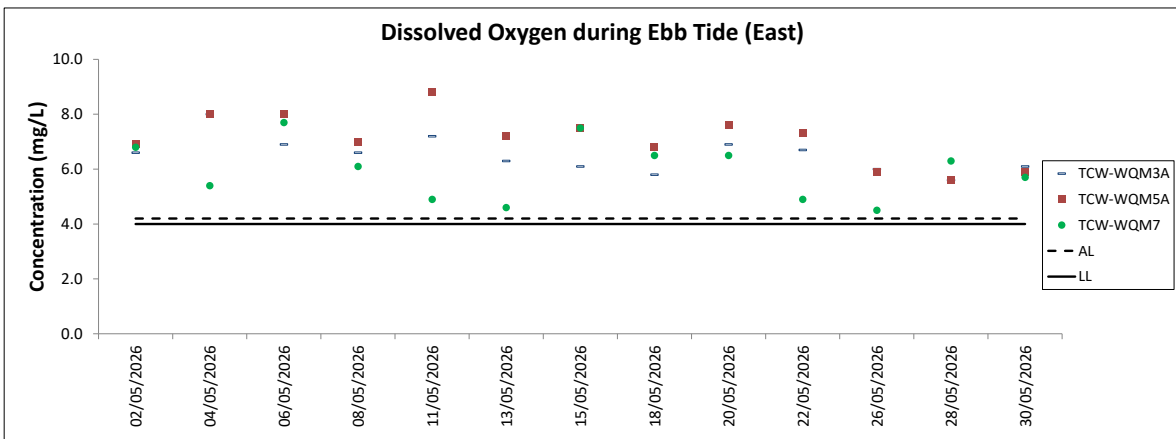
Note: The Action and Limit Level of dissolved oxygen can be referred to Table 4.3 of the monthly EM&A report.
 Major site activities carried out during the reporting period are summarized in Section 1.4 of the monthly EM&A report.
 Weather conditions during monitoring are presented in the data tables above.
 QA/ QC requirements as stipulated in the EM&A Manual were carried out during measurement.

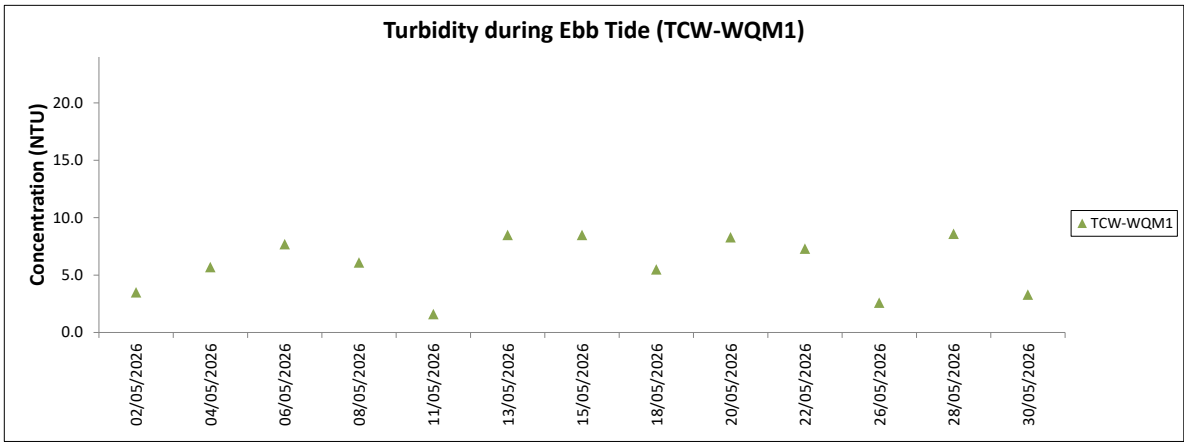
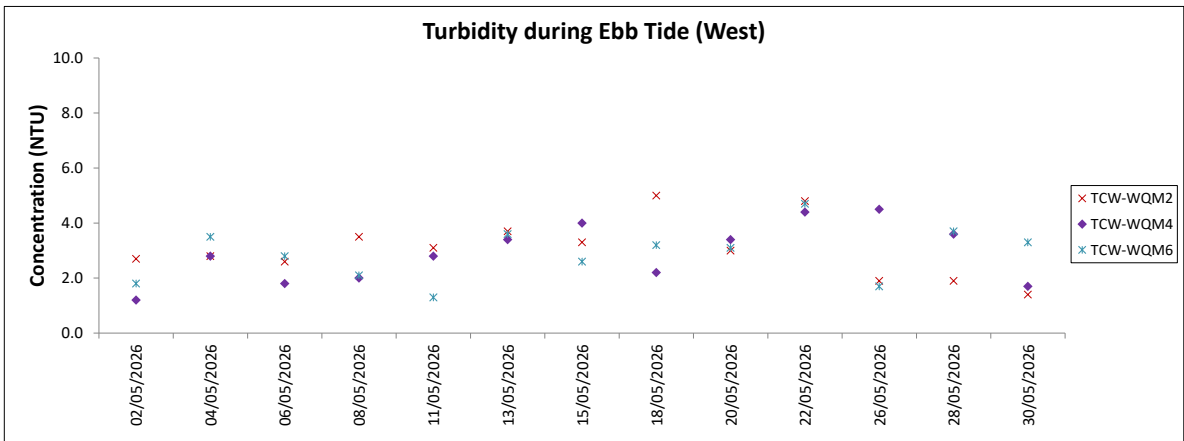
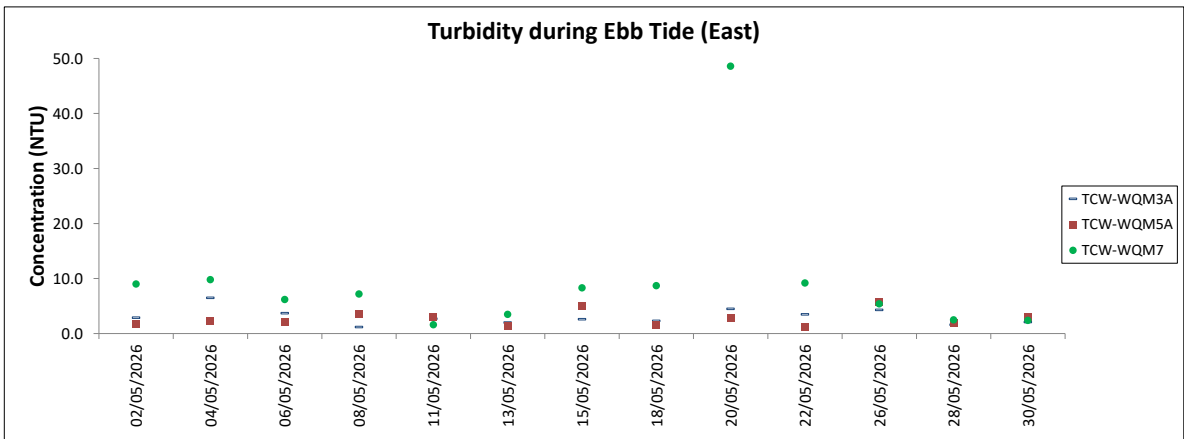
Note: The Action and Limit Level of turbidity can be referred to Table 4.3 of the monthly EM&A report.
 Major site activities carried out during the reporting period are summarized in Section 1.4 of the monthly EM&A report.
 Weather conditions during monitoring are presented in the data tables above.
 QA/ QC requirements as stipulated in the EM&A Manual were carried out during measurement.

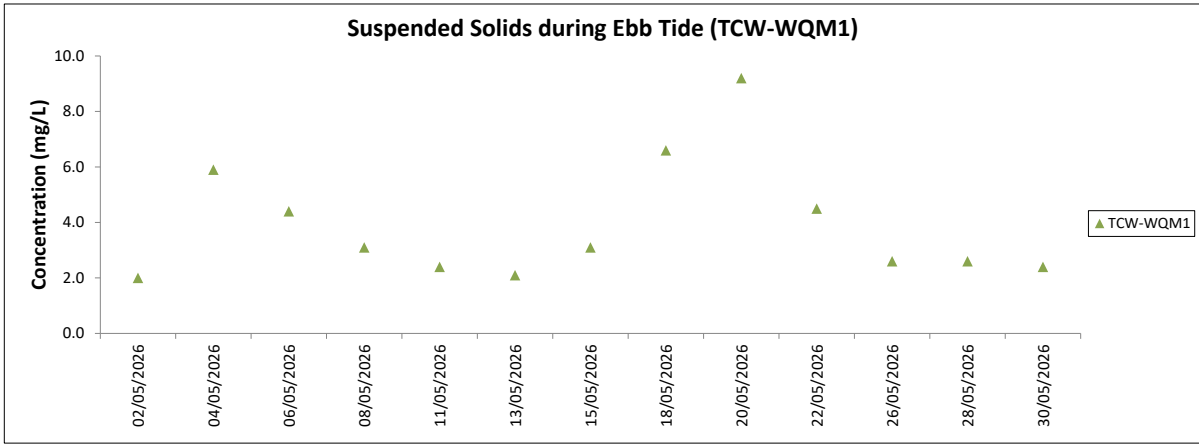
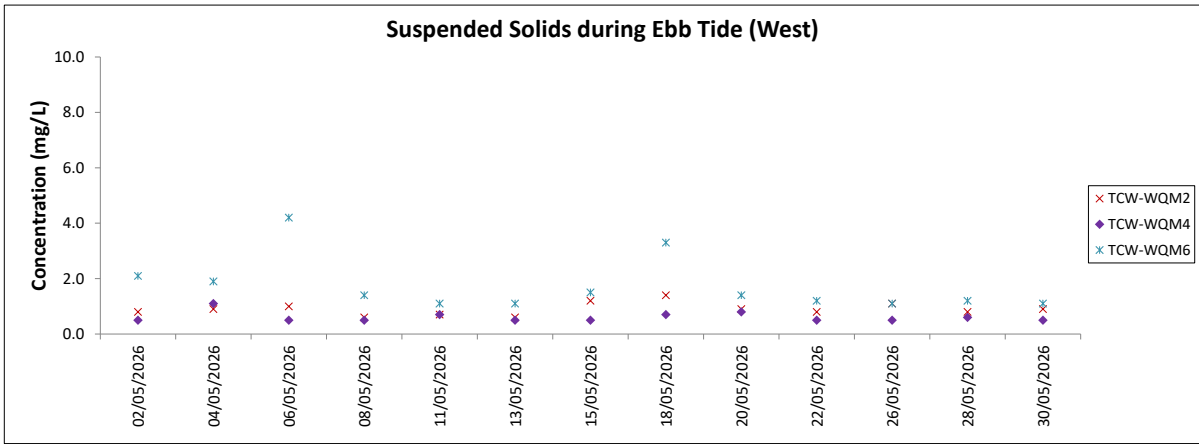
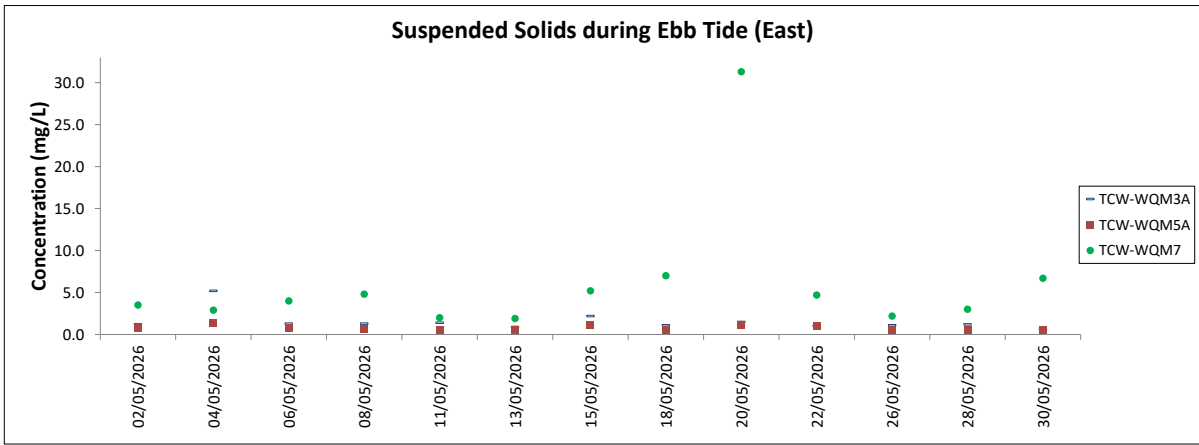
Note: The Action and Limit Level of suspended solids can be referred to Table 4.3 of the monthly EM&A report. Major site activities carried out during the reporting period are summarized in Section 1.4 of the monthly EM&A report. Weather conditions during monitoring are presented in the data tables above. QA/QC requirements as stipulated in the EM&A Manual were carried out during measurement.

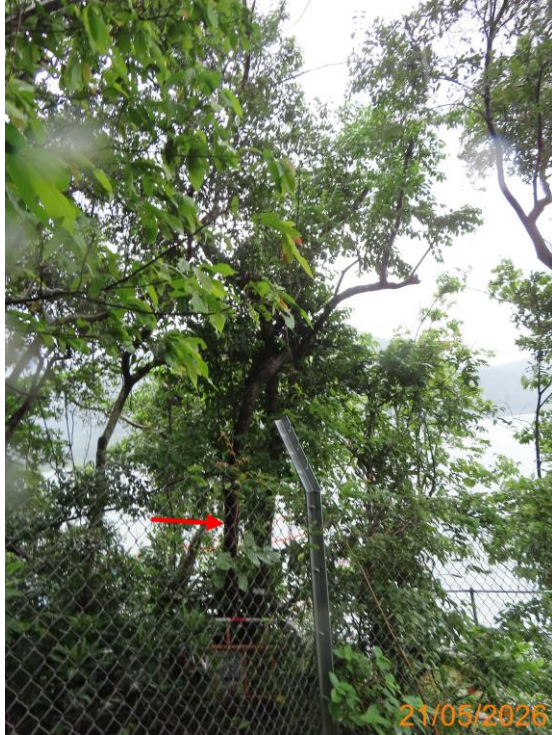
1: T8217

Monthly monitoring was conducted by QB appointed under Contract 5 on 21 May 2026. Branch failure was found at the individual of *Canthium dicoccum* (Tree No. T8217). The failure was suspected to be caused by strong wind induced by Typhoon WIPHA and adverse weather in July 2025. Overall condition of the individual and its remaining part was fair. Third epicormics branch of the individual of *Canthium dicoccum* (Tree No. T8231) was found broken during the inspection

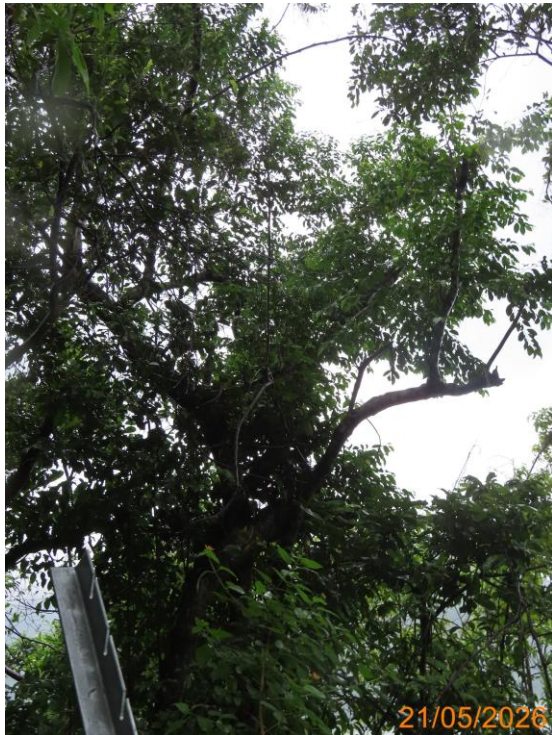
2: T8217_Cross branches

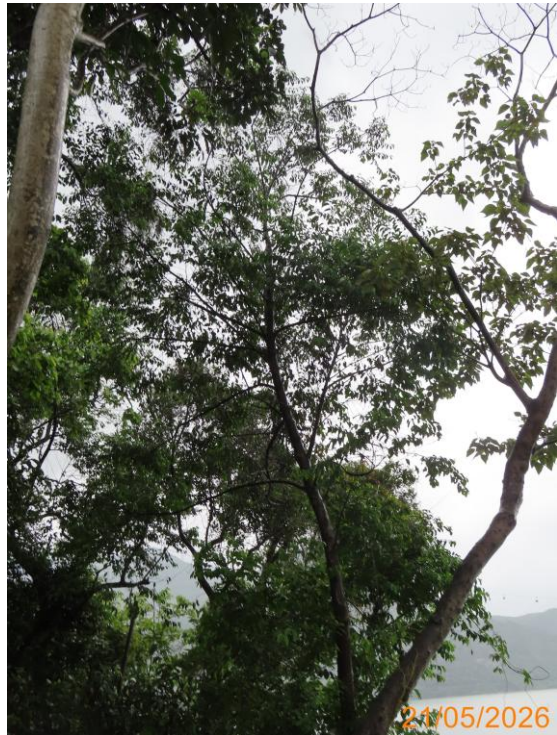
7: T8231_ Pruning of broken epicormics

T8231	<i>Canthium dicoccum</i>	魚骨木	IUCN:VU	7	190	6	L	P	A	P	Retain	Second epicormic failure was found on 21 July 2025 due to Typhoon signal No. 10, third epicormics failure was found on 21 May 2026 due to Amber Rainstorm Warning signal, Overall condition of tree and its remaining part is fair	There is no proper and safe assess towards T8231 & T8217, thus, plastics barriers were installed in lieu of 2m high barrier. Epicormic branch failure was found on 03 May 2024. Staking to provide extra support and pruning of jagged wound to provide a clean cut was conducted on 16 May 2024. Application of insecticide and fungicide on wound was conducted on 22 May 2026, Adjustment of trunk protection pad was conducted on 22 May 2026. The Staking was in normal condition during the time of inspection. No further significant defects were observed. Second epicormic failure was found on 21 July 2025, Overall condition of tree and its remaining part is fair. Pruning of jagged wound to provide a clean cut is recommended. Pruning works was completed on 21 July 2025. Third epicormic failure was found on 21 May 2026. Pruning of jagged wound to provide a clean cut was conducted on 29 May 2026.

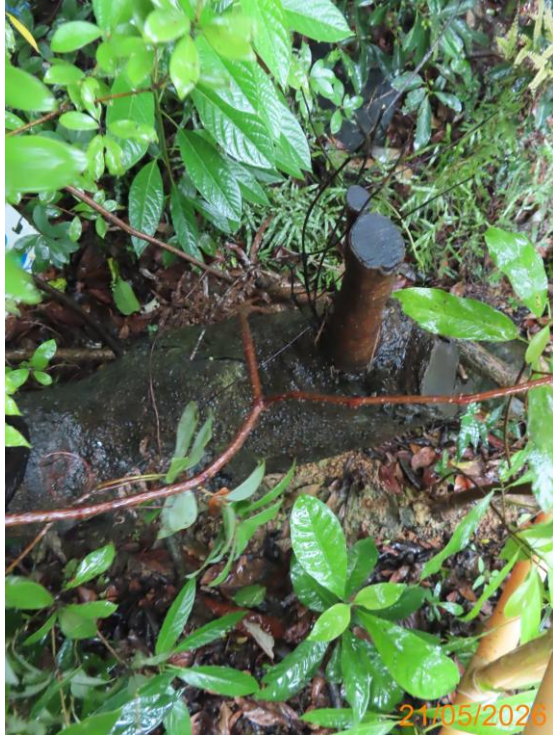
8: T8231_Crown

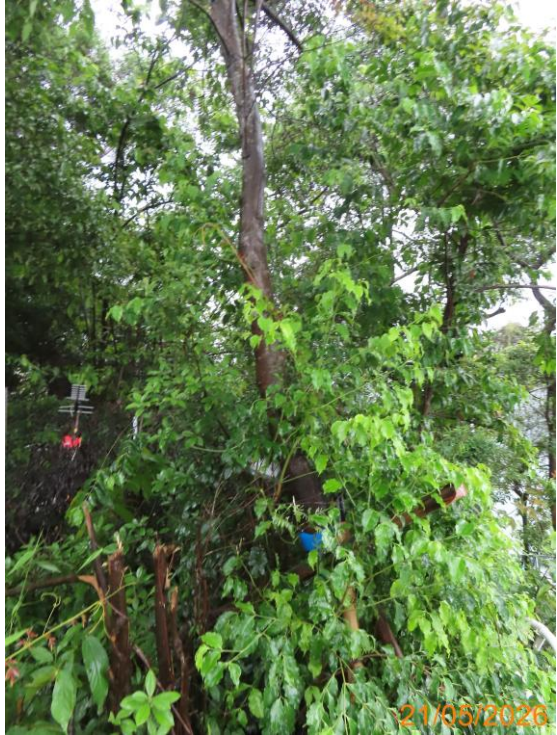
9: T8231_Trunk base

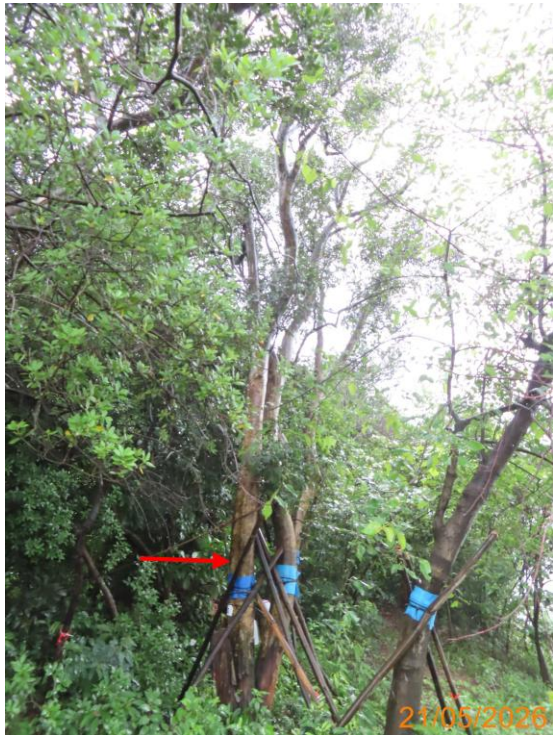
10: T8231_Trunk

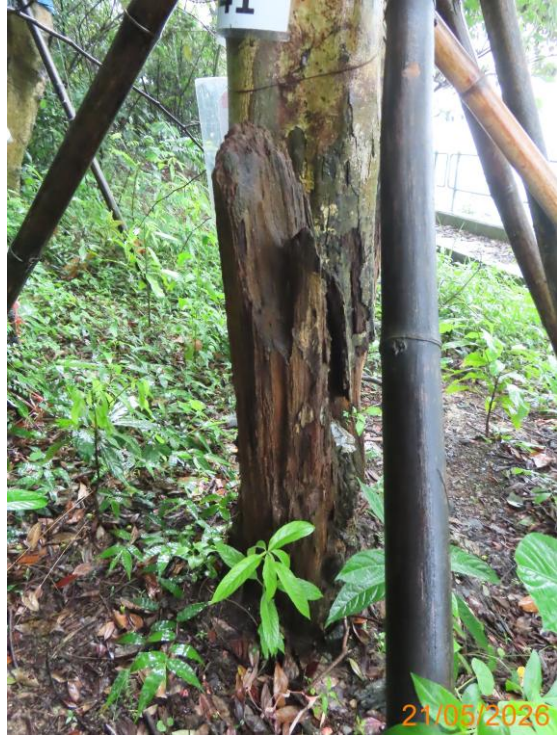
13: U041_Crown

U041	<i>Aquilaria sinensis</i>	土沉香	RPPHK; Cap.586; IUCN:VU	10	318	4	M	A	P	P	Retain	No obvious old termite track was found, damage of wood tissue was observed. Peeling off of bark and sign of split of internal wood tissue was observed. Trunk wound significantly decayed. High trunk failure risk.	Located closed to cut slope. The crack on trunk was found slightly larger since late March 2024. Peeling off of bark and split of internal wood tissue was observed in July 2024. Abnormal bark crack was found in December 2024. Additional guying for tree no. U041 has been installed as an enhanced stabilization measure alongside the bamboo staking in May 2025. Adjustment of guying and application of insecticide and fungicide was conducted on 22 May 2026. Adjustment of trunk protection pad was conducted on 22 May 2026.
U042	<i>Gmelina chinensis</i>	石梓	RPPHK	6	150	2	M	A	P	A	Retain	Large wound near trunk base with wound wood development. Trunk wound is decaying.	Located closed to cut slope. Application of insecticide and fungicide as preventive measure was conducted on 22 May 2026. Adjustment of trunk protection pad was conducted on 22 May 2026.

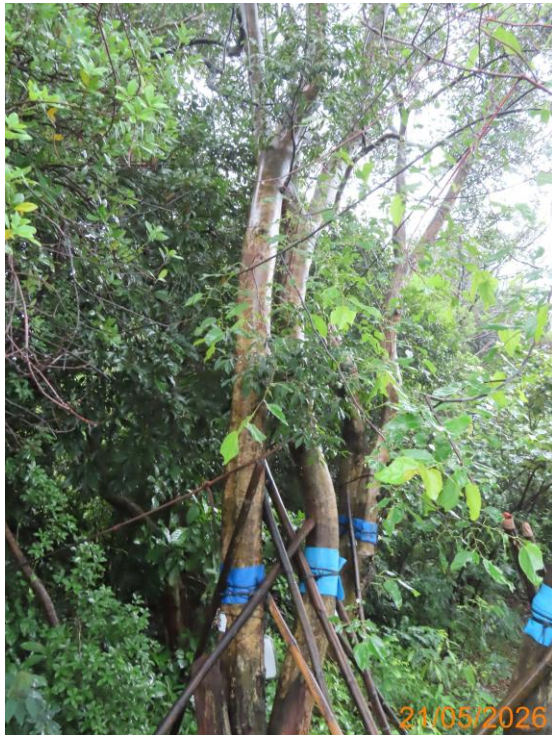
14: U041_Dead stump

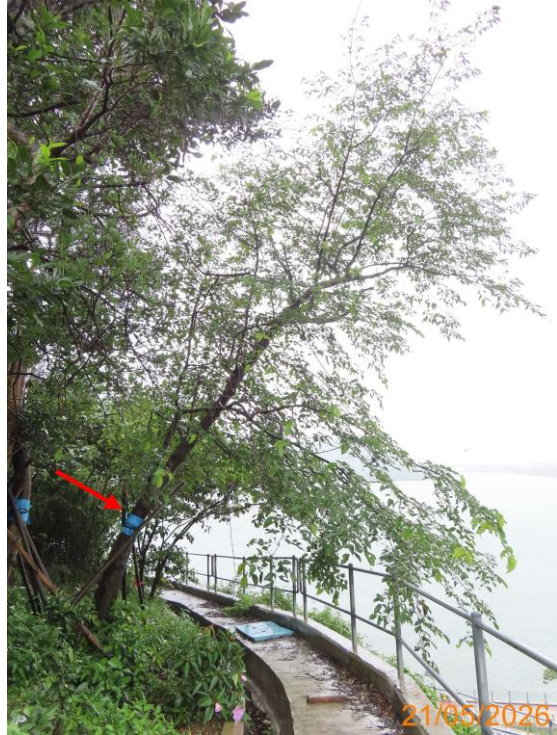
17: U041_Wound damage at trunk union#2

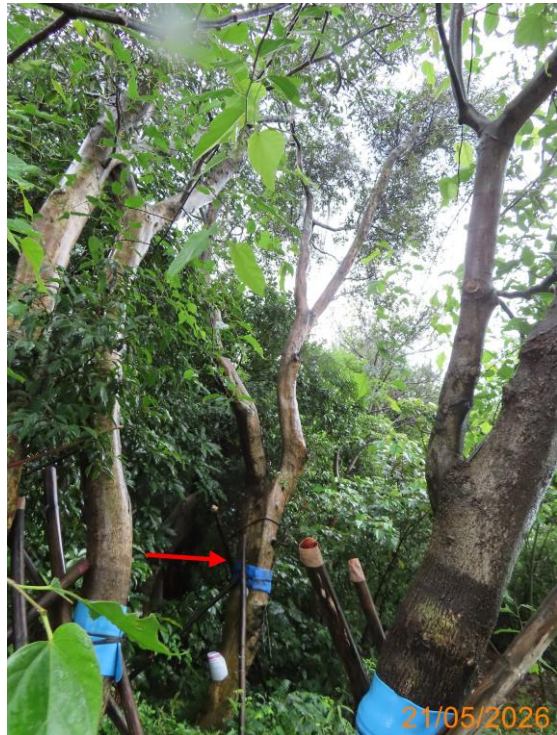
20: U043

U043	<i>Aquilaria sinensis</i>	土沉香	RPPHK; Cap.586; IUCN:VU	9	310	4	M	A	P	P	Retain	Crack on trunk base. Trunk wound significantly decayed. High trunk failure risk.	Located closed to cut slope and fenced off by 2m high barrier. Application of insecticide and fungicide was conducted on 22 May 2026. Adjustment of trunk protection pad was conducted on 22 May 2026.

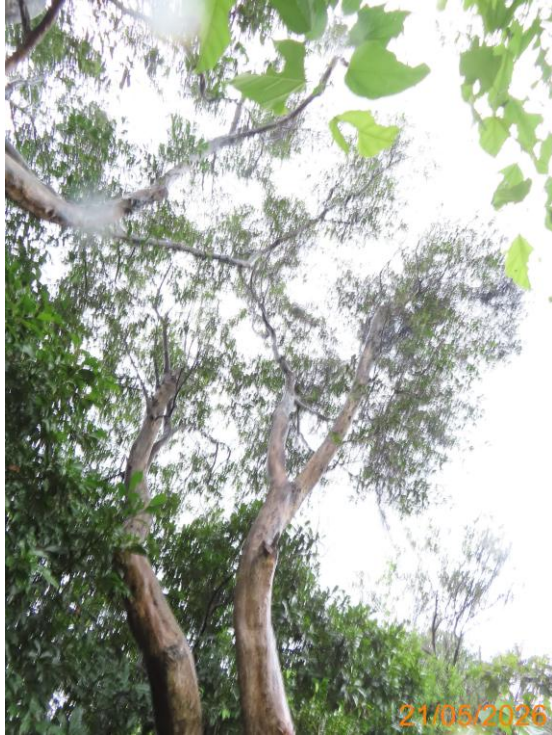
21: U043_Trunk

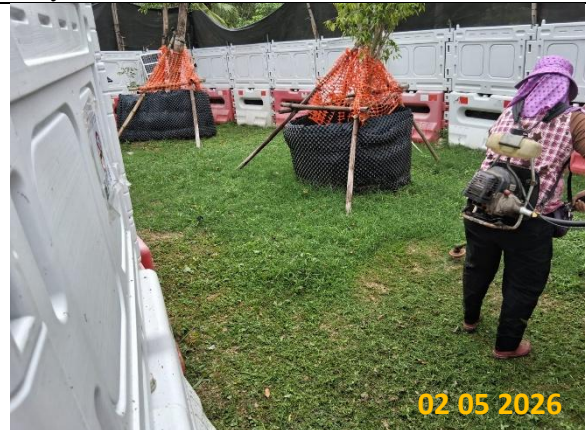
Manual watering was carried out for A8 during the reporting period. The watering frequency is one to two times per week.

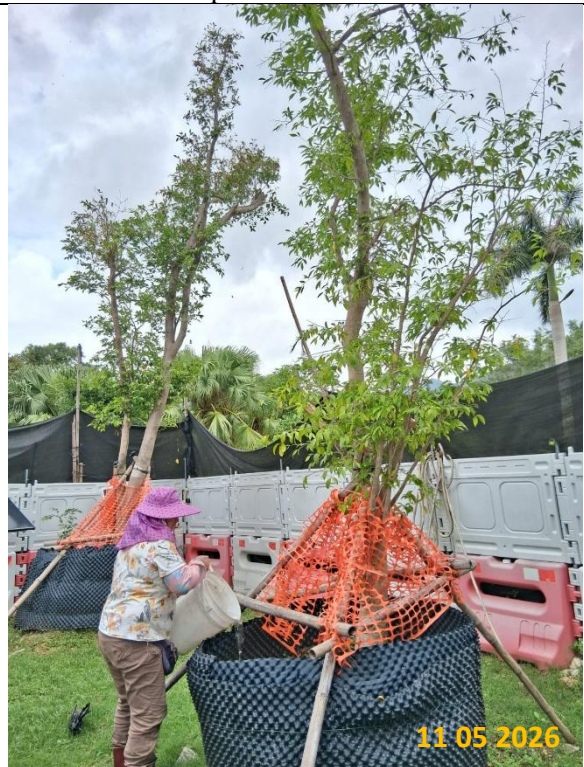
Manual watering was carried out for A12 during the reporting period. The watering frequency is one to two times per week.
