# Agreement No. CE 64/2020 (EP) Environmental Team for Tung Chung New Town Extension (West) – Design and Construction

Monthly Environmental Monitoring & Audit Report for November 2022

December 2022

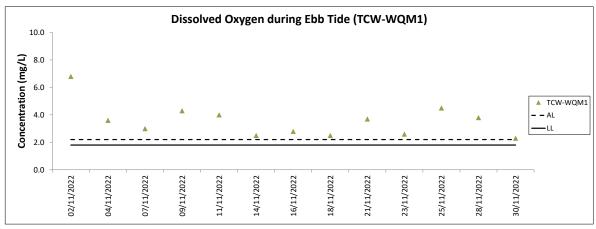
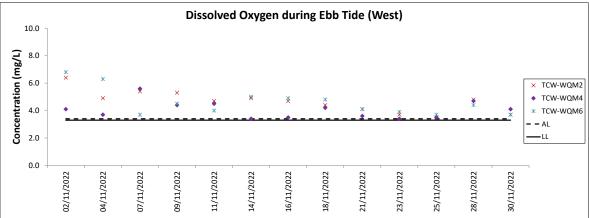
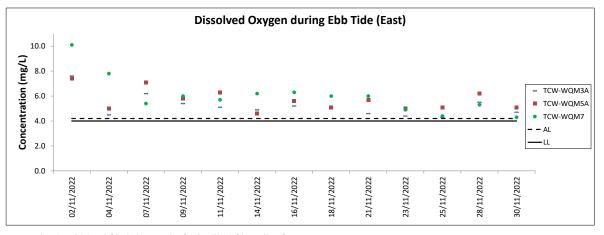
# **H4.** Water Quality Monitoring Results

Note: The Action and Limit Level of dissolved oxygen can be referred to Table 4.3 of the monthly EM&A report.

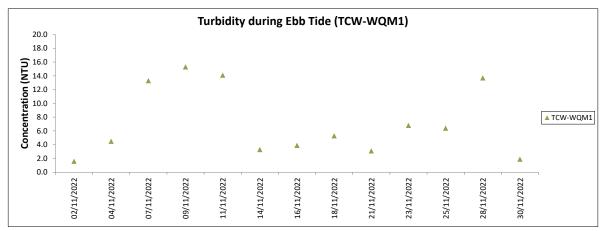
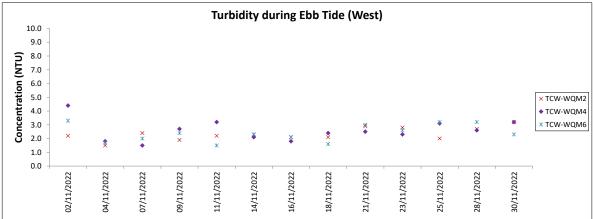
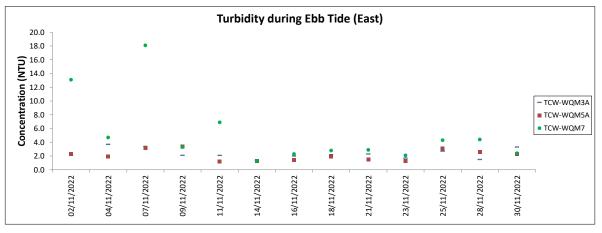
Note: The Action and Limit Level of turbidity can be referred to Table 4.3 of the monthly EM&A report.

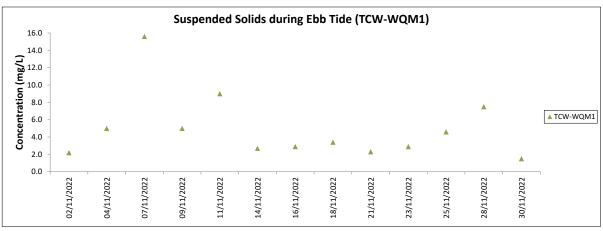
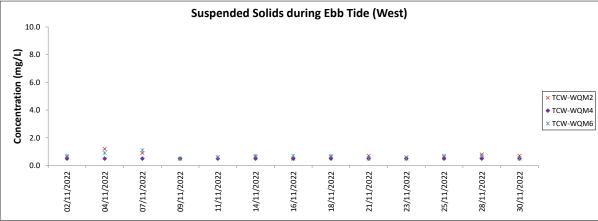
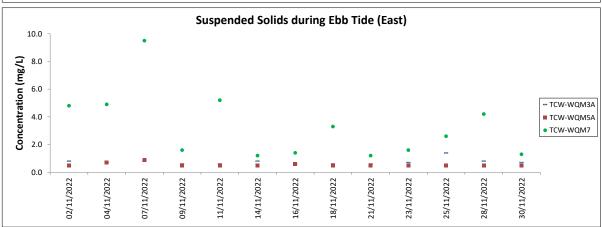
Note: The Action and Limit Level of suspended solids can be referred to Table 4.3 of the monthly EM&A report.

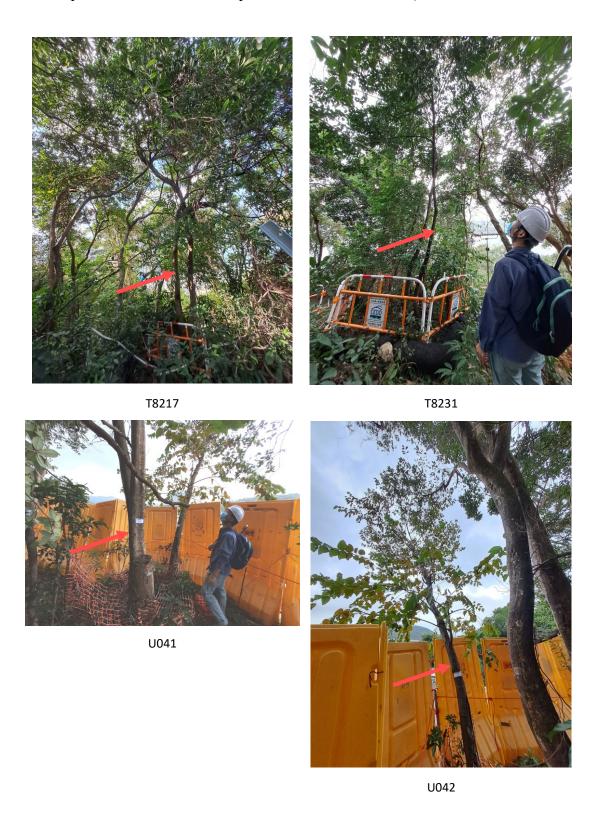
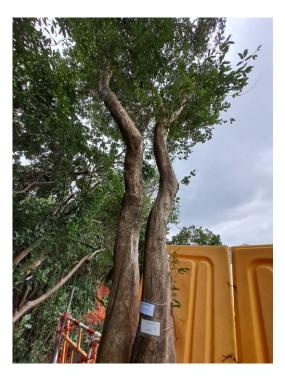
# J1. Plant Species of Conservation Importance Monitoring Under Contract 5

Monthly monitoring of the in-situ preserved plant species of conservation importance by the Qualified Botanist (QB) appointed under Contract 5 and Contract 6 respectively were implemented in the reporting period. Termite track with live termites was recorded at one (1) individual of *Aquilaria sinensis* (Tree No. U043) under Contract 5. Insecticide was applied for the concerned plant as recommended by the QB appointed under Contract 5.

Tree protection zones for the *in-situ* preserved plant species of conservation importance were demarcated. No injuries and/or damages to the individuals of the *in-situ* preserved plant species of conservation importance were reported by the QB during the reporting period. Photographic record and tree schedule of the preserved plant species of conservation importance monitoring are provided in **Appendix J**.

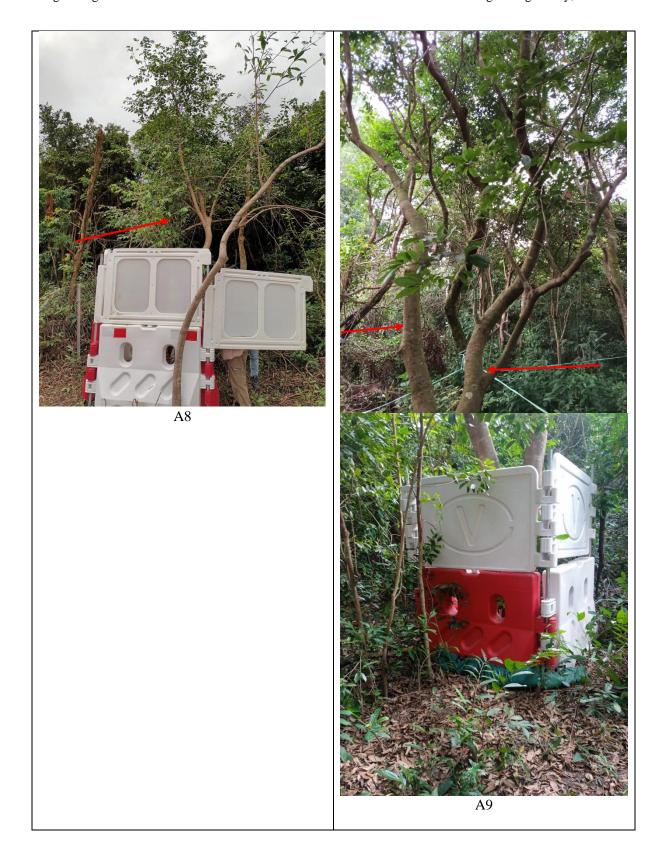
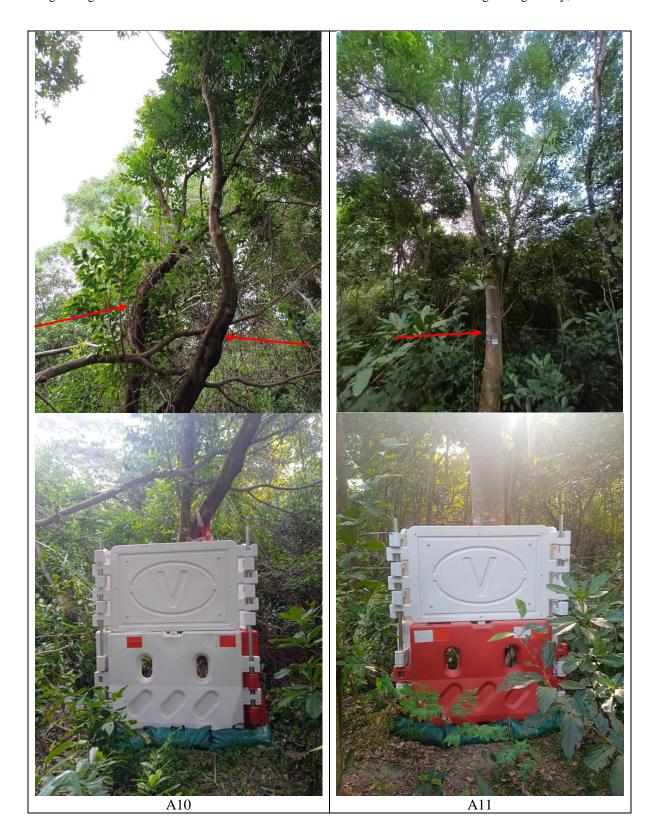
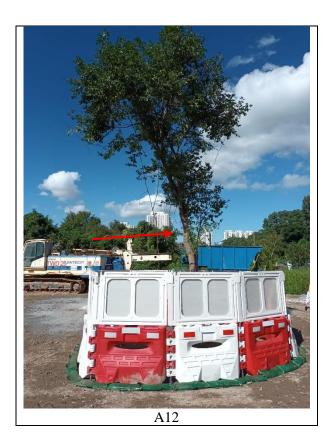
# J2. Plant Species of Conservation Importance Monitoring Under Contract 6

As for the plant species of conservation importance within the works area of Contract 6, there were twelve (12) individuals of *Aquilaria sinensis* identified. Three (3) individuals of *Aquilaria sinensis* were recommended being preserved *in-situ* while two (2) individuals of *Aquilaria sinensis* were recommended being transplanted to the receptor site in accordance with the Preservation and/or Translocation Proposal for Plant Species of Conservation Importance submitted under section 3.1.1 of Detailed Preservation and/or Translocation Plan for Plant Species of Conservation Importance (Condition 2.21 of the EP No. EP-519/2016). The remaining individuals were recommended to be removed owing to poor form and structure condition.
