Agreement No. CE 64/2020 (EP) Environmental Team for Tung Chung New Town Extension (West) – Design and Construction

Monthly Environmental Monitoring & Audit Report for March 2024

April 2024

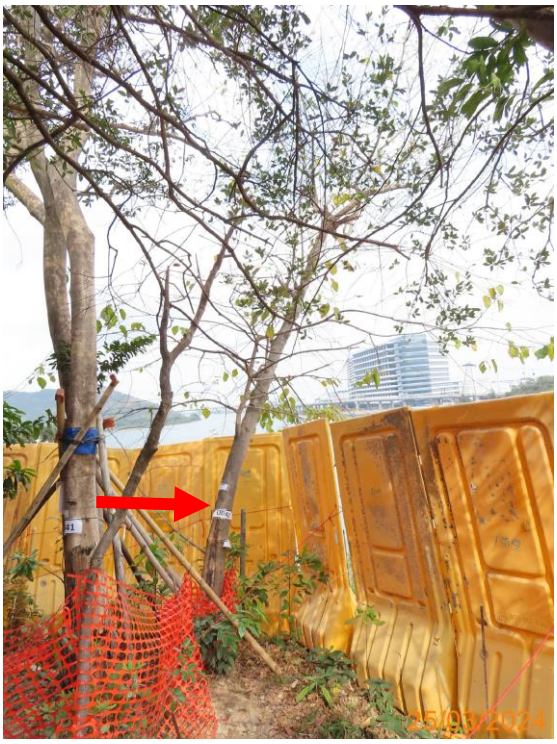
12: U042

10: U041_Wood damage at trunk union

11: U041_Wood damage by termite

13: U042_Wound on trunk

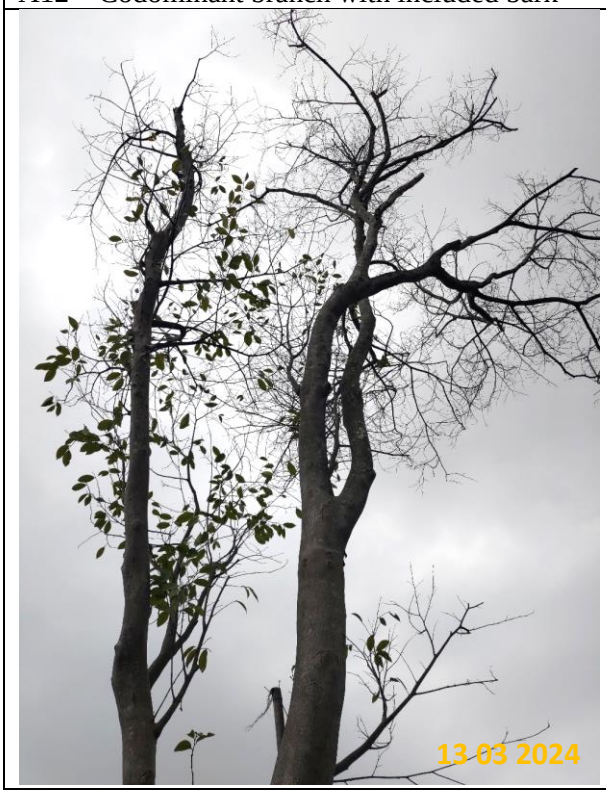
A12 - Overall View	A12 – Foliage density is low since its collapse during Typhoon KOINU. The foliage density unchanged in current inspection.

A12 – Codominant branch with included bark	A12 – trunk and root condition

Manual watering was carried out for A8 during the reporting period. The watering frequency is three time per week (will be adjusted due to wet season came).	Manual watering was carried out for A12 during the reporting period. The watering frequency is three time per week (will be adjusted due to wet season came).

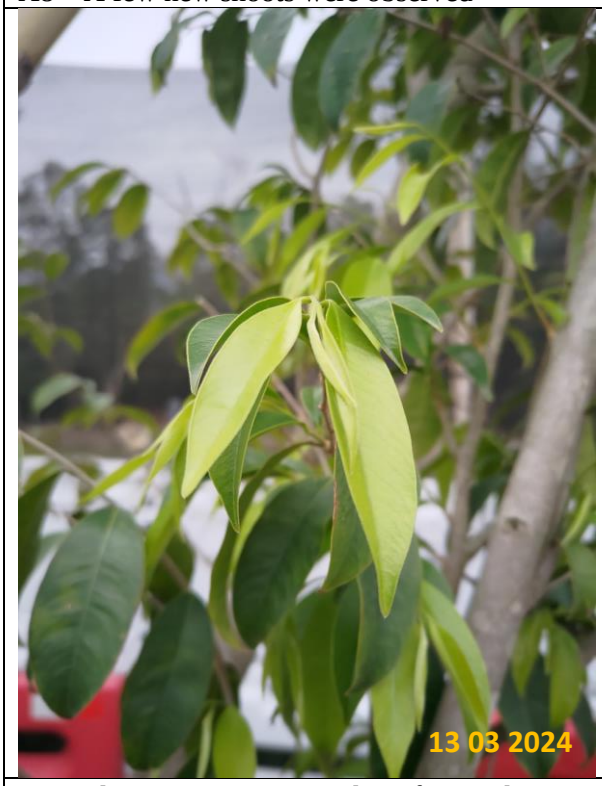
A8 – A few new shoots were observed	A12 – A few new shoots were observed

The semiautomatic irrigation was checked and is in order. The watering frequency is three times per week (will be adjusted due to wet season came).	CCTV and fencing are in order
