CEDD Contract No. NL/2020/06

Tree Schedule for Survey of Plant Species of Conservation Importance

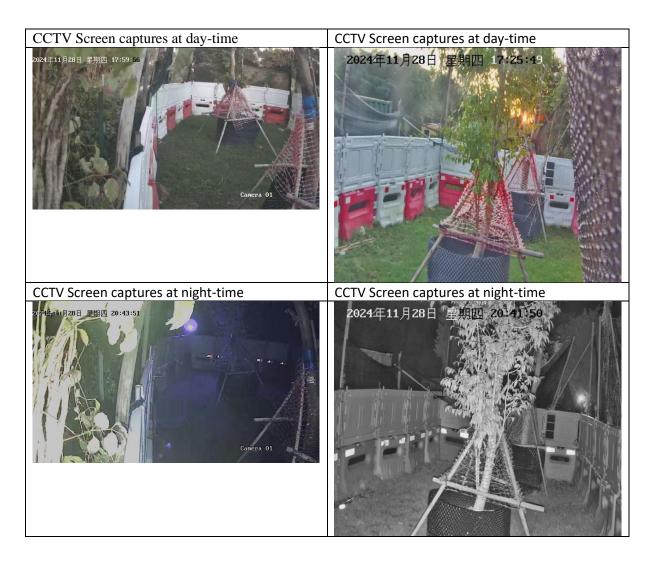
No.	Species Scientific Chinese		Conservatio	Measurements DBH Height Crown			Tree Condition (Good(G) / Average(A) / Poor(P))			Recommendation (Retain / Transplant /	Findings	Remark
	Name	name	Status	(mm)	(m)	(m)	Form	Health	Structure	Remove)		
A8 (T8996)	Aquilaria sinensis	土沉香	RPPHK; Cap.586; IUCN:VU	110	5	4	Ρ	A	Ρ	Transplant	There was dieback. Foliage density reduced after a typhoon event dated 13-14 Nov 2024	Originally located at Site 1. Trunk wounds were observed before transplant operation. Shallow root. Sudden defoliation happened in May 2023 but recovered in Aug 2023. It was translocated to the temporary holding nursery on 29 Sep 2023. A branch (5cm) was broken and foliage density decreased due to typhoon in Oct 2023.
A12 (T3537)	Aquilaria sinensis	土沉香	RPPHK; Cap.586; IUCN:VU	185	8	3	Ρ	Ρ	A	Transplant	foliage density is low. It was slightly lean after a typhoon event dated 13-14 Nov 2024. The tree was reinstated on 14 Nov 2024.	Shallow root. Original root ball was full of stones which were removed partially during the translocation. It was translocated to the temporary holding pursery on 29
