Tung Chung New Town Extension – Site Formation and Infrastructure Works at Tung Chung Valley, Phase 1

Tree Schedule for Survey of Plant Species of Conservation Importance

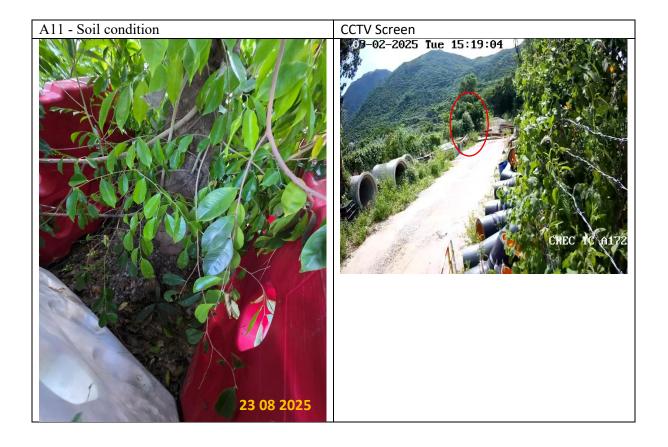
No.	Species		Conservatio	Measurements			Tree Condition (Good(G) / Average(A) / Poor(P))			Recommendation (Retain / Transplant /	Findings	Remark
	Scientific Name	Chinese name	Status	DBH (mm)	Height (m)	Crown (m)	Form	Health	Structure	Remove)		
40	Aquilaria sinensis	土沉香	RPPHK;									Removed due to illegal felling on
A9			Cap.586;	5.586; -	-	-	-	-	-	-	-	Aug 2023 (reported to police on 21
(T7628)			IUCN:VU									Aug 2023)
440	Aquilaria sinensis	土沉香	RPPHK;									Removed due to illegal felling on
A10			Cap.586;	-	-	-	-	-	-	-	-	Aug 2023 (reported to police on 21
(T7538)			IUCN:VU									Aug 2023)
A11 (T7521)	Aquilaria sinensis	土沉香	RPPHK; Cap.586; IUCN:VU	190	3.5	1	Р	Α	Р	Retain	Insect infestation is not significant.	Root-plate movement (mentioned in previous monitoring report). Topped tree due to illegal felling on Aug 2023 (reported to police on 21 Aug 2023). Large decaying trunk wound.

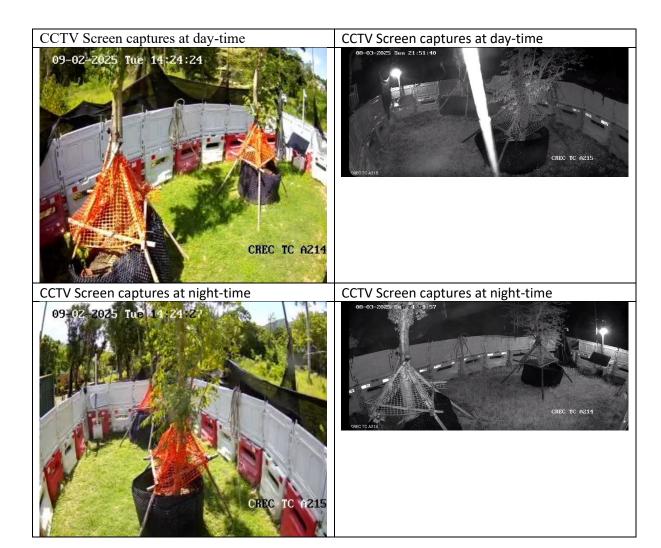
No.	Species		Conservatio n	Measurements			Tree Condition (Good(G) / Average(A) / Poor(P))			Recommendation (Retain / Transplant /	Findings	Remark
	Scientific Name	Chinese name	Status	DBH (mm)	Height (m)	Crown (m)	Form	Health	Structure	Remove)		
A8 (T8996)	Aquilaria sinensis	土沉香	RPPHK; Cap.586; IUCN:VU	110	5	4	Р	Р	Р	Transplant	Ant nest was not found. The foliage density is low and further reduced after recent inclement weather events. No obvious wound wood production. Severity of the insect feeding was low.	Originally located at Site 1. Trunk wounds were observed before transplant operation. Shallow root. Sudden defoliation happened in May 2023 but recovered in Aug 2023. It was translocated to the temporary holding nursery on 29 Sep 2023. A branch (5cm) was broken and foliage density decreased due to typhoon in Oct 2023. Decaying wounds and exposed dead woods on trunk.
A12 (T3537)	Aquilaria sinensis	土沉香	RPPHK; Cap.586; IUCN:VU	185	8	3	Р	Р	А	Transplant	The foliage density is low and further reduced after typhoon after recent inclement weather events No obvious wound wood production. Severity of the insect feeding was low.	Originally located at Site 5. Trunk wounds were observed before transplant operation. Shallow root. Original root ball was full of stones which were removed partially during the translocation. It was translocated to the temporary holding nursery on 29 Sep 2023. It collapsed during typhoon dated Oct 2023 resulted in largely reduction in foliage density. It was slightly lean after a typhoon event dated 13-14 Nov 2024 and reinstated. Decaying wounds and exposed dead woods on trunk.
