Tree Schedule for Survey of Plant Species of Conservation Importance

Tung Chung New Town Extension – Site Formation and Infrastructure Works at Tung Chung Valley, Phase 1

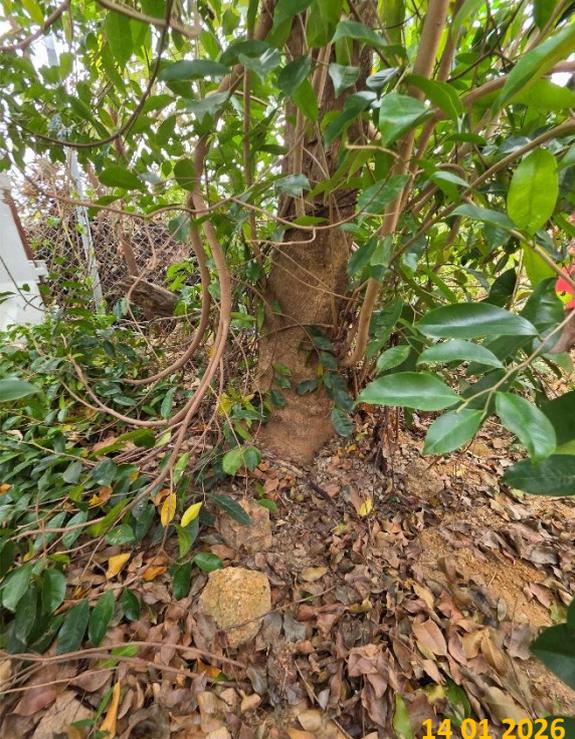
<p>14 01 2026</p>
<p>A11 – Shoots are epicormic generated from cut trunk which is decaying severely</p>	<p>A11 - Soil condition</p>
