**Tree Schedule for Survey of Plant Species of Conservation Importance**

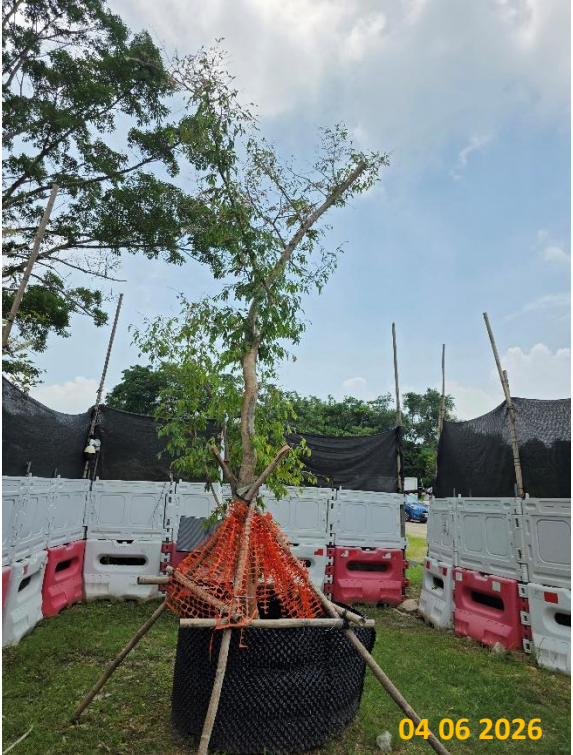
| No. | Species | | Conservation Status | Measurements | | | Tree Condition (Good(G) / Average(A) / Poor(P)) | | | Recommendation (Retain / Transplant / Remove) | Findings | Remark |
|---|---|---|---|---|---|---|---|---|---|---|---|---|
| A8<br>(T8996) | <i>Aquilaria sinensis</i> | 土沉香 | RPPHK;<br>Cap.586;<br>IUCN:VU | 110 | 5 | 4 | P | P | P | Transplant | No obvious wound wood production. Fruiting. Severity of the insect feeding was high. Pest control was done on 27 June 2026. | Trunk wounds were observed before transplant operation. Shallow root. Sudden defoliation happened in May 2023 but recovered in Aug 2023. It was translocated to the temporary holding nursery on 29 Sep 2023. A branch (5cm) was broken due to typhoon in Oct 2023. Decaying wounds and exposed dead woods on trunk. The foliage density is low and further reduced after inclement weather events on Aug/Sep 2025. |

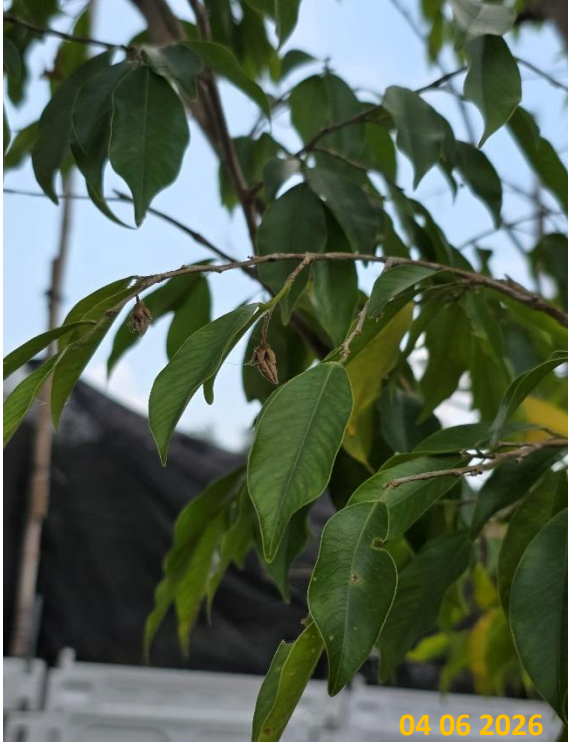
| <p>A8 – Insect pest was observed</p> <p>04 06 2026</p> | <p>A8 – Fruiting</p> <p>04 06 2026</p> |

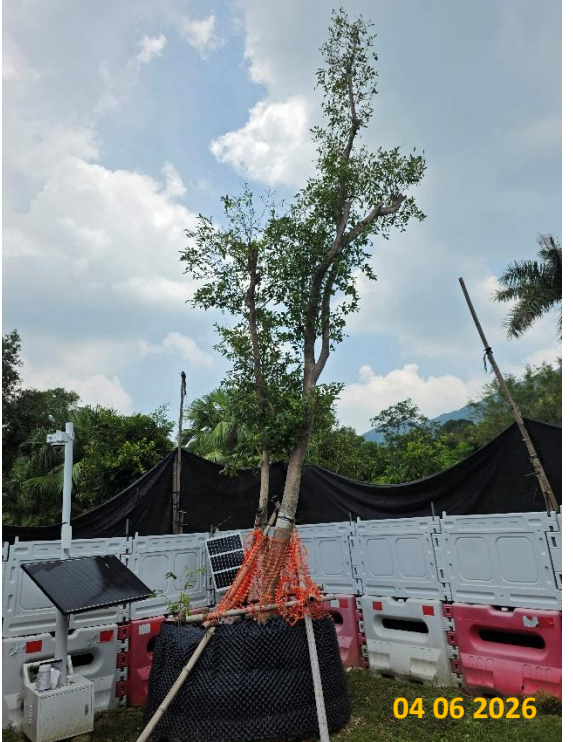
| No. | Species | | Conservation Status | Measurements | | | Tree Condition (Good(G) / Average(A) / Poor(P)) | | | Recommendation (Retain / Transplant / Remove) | Findings | Remark |
|---|---|---|---|---|---|---|---|---|---|---|---|---|
| A12<br>(T3537) | <i>Aquilaria sinensis</i> | 土沉香 | RPPHK;<br>Cap.586;<br>IUCN:VU | 185 | 8 | 3 | P | P | A | Transplant | No obvious wound wood production. Fruiting. Severity of the insect feeding was high. Pest control was done on 27 June 2026. | Trunk wounds were observed before transplant operation. Shallow root. Original root ball was full of stones which were removed partially during the translocation. It was translocated to the temporary holding nursery on 29 Sep 2023. It collapsed during typhoon dated Oct 2023 resulted in largely reduction in foliage density. It was slightly lean after a typhoon event dated 13-14 Nov 2024 and reinstated. Decaying wounds and exposed dead woods on trunk. The foliage density is low and further reduced after inclement weather events on Aug/Sep 2025. |

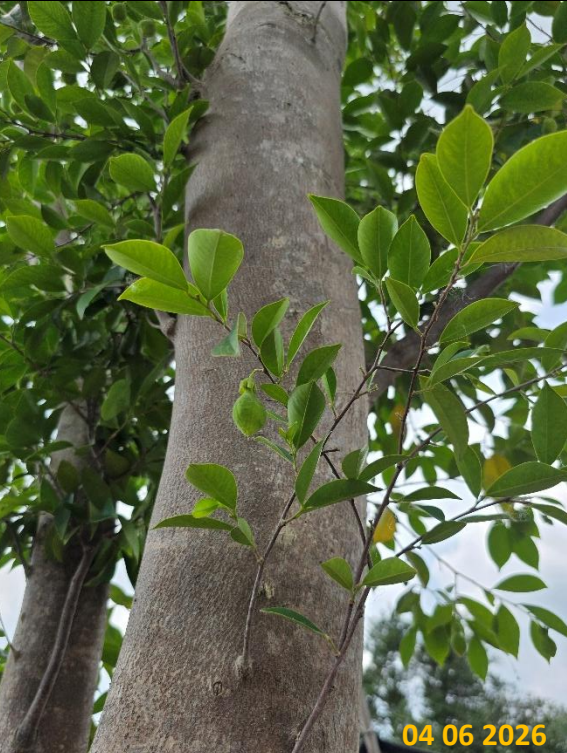
| <p>A12 – Epicormics on trunk. Decaying wound on Trunk.</p> <p>04 06 2026</p> | <p>A12 – Fruiting</p> <p>04 06 2026</p> |
