**Agreement No. CE 64/2020 (EP)  
Environmental Team for  
Tung Chung New Town  
Extension (West) –  
Design and Construction**

Monthly Environmental Monitoring & Audit Report  
for December 2021

**Environmental Permit No. EP-519/2016**

**Tung Chung New Town Extension (West)**

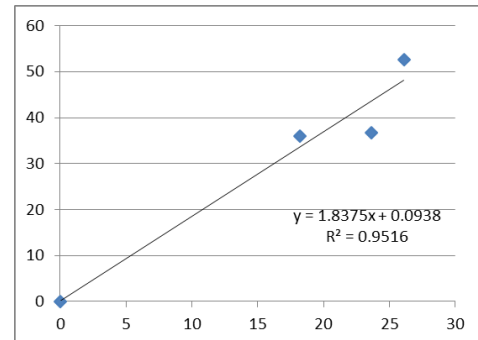
Slope (K-factor): 1.8375 ( $\mu\text{g}/\text{m}^3$ )/CPM  
Correlation Coefficient (R) 0.9755  
Date of Issue 19 November 2021

1. **Strong** Correlation ( $R > 0.8$ )
2. Factor 1.8375 ( $\mu\text{g}/\text{m}^3$ )/CPM should be applied for TSP monitoring

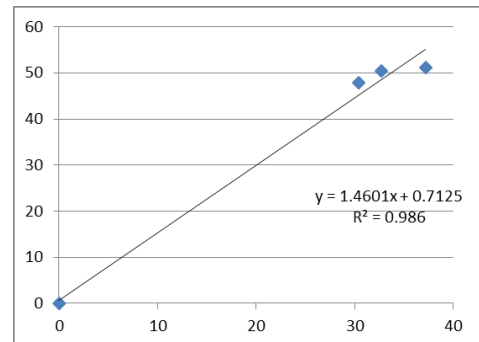
Slope (K-factor): 1.4601 ( $\mu\text{g}/\text{m}^3$ )/CPM  
Correlation Coefficient (R) 0.9930  
Date of Issue 8 November 2021

- Strong** Correlation ( $R > 0.8$ )
- Factor 1.4601 ( $\mu\text{g}/\text{m}^3$ )/CPM should be applied for TSP monitoring

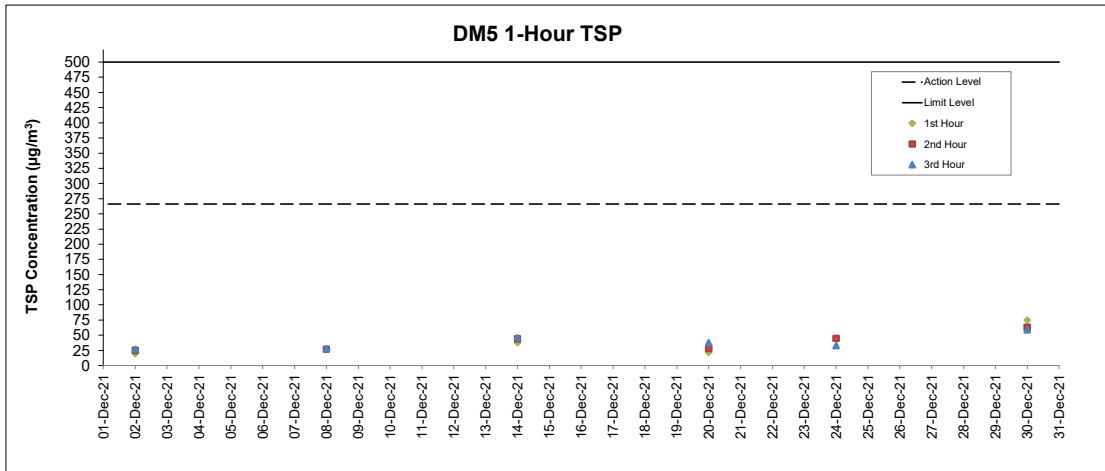
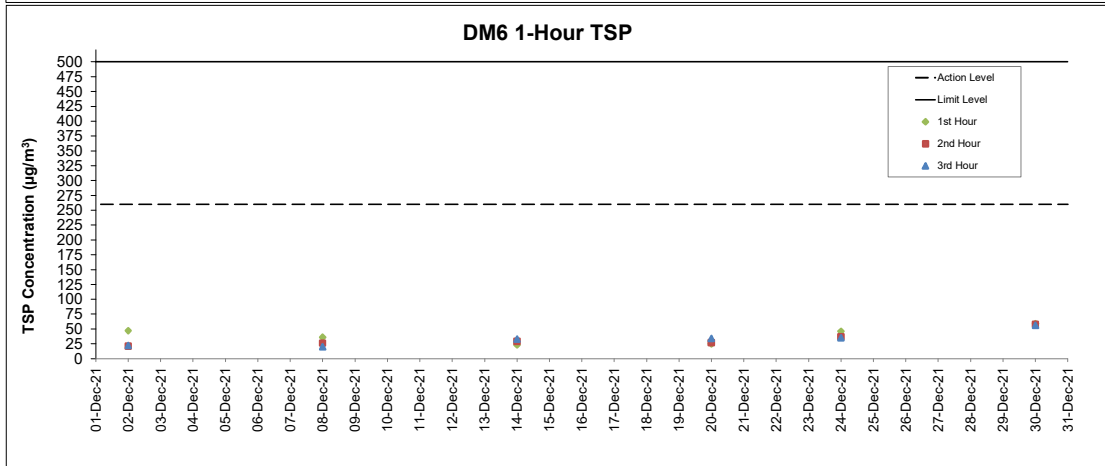
**Station: DM6 - Mok Ka**

Date	Start Time	Finish Time	Weather	1-hr TSP ( $\mu\text{g}/\text{m}^3$ )	Action Level ( $\mu\text{g}/\text{m}^3$ )	Limit Level ( $\mu\text{g}/\text{m}^3$ )
02-Dec-21	12:31	13:31	Sunny	47.0	260	500
02-Dec-21	13:31	14:31	Sunny	21.0	260	500
02-Dec-21	14:31	15:31	Sunny	22.0	260	500
08-Dec-21	7:50	8:50	Sunny	36.0	260	500
08-Dec-21	8:50	9:50	Sunny	26.0	260	500
08-Dec-21	9:50	10:50	Sunny	20.0	260	500
14-Dec-21	12:18	13:18	Sunny	23.0	260	500
14-Dec-21	13:18	14:18	Sunny	29.0	260	500
14-Dec-21	14:18	15:18	Sunny	33.0	260	500
20-Dec-21	8:22	9:22	Cloudy	25.0	260	500
20-Dec-21	9:22	10:22	Cloudy	27.0	260	500
20-Dec-21	10:22	11:22	Cloudy	34.0	260	500
24-Dec-21	8:37	9:37	Cloudy	46.0	260	500
24-Dec-21	9:37	10:37	Cloudy	37.0	260	500
24-Dec-21	10:37	11:37	Cloudy	35.0	260	500
30-Dec-21	8:45	9:45	Sunny	59.0	260	500
30-Dec-21	9:45	10:45	Sunny	58.0	260	500
30-Dec-21	10:45	11:45	Sunny	56.0	260	500

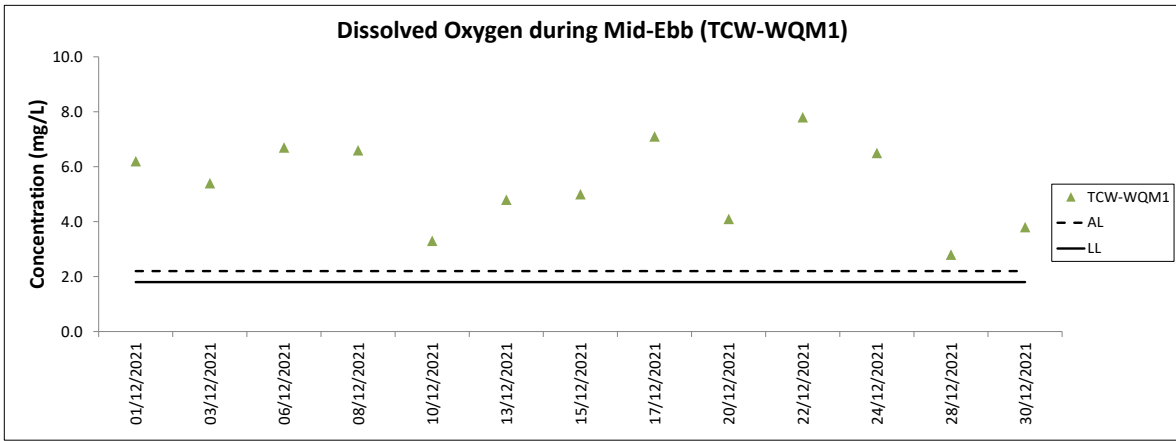
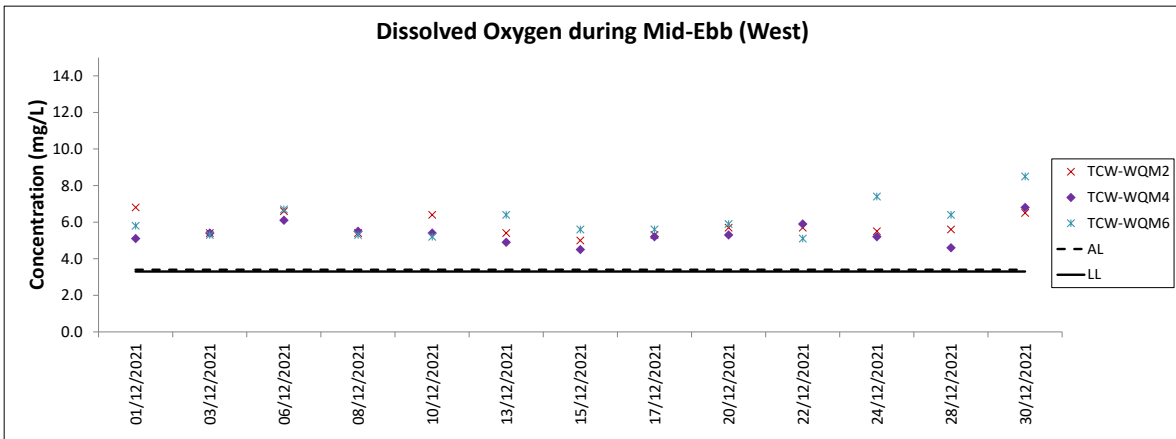
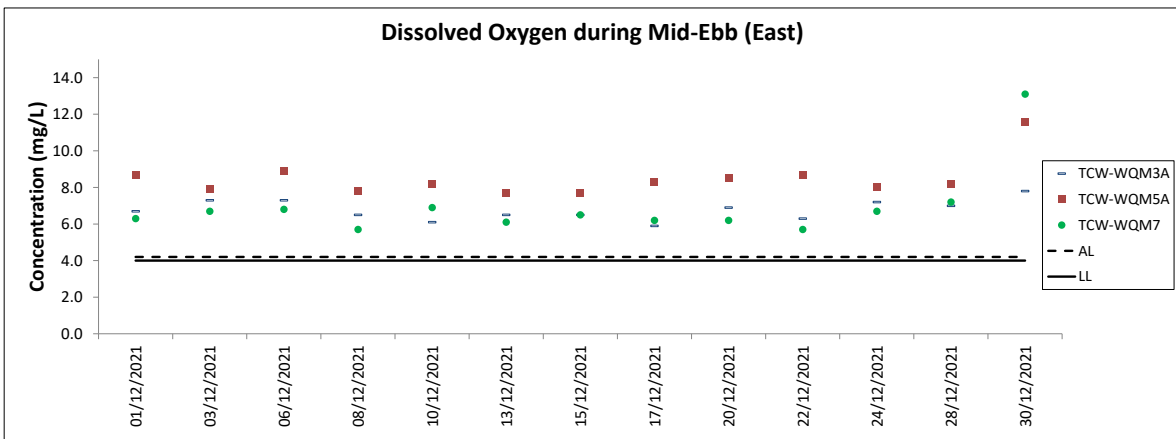
Note: The Action and Limit Level of dissolved oxygen can be referred to Table 4.3 of the monthly EM&A report.  
 Major site activities carried out during the reporting period are summarized in Section 1.4 of the monthly EM&A report.  
 Weather conditions during monitoring are presented in the data tables below.  
 QA/ QC requirements as stipulated in the EM&A Manual were carried out during measurement.

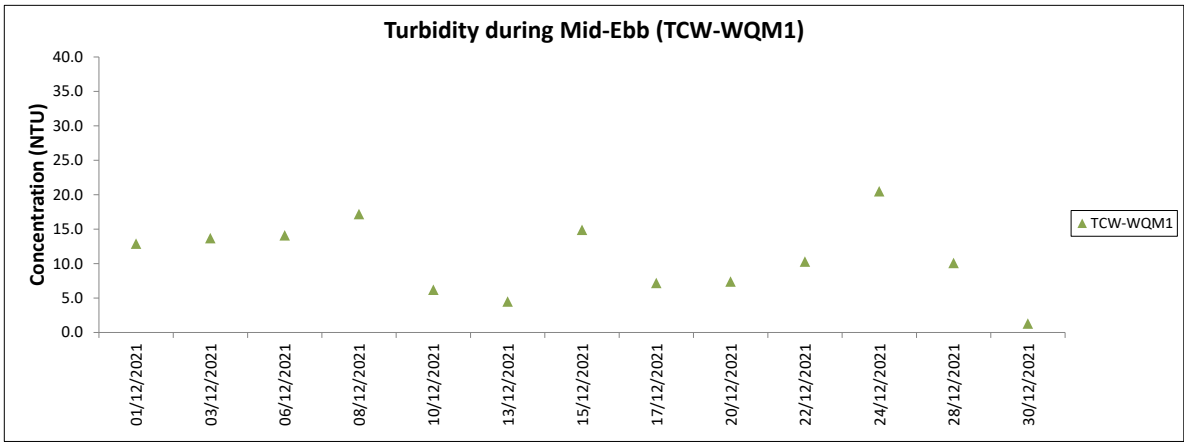
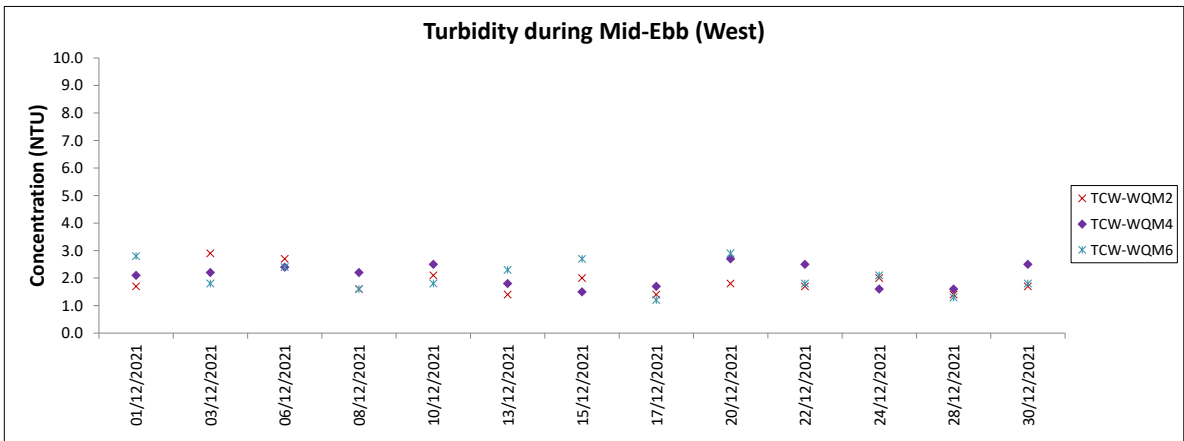
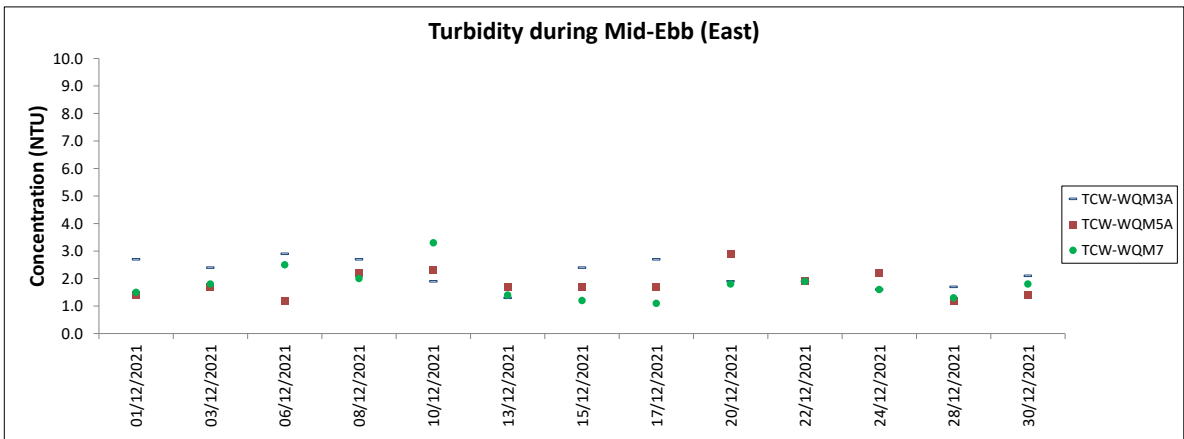
Note: The Action and Limit Level of turbidity can be referred to Table 4.3 of the monthly EM&A report.  
 Major site activities carried out during the reporting period are summarized in Section 1.4 of the monthly EM&A report.  
 Weather conditions during monitoring are presented in the data tables below.  
 QA/ QC requirements as stipulated in the EM&A Manual were carried out during measurement.

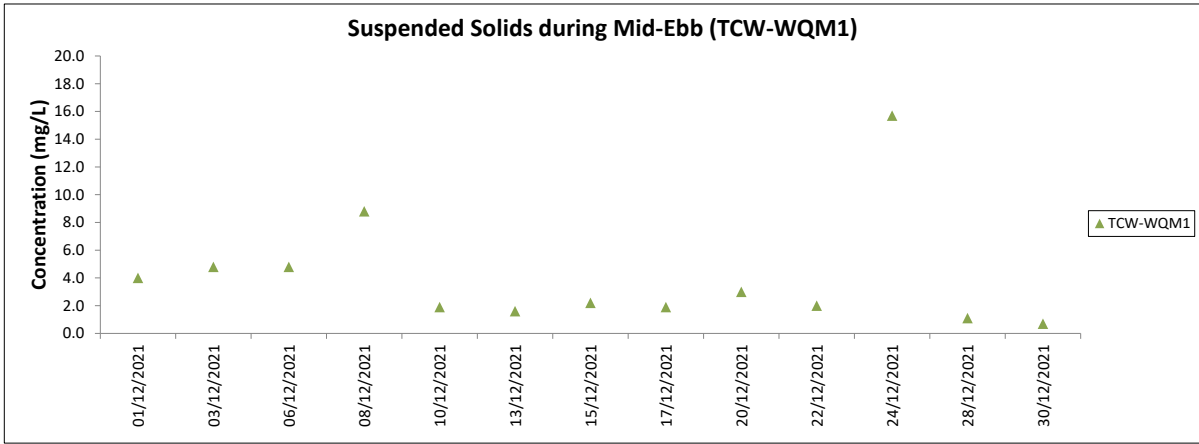
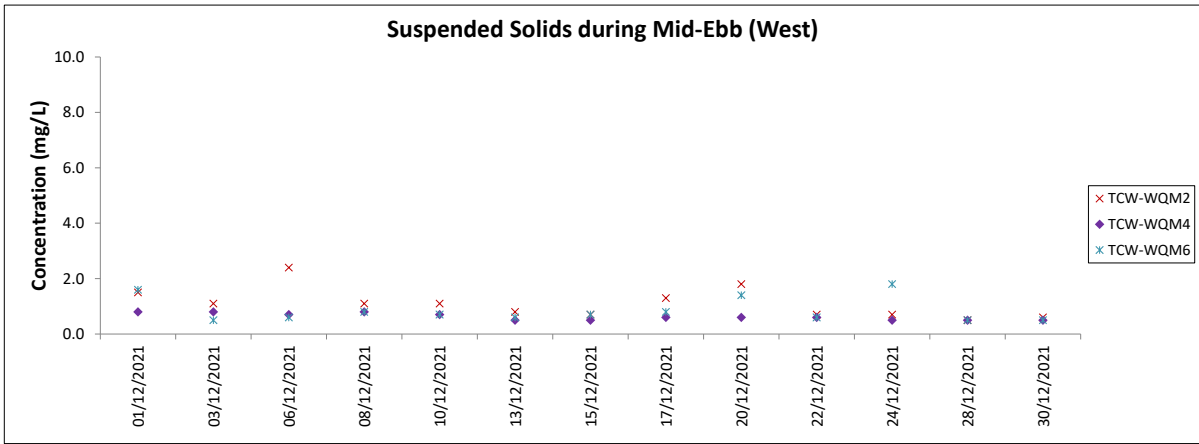
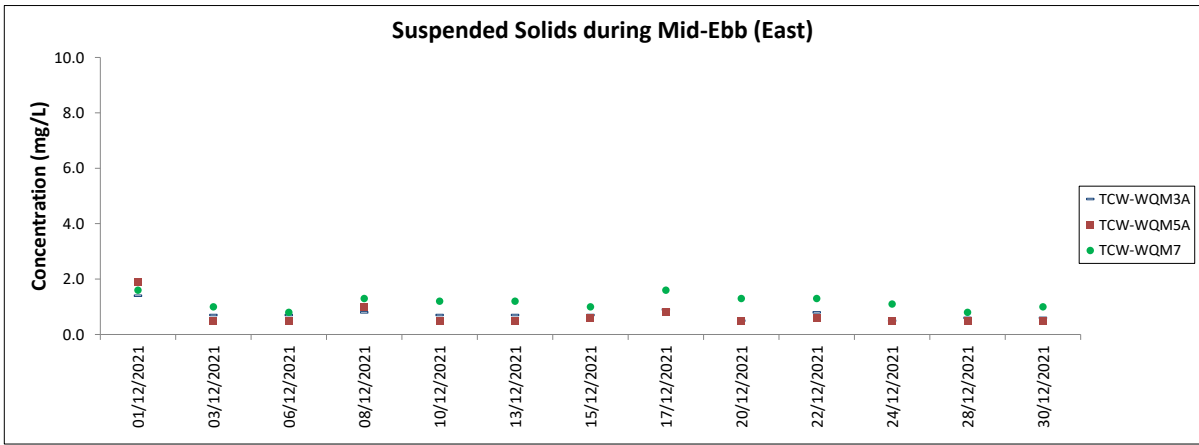
Note: The Action and Limit Level of suspended solids can be referred to Table 4.3 of the monthly EM&A report. Major site activities carried out during the reporting period are summarized in Section 1.4 of the monthly EM&A report. Weather conditions during monitoring are presented in the data tables below. QA/QC requirements as stipulated in the EM&A Manual were carried out during measurement.
