**Agreement No. CE 64/2020 (EP)
Environmental Team for
Tung Chung New Town
Extension (West) –
Design and Construction**

Monthly Environmental Monitoring & Audit Report
for January 2022

February 2022

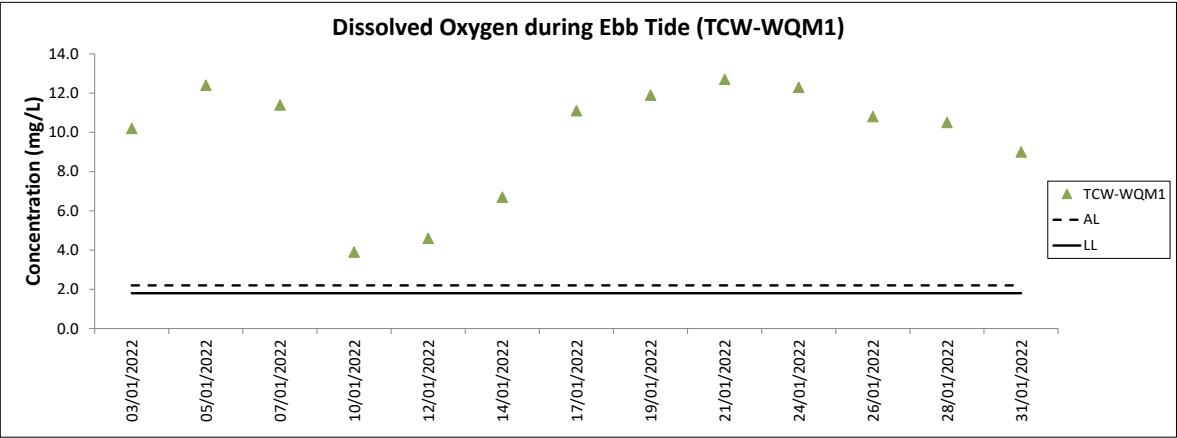
Note: The Action and Limit Level of dissolved oxygen can be referred to Table 4.3 of the monthly EM&A report.
 Major site activities carried out during the reporting period are summarized in Section 1.4 of the monthly EM&A report.
 Weather conditions during monitoring are presented in the data tables above.
 QA/ QC requirements as stipulated in the EM&A Manual were carried out during measurement.

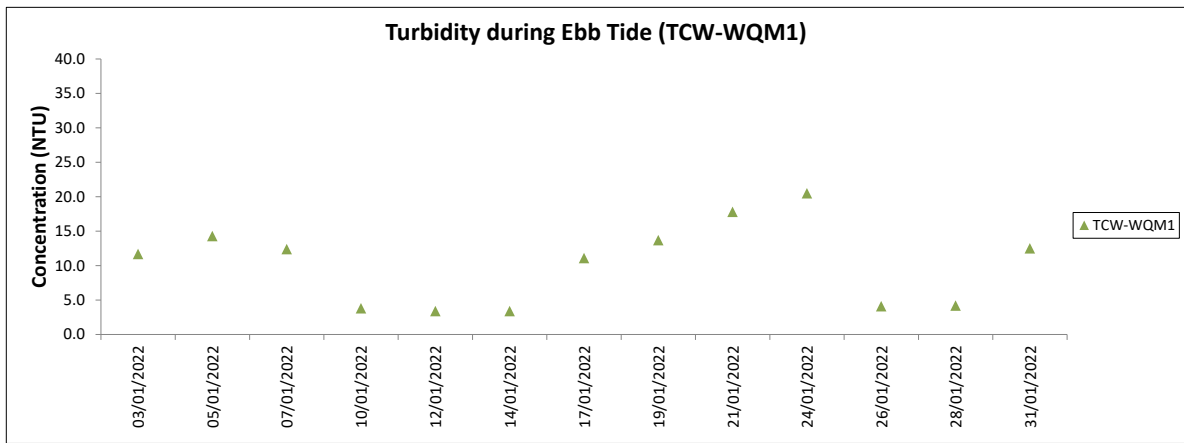
Note: The Action and Limit Level of turbidity can be referred to Table 4.3 of the monthly EM&A report.
Major site activities carried out during the reporting period are summarized in Section 1.4 of the monthly EM&A report.
Weather conditions during monitoring are presented in the data tables above.
QA/ QC requirements as stipulated in the EM&A Manual were carried out during measurement.
