**Agreement No. CE 64/2020 (EP)  
Environmental Team for  
Tung Chung New Town  
Extension (West) –  
Design and Construction**

Monthly Environmental Monitoring & Audit Report  
for April 2022

**Environmental Permit No. EP-519/2016**

**Tung Chung New Town Extension (West)**

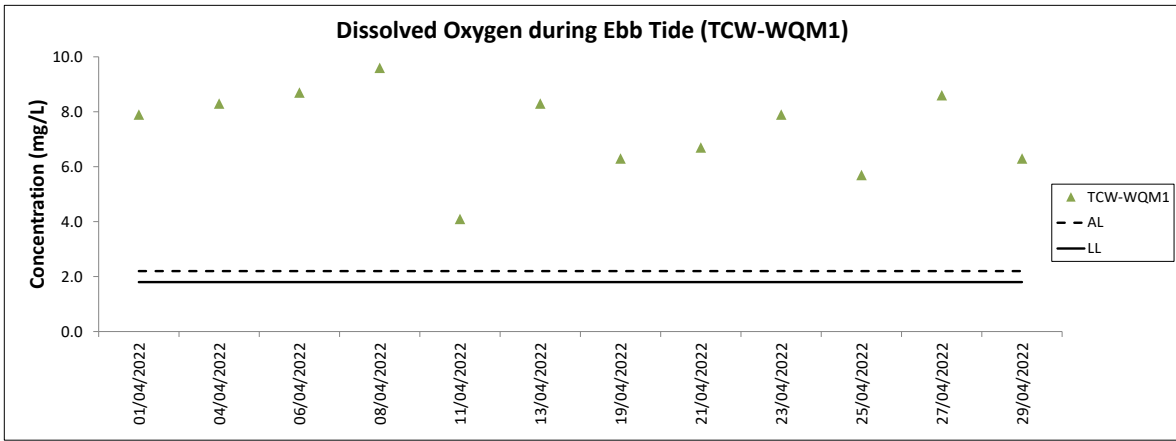
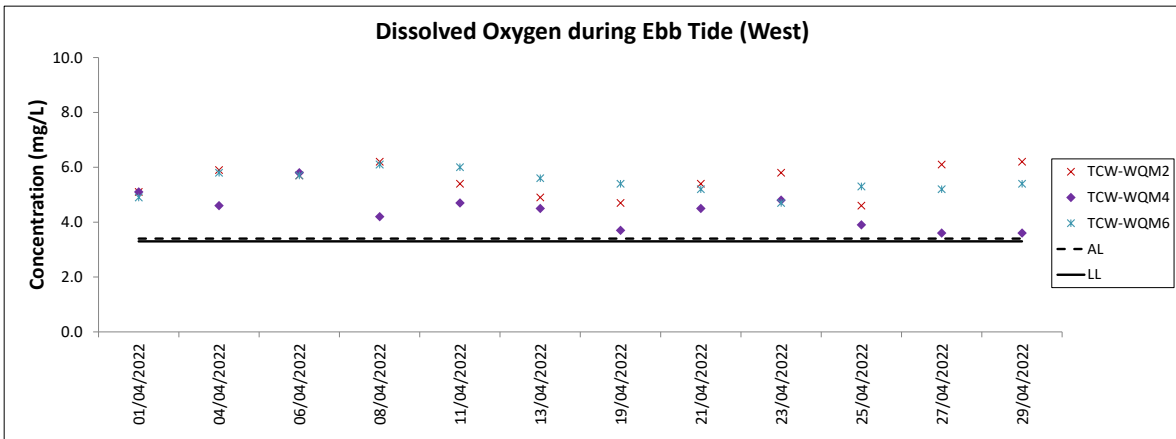
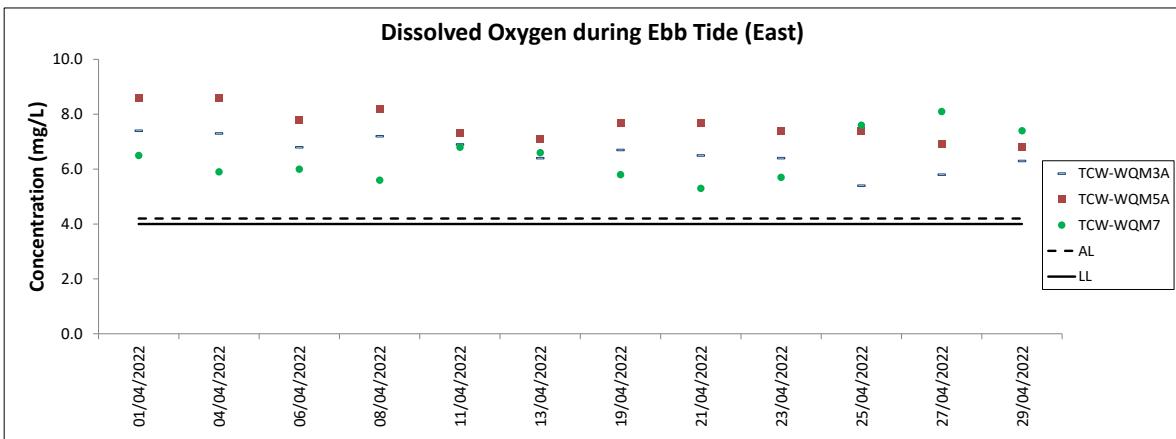
## **H4. Water Quality Monitoring Results**

Note: The Action and Limit Level of dissolved oxygen can be referred to Table 4.3 of the monthly EM&A report.  
 Major site activities carried out during the reporting period are summarized in Section 1.4 of the monthly EM&A report.  
 Weather conditions during monitoring are presented in the data tables above.  
 QA/ QC requirements as stipulated in the EM&A Manual were carried out during measurement.

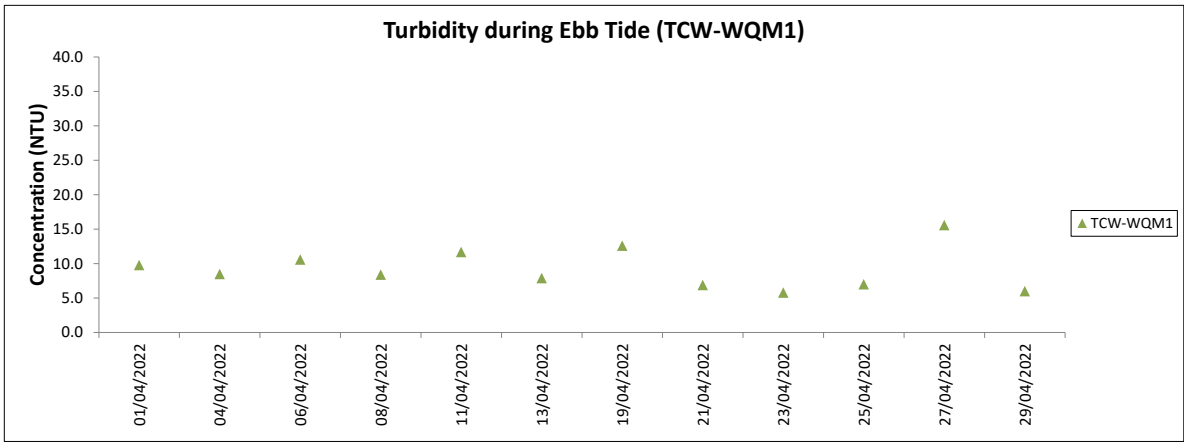
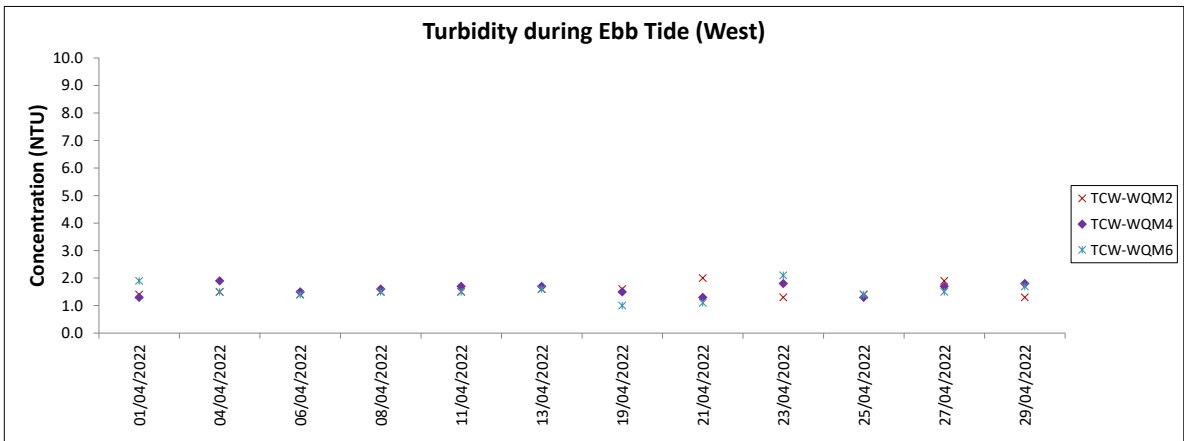
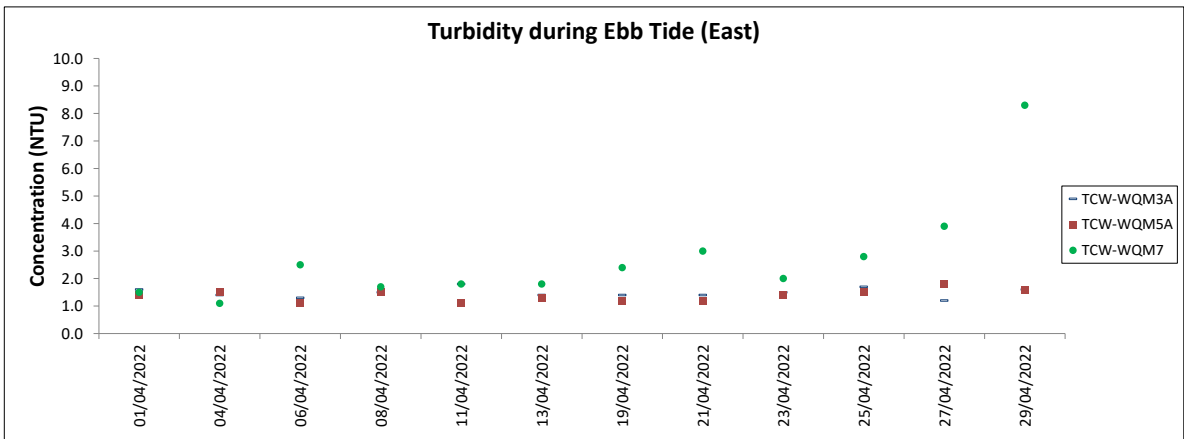
Note: The Action and Limit Level of turbidity can be referred to Table 4.3 of the monthly EM&A report.  
 Major site activities carried out during the reporting period are summarized in Section 1.4 of the monthly EM&A report.  
 Weather conditions during monitoring are presented in the data tables above.  
 QA/ QC requirements as stipulated in the EM&A Manual were carried out during measurement.

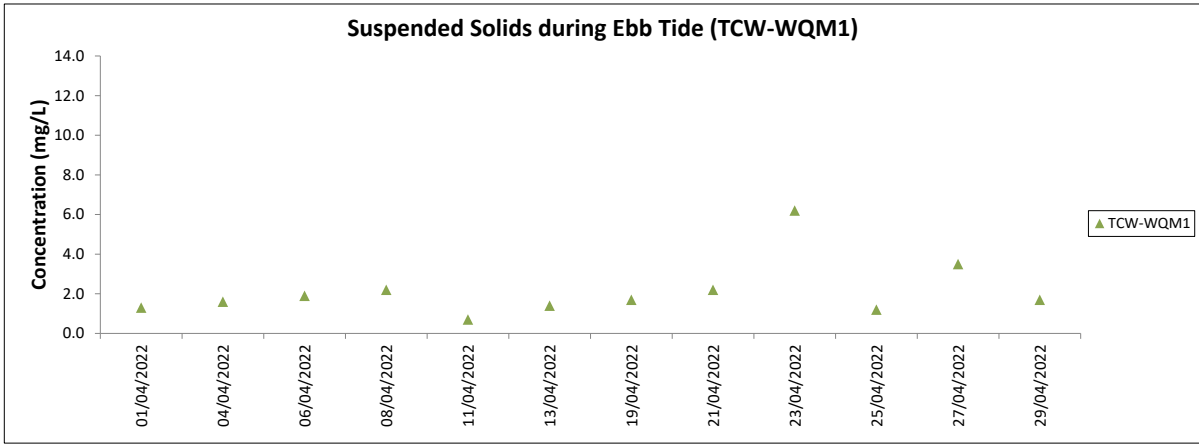
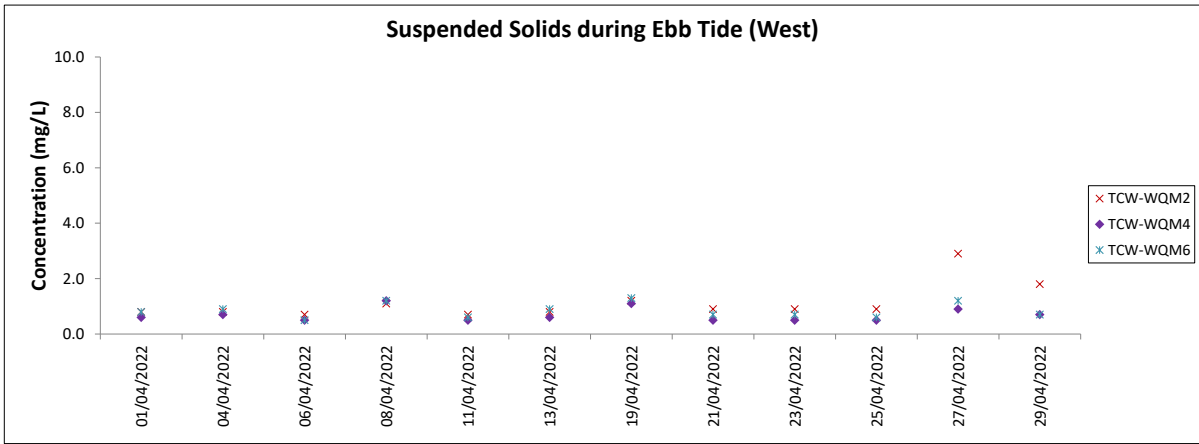
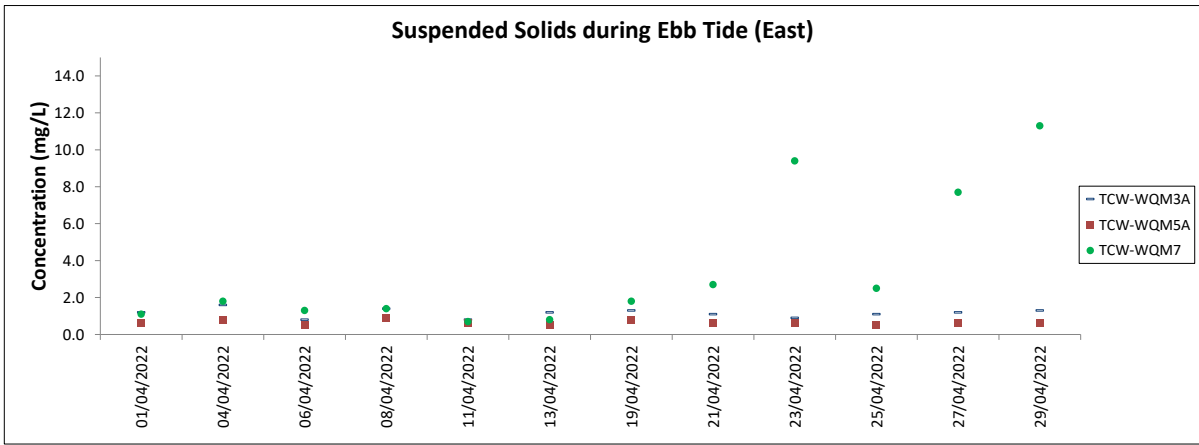
Note: The Action and Limit Level of suspended solids can be referred to Table 4.3 of the monthly EM&A report.  
 Major site activities carried out during the reporting period are summarized in Section 1.4 of the monthly EM&A report.  
 Weather conditions during monitoring are presented in the data tables above.  
 QA/QC requirements as stipulated in the EM&A Manual were carried out during measurement.
